SEDIMENT RELATED-DISASTER DUE TO INTENSE RAINFALL IN MT. BAWAKARAENG CALDERA, SOUTH SULAWASI, INDONESIA

Key words: Mt. Bawakaraeng Caldera, debris-flow, landslide, mitigation

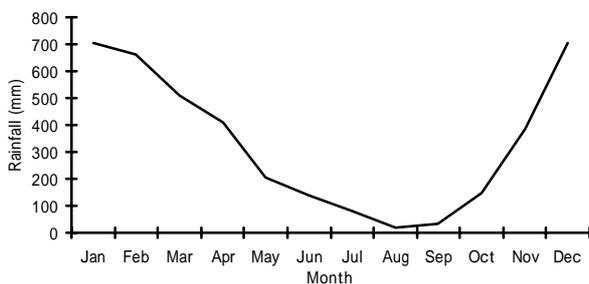
Fig. 2 The monthly average rainfall at the study area (source: monthly rainfall data from 1975 to 2005 in Malino station, 10 km away from Mt. Bawakaraeng Caldera).

Generally, the high intensity rainfall occurs from December to March in the study area. The monthly average rainfall is shown in Fig. 2.

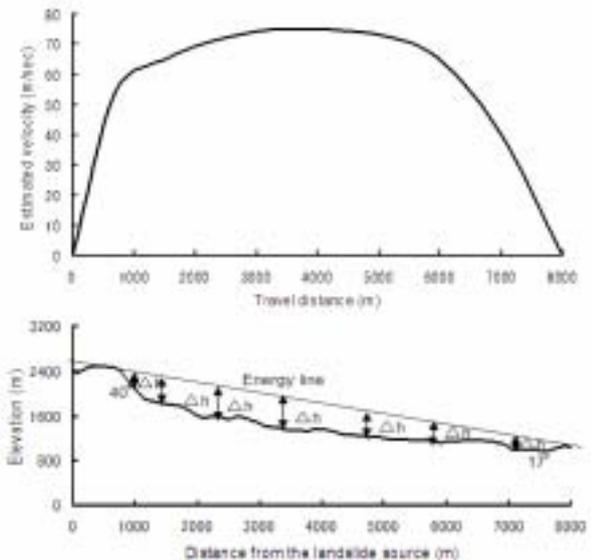
The slope gradient is 40° and 17° at the head and toe parts respectively. The longitudinal profile along the course of mass flow is shown in Fig. 3. The transportation of sediment lies within the range of 8,000 m from the source. In order the flow velocity to estimate, the energy line starting from the head of the landslide to the end of sediment where the transportation had been stopped, the velocity was considered to be zero. The following equation was used to compute the flow velocity of landslide.

$$V = \sqrt{2g\Delta h} \quad (1)$$

where, V is estimated mean velocity (m/sec), g is acceleration due to gravity (m/sec^2) and Δh is height of sliding mass from energy line (m).

The maximum estimated velocity was 75 m/sec. The mean velocity was 59 m/sec. This velocity has caused death of 32 people and destruction 14 houses. Therefore, the landslide at

Fig. 3 Longitudinal profile and estimated velocity

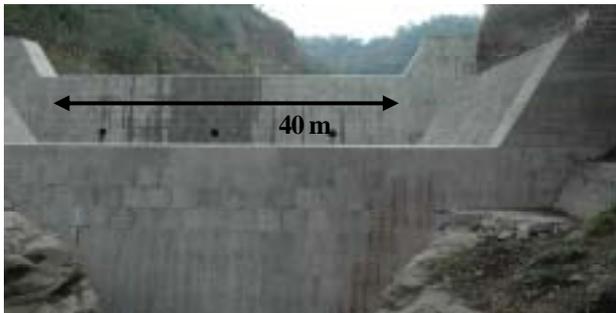
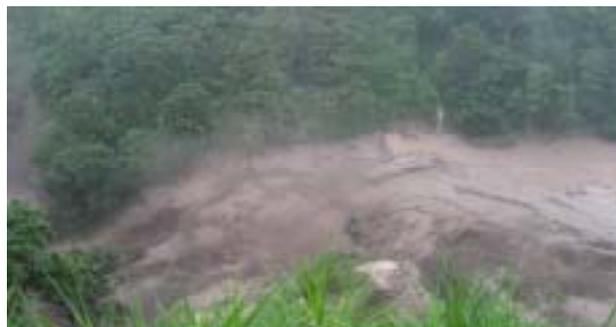
Before debris-flow(upper), During debris-flow(lower)
Fig. 4 Sabo Dam No.7-1 before and during debris-flow (event with this debris-flow is only one, since series of Sabo Dams have been constructed).

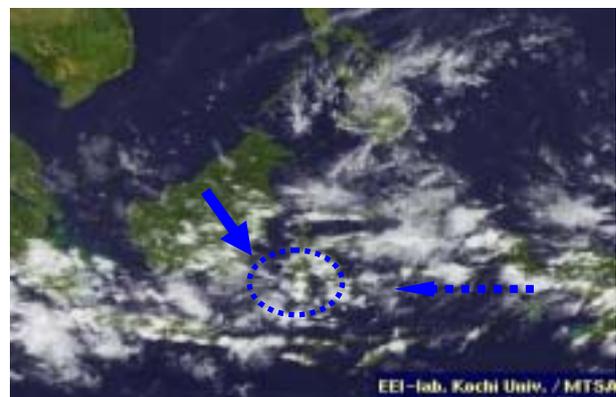
Fig. 5 The orographic clouds inducing intense rain in Southern Sulawesi on February 16, 2007 (with upper air eastward advection).

Similarly, the debris deposited had been formed large-scale debris which was discharged into the Jeneberang River at a burst on February 16, 2007. The mean velocity of the debris-flow is 32 m/sec. The volume of the debris-flow was estimated about 7.8 million m^3 . The velocity of debris-flow became 10 m/sec below 1 km downstream of the Sabo Dam No.7-1. There are three dams named Sabo dam No.7-1 to Sabo dam No. 7-3 for mitigation of sediment disaster. Photographs of Sabo Dam No.7-1 before and during debris-flow are shown in Fig. 4 and Fig. 5 represents the orographic clouds inducing intense rain in South Sulawesi which caused debris-flow on February 16, 2007.

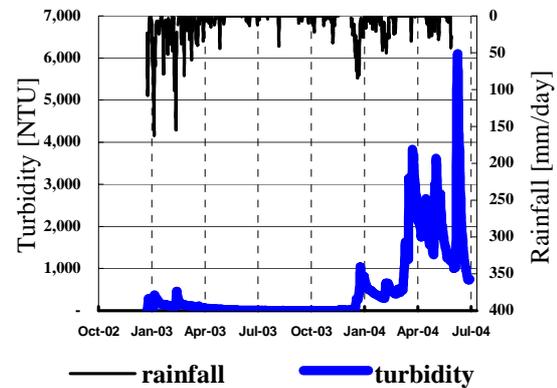
Fig. 6 Turbidity of Bili-Bili Dam Reservoir and daily rainfall condition in January 2003 to July 2004 (Ministry of Public Works, 2005)

40 - 200 m. During the dry season, the sediment does not disturb the river flow. However, when there is heavy rain, water erodes the sediment into the Jeneberang River until the entrance of the Bili-Bili Dam and the water treatment company Somba Opu. This company belongs to the local government (PDAM), supplies water from the Jeneberang River to two districts (municipalities), Gowa and Makassar. This is the worst disaster ever happened in the history of the drinking water company in Makassar. Fig. 6 shows the relationship between turbidity and rainfall pattern from January 2003 to July 2004. Before the landslide occurred, the turbidity of Jeneberang River that entered

Sombu Opu reached only 0 - 50 NTU (Nephelometric Turbidity Units) with a maximum value of 100 NTU at times. But after landslide the value sometimes exceeds 6000 NTU. However, with an NTU value of 6,000, 1 out of 2 liters of a sample is mud. This result is obtained after adding double chemical additives, Poly aluminum chlorite (PAC), in order to clean the water from the mud. Hence, the fish habitat of the Jeneberang River was affected; in general, the river ecosystem was destroyed. The landslide also caused intense sedimentation of the Bili-Bili dam, reducing the lifetime and function of the dam.

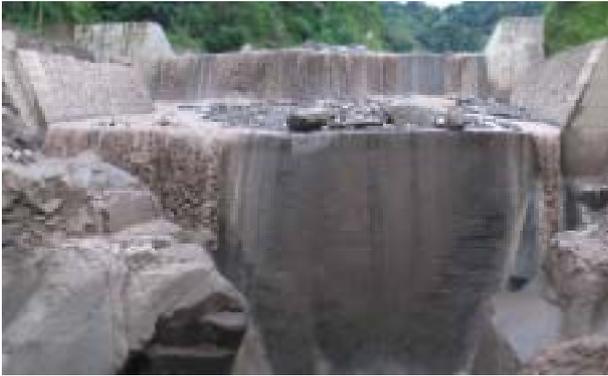
Fig. 7 Downstream view of concrete Sabo Dam No 7-1 in Jeneberang River, 7 km far from Mt. Bawakaraeng (photograph by Hazama, 2007).

To reduce the subsequent sediment-related disaster in study area, a pilot project under the cooperation of Japanese and Indonesian governments have been conducted for hazard mitigation. For debris basins surrounded by residential development, the capability to remove material may be necessary on a 24-hr basis during storms and three Sabo Dams out of seven planned are constructed so far in Mt. Bawakareang Caldera area (Fig. 7, 8 and 9).

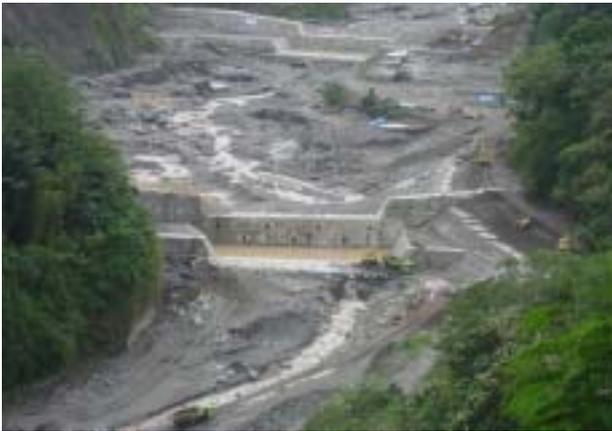
Fig. 8 Downstream view of concrete Sabo Dam No 7-2 in Jeneberang River (photograph by Hazama, 2007).

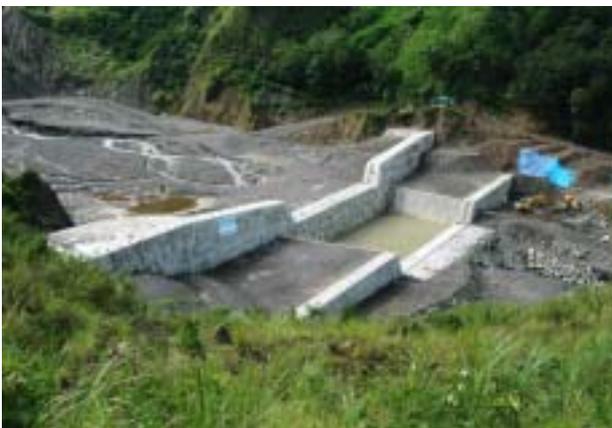
Fig. 9 Upstream view of concrete Sabo Dam No 7-3 in Jeneberang River (photograph by Hazama, 2007).

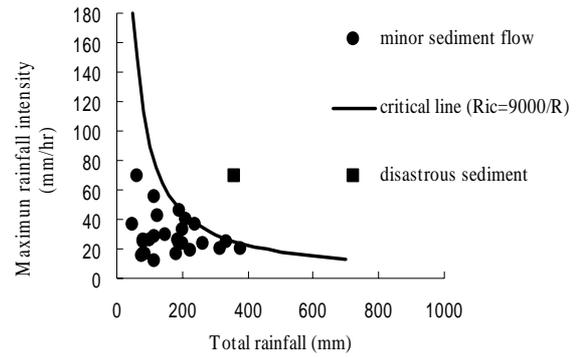
in March 2004 led to landslide after three days. Fig. 10 illustrates when rainfall condition exceeds the critical line, disastrous sediment may be induced.

Fig. 10 Relationship between the maximum rainfall intensity and the total rainfall (rain-gauge in Malino station, 10 km from Mt. Bawakaraeng Caldera, rainfall data from 1999 to 2004, large-scale landslide in March 26, 2004 with maximum intensity 70 mm/hr with volume about 232 million m³).

where, Cd corresponds to "C" for daily rain Pd, Ci is "C" for rain intensity Pi. For a torrent, Cd takes a value of 12000 and Ci is 9000 at the study area. The obtainable results using this equation are shown on Fig. 10 and Fig. 11 respectively.

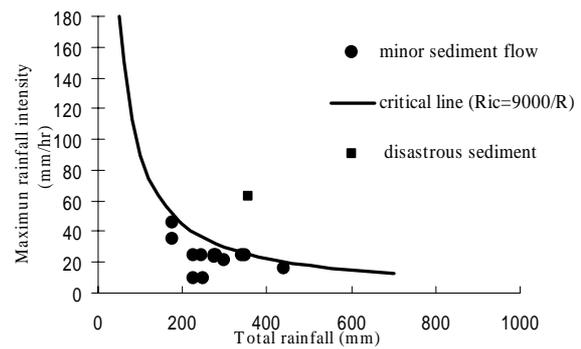
However, when rainfall condition below the critical line, a minor sediment flow may be occurred as illustrated clearly by Fig. 11.

Fig. 11 Relationship between the maximum rainfall intensity and the total rainfall (rain-gauge in Lengkesse Village, entrance to Mt. Bawakaraeng Caldera, rainfall data from 2005 to 2007, large scale debris-flow on February 16, 2007 with maximum intensity 40 mm/hr with volume about 7.8 million m³).

In this case there was an intense debris-flow due to rainfall and a huge amount of sediment deposited during the March 2004 landslide. Debris-flow is likely to occur in many cases even if the rainfall intensity is below the critical line.
