PHYSICAL AND CHEMICAL PROPERTIES OF SLIP SURFACE IN LANDSLIDES TRIGGERED BY HEAVY RAINFALL AT HITA, OITA, JAPAN

Mega Lia ISTIYANTI¹, Satoshi GOTO²

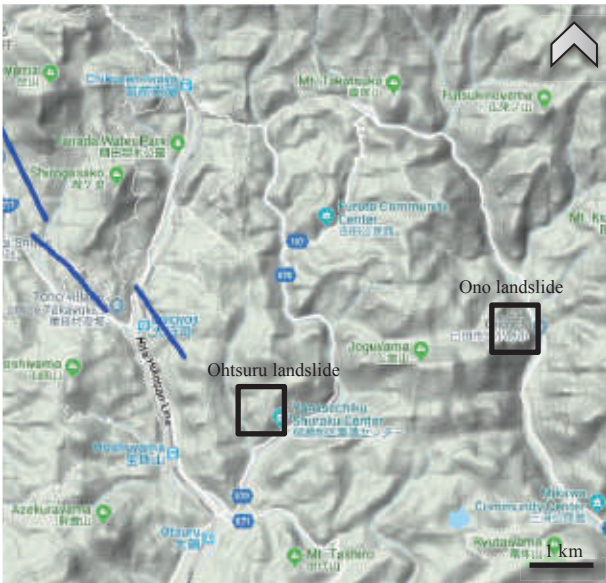
Fig. 3 Active fault zone map near research location (<https://gbank.gsj.jp>)

The research locations have not passed by active fault zone. However, Nishiyama fault zone is located near research location. This active fault zone distributed from Okinoshima to Asakura. The length of section from Kaho-gun Katsuragawa-cho until

Asakura-gun Toho-mura, Asakura-shi is 29 km (**Fig. 3**) (<http://gbank.gsj.jp>).

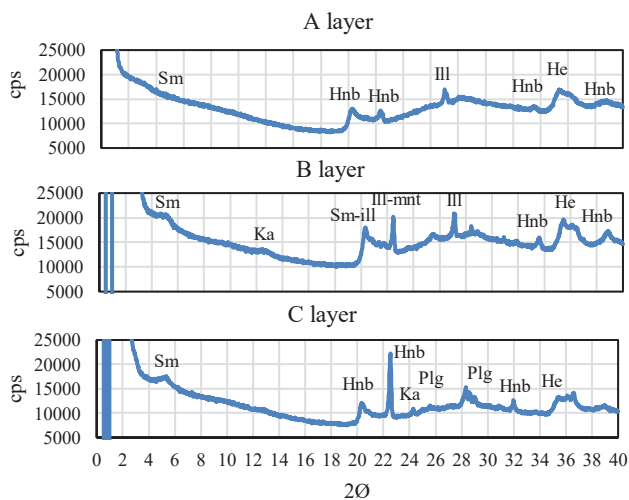
Fig. 5 X-ray diffraction analysis results in Ono landslide

The X-ray diffraction analysis shows the clay minerals more contains in A and B layer, moreover, C layer more contains hornblende and plagioclase (Fig. 5). Landslide materials in Ono, contain smectite, kaolinite, illite, illite-montmorillonite, hornblende, and hematite. Smectite, kaolinite, illite, and illite-montmorillonite are type of clay minerals.

Plagioclase and hornblende are kind for igneous rocks base minerals on Bowen reaction. On Mitchell and Soga (2005), Hematite is other clay minerals in oxides group.

On the soil properties analyses results, B soil layer represent the slip surface characteristics. However, on the minerals analyses results, different contain between A and B layer with C layer may represent the slip surface characteristics.

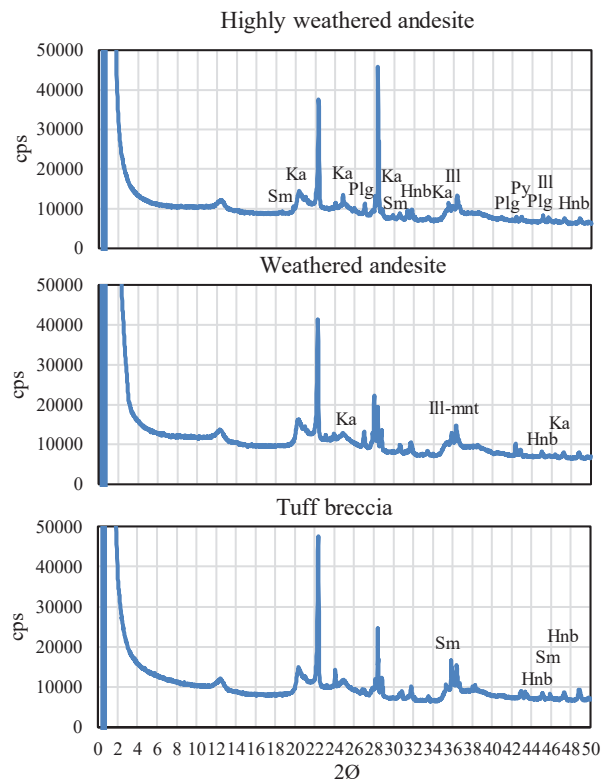
Fig. 7 X-ray diffraction analysis results in Ohtsuru landslide increase from weathering andesite to tuff breccia. However, the soil hardness value in tuff breccia layer is high.

X-ray diffraction analysis results shows many kinds of minerals are contained in highly weathered andesite, different with other soil layer (Fig. 7). Weathered andesite and tuff breccia are contained a few of minerals such as kaolinite, illite-montmorillonite, hornblende, and smectite.

Tuff breccia contains a smectite which have a swelling ability. The water flow may have located at the boundary of tuff breccia and andesite layer and have a reaction with smectite in tuff breccia. The swelling ability on smectite can triggered the collapse of tuff breccia layer.
