Geotechnical aspect of the damage caused by the April 25th, 2015 Gorkha earthquake of Nepal

Key Facts
- Hazard Type: Earthquake
- Date of the disaster: April 25th, 2015
- Location of the survey (Lat. Lon., name or address): Kathumandu, SunKoshi, Melamchi, Dhunche
- Date of the field survey (if any): May 27th to June 2nd, 2015
- Survey tools (if any): Laser ranger, GPS receiver
- Key findings: Creeping mountain slopes, local soil subsidence, peak discharges in monsoon rains

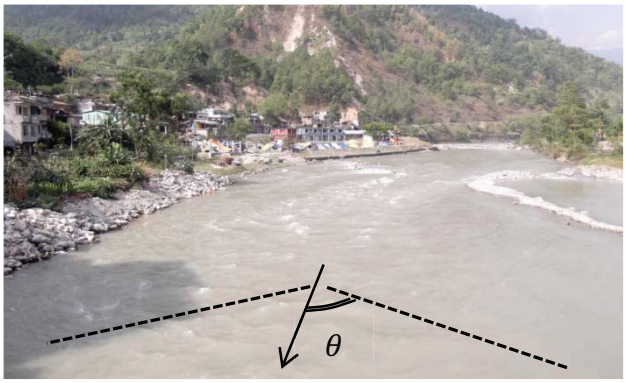
River water depth h is first estimated by observing hydraulic disturbances transmitted downstream within a steady cone of apex angle θ (Fig. 2)

Fig. 2 Hydraulic jump propagating across flow at an angle θ at Point 2 (N27.75387°, E85.82750°). The distortion of angle θ in the photo is corrected.

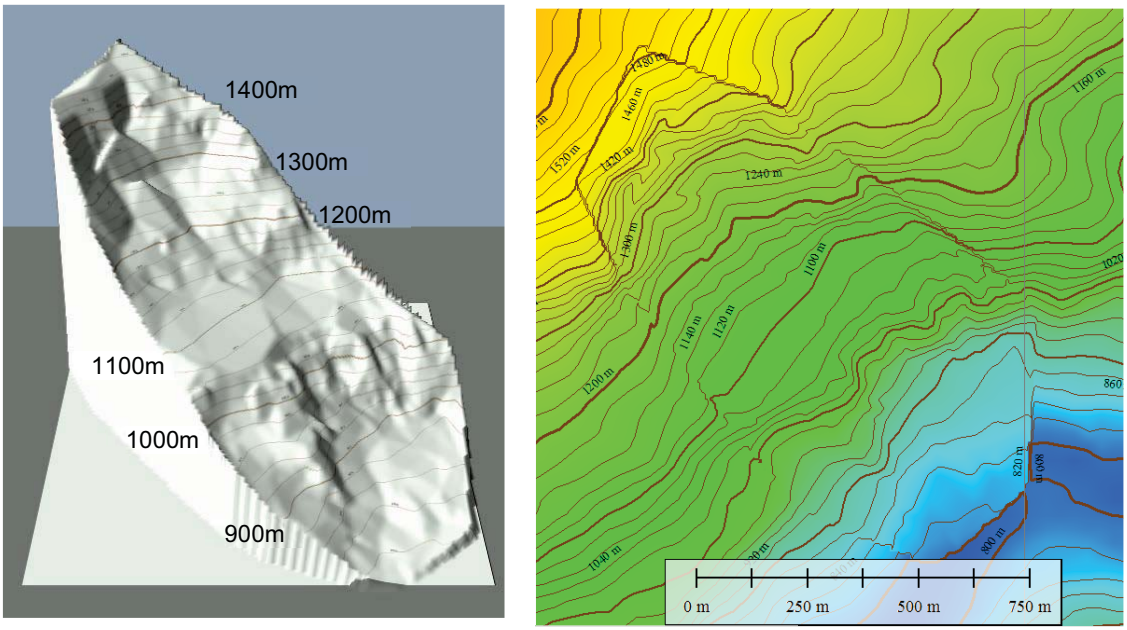
The obtained digital elevation model for the exposed slip surface of Sunkoshi is shown in Fig. 4. Though the entire stretch of the exposed surface was not completely covered, there are a clear hollow of the top source region, major triple-terraced cliffs on the top, halfway up and near the toe of the exposed surface with conic talus deposits (collections of broken rock fragments) rimming along the bases of these cliffs. The angle of repose for these talus deposits varies from 15 for low-lying coarse rock deposits to 30 degrees for high-lying finer granular deposits.

Fig. 4 DEM of slip surface of Sunkoshi Landslide

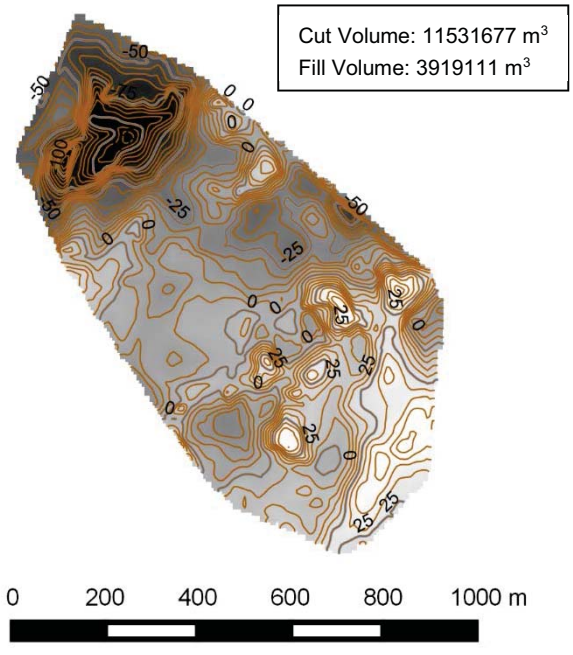
The 30m SRTM DEM[9] was used herein as the terrain model before the landslide event, and compared with the obtained digital elevation model of the exposed slip surface. Fig. 5 shows the change in elevation within the measured slip surface area.

The volumes of the detached and deposited masses are estimated to be 11.6 million m^3 and 3.9 million m^3 respectively. The observed area is not covering the major part of the soil mass that has fallen into the river, and the remaining mass of 7.7 million m^3 may

Fig. 5 Change in elevation within exposed slip surface

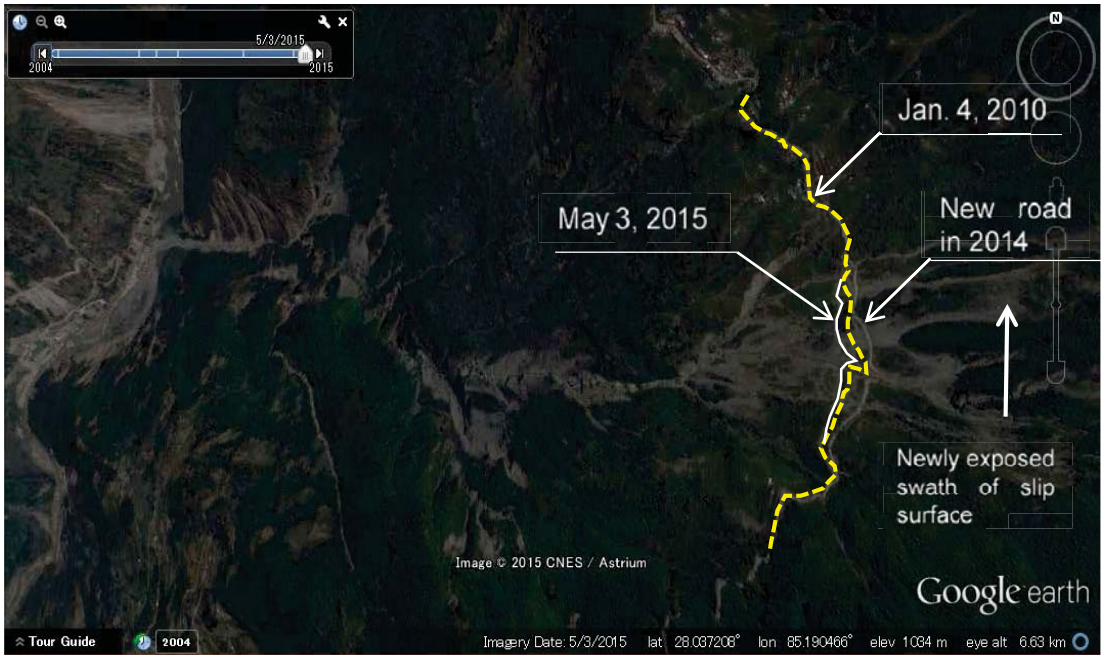
However, the road started moving inch by inch towards the toe. Fig. 6 shows two satellite images of the zone from different times, the upper and lower ones from May 3, 2015 and January 4, 2010, respectively. It is noted in the latest 2015 photo that the temporary road section crossing the landslide zone is currently west of the location where this section used to be in 2010, indicating that this section

Fig. 6 Landslide zone (Satellite images taken from Google Earth)

has been carried down the slope over about 30m horizontal distance. Moreover swaths of bare slip surfaces above the temporary road, which swaths were not visible in the 2010 photo, are appearing and becoming thicker year by year. Though the earthquake had reportedly invisible and indirect effect upon the remaining landslide mass, the movement of the mass can be further accelerated in the upcoming rainy season of 2015.

(1) Continuous monitoring of creeping slopes from satellites is important. Once early signs of accelerated movements are found, pin-point countermeasures can be taken in a quick and rational manner.

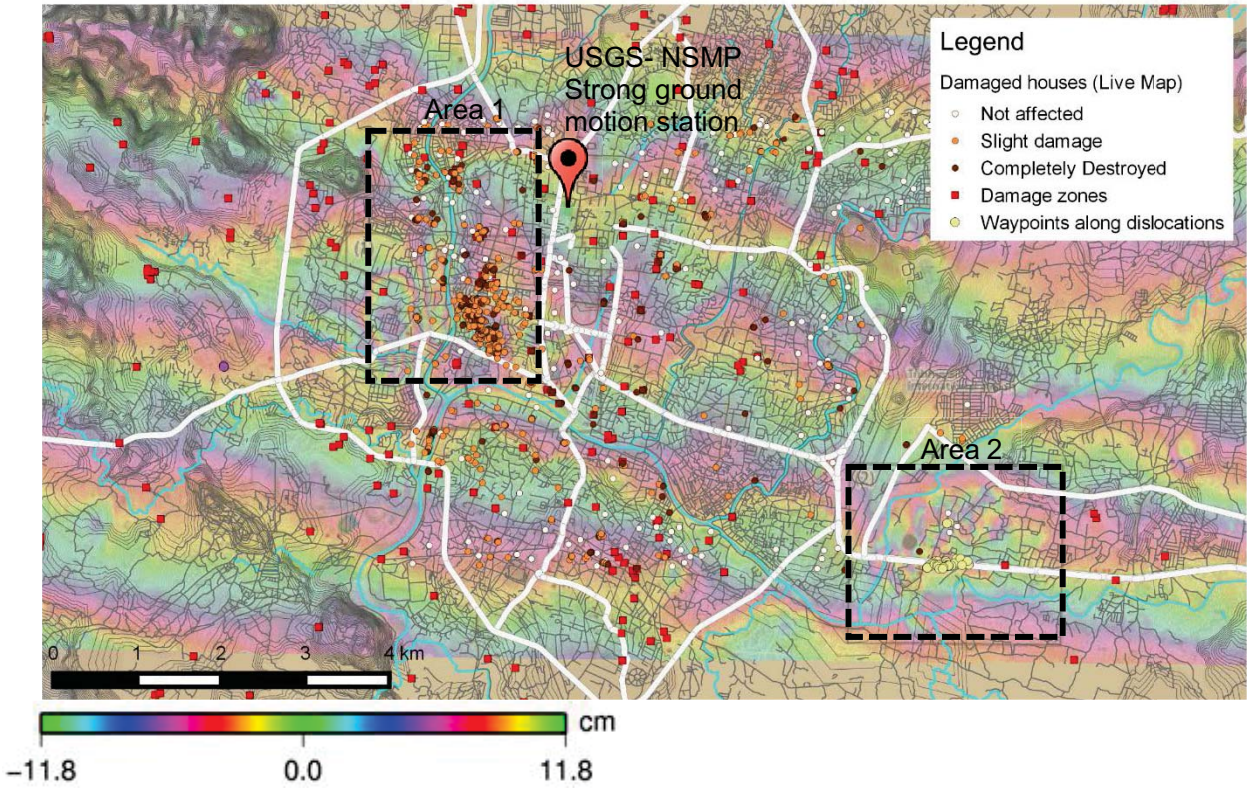
However, this motion may not necessarily represent the motions particularly in areas most seriously hit by this earthquake. The GDACS (Global Disaster Alert and Coordination System) LIVE map[4)], which integrates geo-spatial data from a range of sources in support to response efforts following the Gorkha earthquake, shows that seriously damaged houses and buildings were clustered very locally along rims of terraces and valleys of streams that cut the terraces down to a little lower elevations. When these damaged houses and buildings are mapped upon the PALSAR II interferogram[12)], it is noted that the biggest cluster of damaged houses/ buildings can be found where the east-west trending parallel firinge pattern shows some clear disturbance (Area 1 in Fig. 9). This disturbance can be considered to be a local deformation of the ground. There is not necessarily a clear causual relationship confirmed between the local ground deformation and the cluster of damaged

Fig. 9 Distribution of damaged houses/ buildings on GDACS Live map derived from satellite imagery and field data, and PALSAR II interferogram[12] showing some disturbances in Areas 1 and 2.

houses/ buildings. However, the ground motion here may have been intense enough to cause both the ground deformation and the damage to houses/ buildings though the sequence of these two are not clear yet.

to be carefully reflected upon rehabilitation plans in a rational manner, because as has been frequently seen in the past earthquakes, it can take months for liquefied/weakened soil to regain its initial strength, and even after it regains the strength, the soil can remain susceptible to re-liquefaction in a next big earthquake. To pinpointing locations of weak soils, InSAR imageries may be useful as shown in Fig. 9.

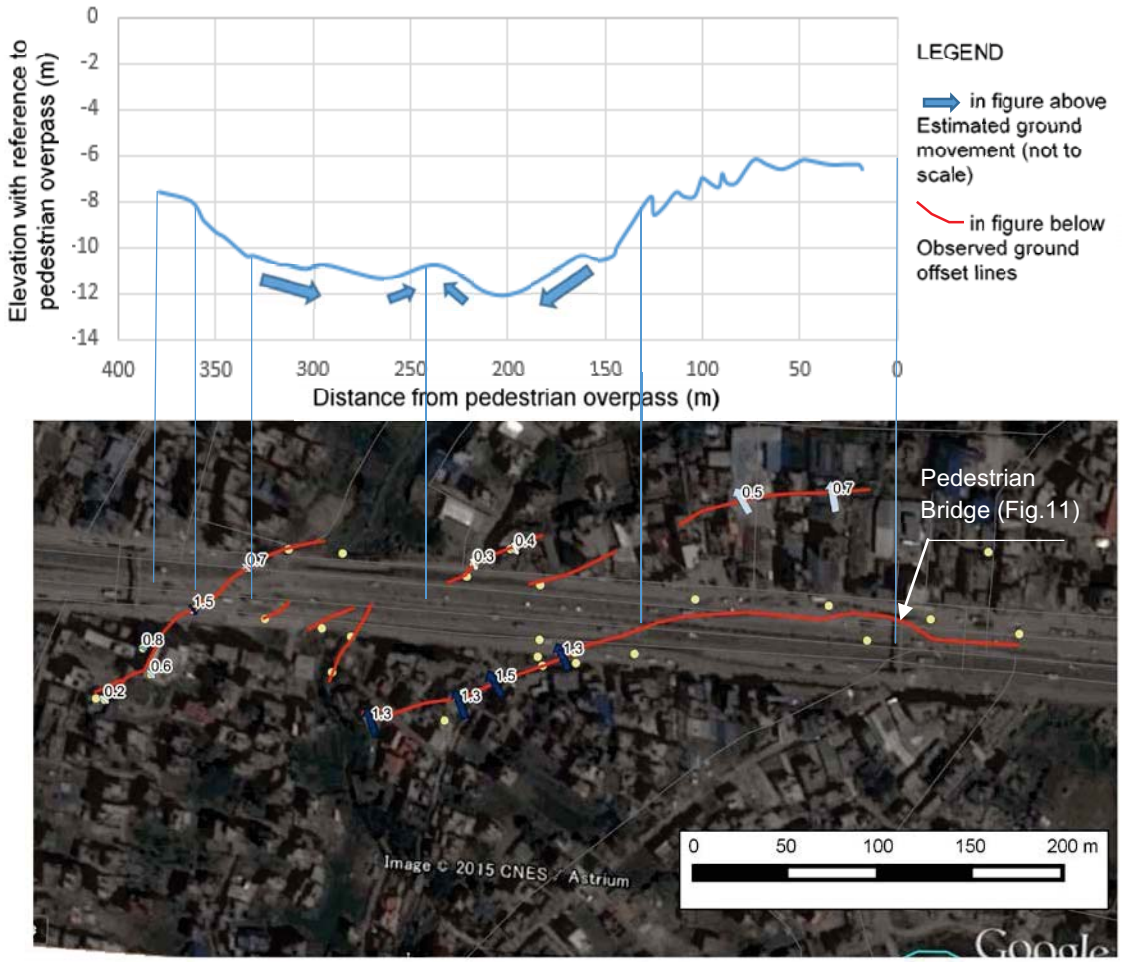
One more disturbance of the fringe pattern of PALSAR 2 interferogram (Area 2 in Fig. 9) can be found about 2 km southeast of the Kathmandu International Airport. One segment of the Kathmandu-Bhaktapur Road section of the Araniko Highway goes across this area. Several lines of vertical ground dislocations appeared diagonally across this road making up a 200m wide swath of ground failure. Way points were marked along visible dislocation lines by a GPS receiver as shown in Fig. 10. The observed ground dislocation lines are about parallel to each other trending in NEE to SWW direction and curving slightly north. These lines die out beyond their eastern and western ends, and about 300 to 400 m long at the most, indicating that the failure was just localized within this short extent of the swath. Two outermost lines of relatively large dislocation indicates that the area between these two major dislocation lines has sunken by about 2m.

However the midmost lines suggest that the lowest wet zone may have been pushed slightly up. To highlight this feature of mass movement, a longitudinal section of the highway was measured by using a handy laser-ranger (Fig. 10).

Though the cause of this ground depression is yet controversial, a local lateral spread of hill slopes towards the low-lying wet ground is considered to have been responsible for this failure. The wet and slightly depressed area along a small creek may have been liquefied and/or weakened enough to allow the hillsides on both sides of the creek to move a little sideways against each other, and bulged. This ground depression was responsible for the deformation of a two-span continuous pedestrian overpass, whose north pier rests exactly on the south-easternmost line of dislocation while the other two are on the relatively intact hill terrace. As the result, the northern pier was on an outward tilt, causing the joint between the pier and the deck to open up by about 40 to 45 cm. It was lucky that the deck of the overpass did not fall onto the highway probably because it was a two-span continuous beam. However there could have been a good chance for any single supported deck of overpass to fall upon the highway with its spans expanded. According to one of our members who have been there on May 2nd, the joint may have been opened a little wider (Fig. 11), indicating that the tilt of the pier has been increasing gradually and/or in a step-wise manner over a month's period since the earthquake hit.

Fig. 10 Depressed section of Araniko Highway and ground offsets in Area 2 (Photo from Google Earth)

(4) Something that should not be forgotten in discussing rehabilitation strategies is that a large earthquake often causes long lasting geotechnical problems. Once liquefied and/or weakened, soil can remain soft for months. Locations with similar land deformations to the depressed section of Araniko Highway are to be identified and their causes are to be thoroughly studied to reflect the natures of weak soils upon rehabilitation/ reconstruction plans.
