Damage of Infrastructures due to 2011 Great East Japan Earthquake

Keiichi Tamura

Public Works Research Institute, Japan

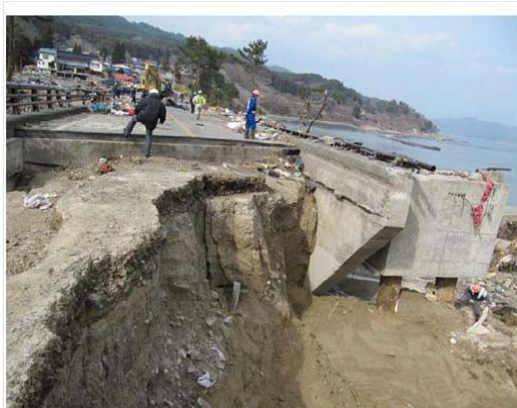
Wash out of embankment

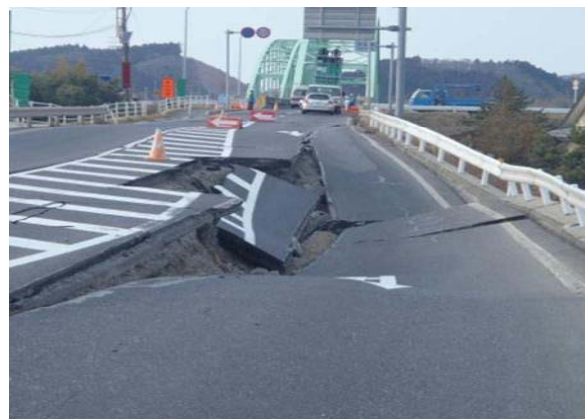
Collapse of embankment

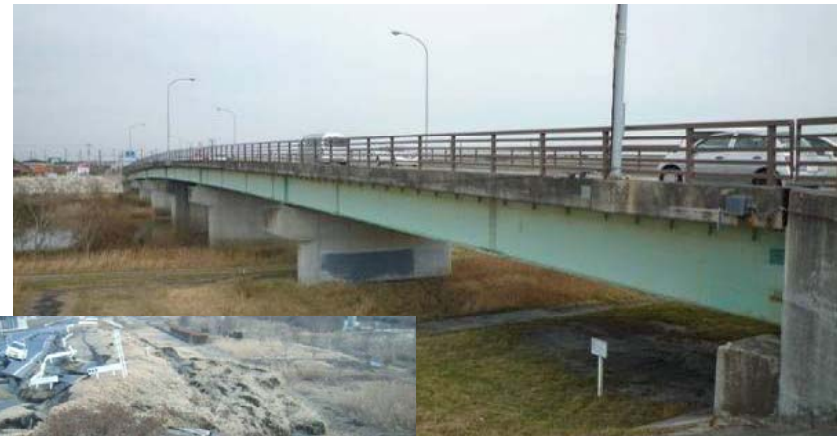
Effects of liquefaction

Liquefaction
at adjacent
levee

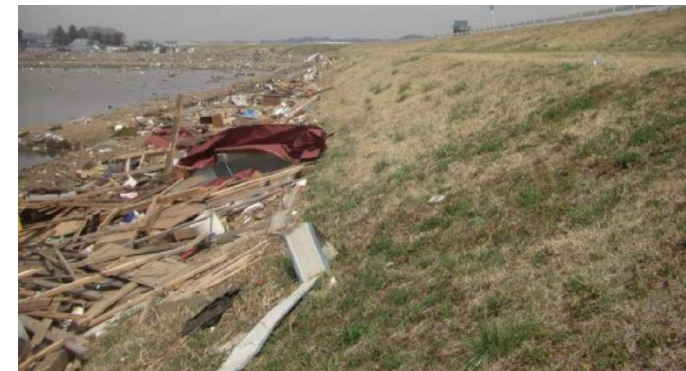
Effectiveness of earthquake countermeasures

- Naruse River (Nakashimo). Improved by sand compaction piles.
- Although the inner side of levee was inundated with tsunami, no settlement or deformation of levee occurred due to ground motion.
