Site Investigation of the Ahar-Varzeghan Earthquake in NW Iran of August 11, 2012

Key Words : *the Ahar-Varzaghan Earthquake, field investigation, damage to houses and buildings, damage to lifelines*

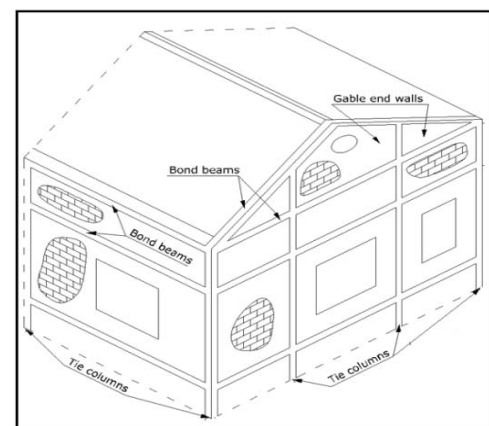
Fig.9 Structure of half reinforced masonry building

Half reinforced buildings are comprised of tie columns and bond beams filled with masonry walls and covered by ordinary joist concrete beams shown in **Fig.9**. This type of buildings has grown to be used in villages after promotion by the Housing Foundation of Iran.
