Tohoku Off Shore Earthquake & Tsunami,
Japan
 $M_w=9.0$ 11 March 2011

Lifelines Performance Assessment
Preliminary Summary

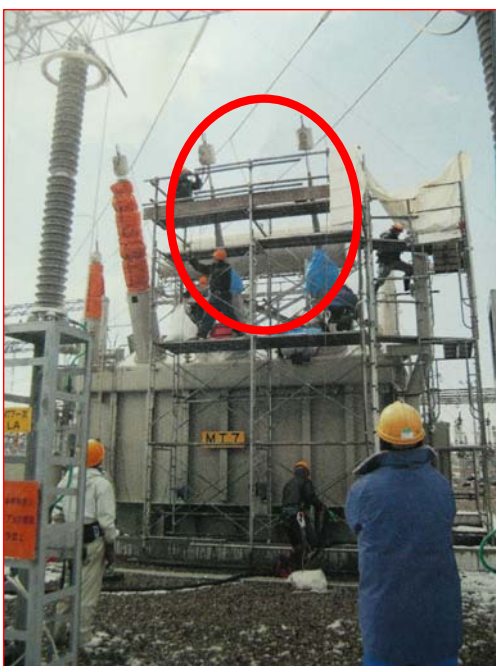
POWER TRANSFORMER FAILURES: Significant issue for transmission line system

Reported Failures

M9	M7.2	M7.1/M6.3
(3/11/11)	(4/7/11)	(4/11-12/11)
47 Shaking	15 Shaking	1 Shaking
23 Tsunami

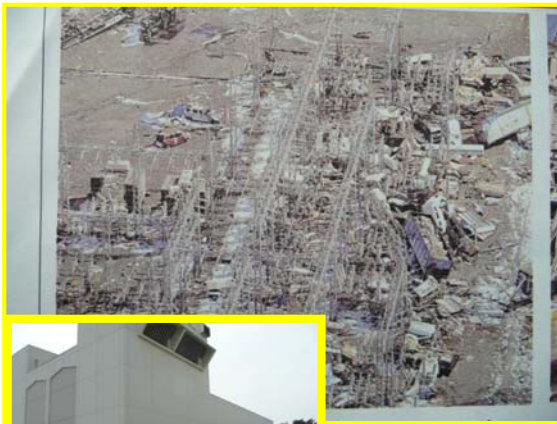
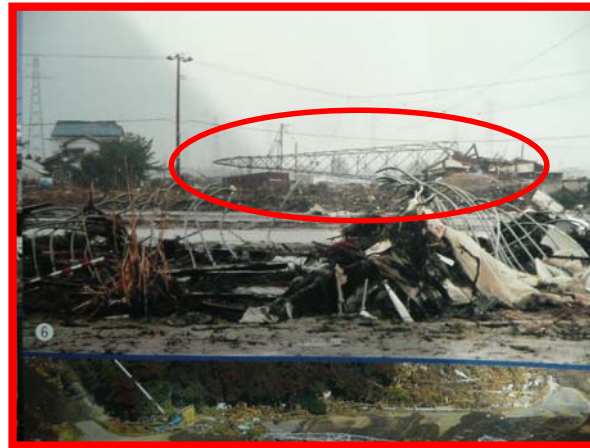
TRANSMISSION LINE TOWER

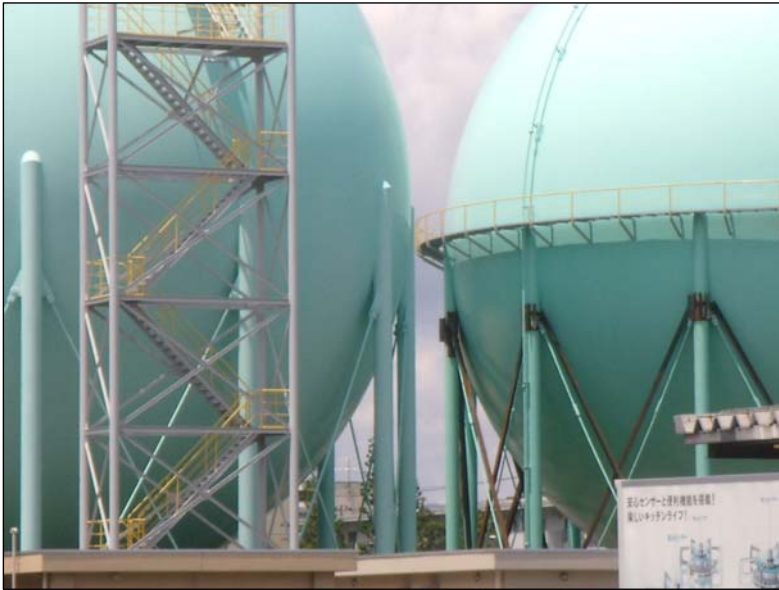
1. Information from Profs Nojima and Maruyama
 1. 84 days for 100% restoration
2. Sendai Gas Bureau
 1. Sendai system: 60 seismometers, 11 blocks, 3 blocks manually closed after earthquake, all 11 blocks after tsunami
 2. Transmission & Distribution Pipe breaks: 20 DIP, 170 steel, **0 PE**
 3. Gas Holders (spherical tanks) bracing damage
 4. 30% (pre-3.11) to 100 % Niigata pipelines (and Tokyo Gas servicing)
 5. No fires
 6. Concentrated damage in cut and fill slope
3. Sendai LNG port facility:
 1. Good performance , except salt water damage & pipes/equipment
 2. Emergency generator waterproofed and reliable
 3. Restart Dec. 2011

Recommendations:

1. Protect Important Equipment with waterproofing
2. Improve service line performance in cut/fill slopes
3. Improve bracing for gas holders (spherical tanks)

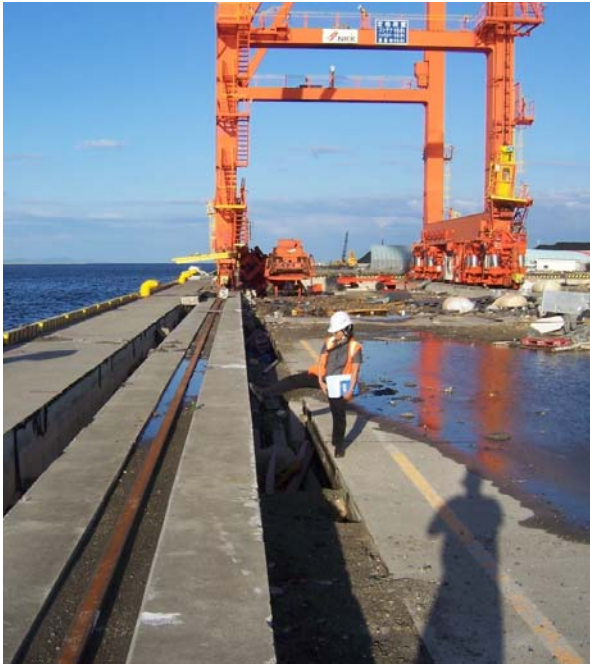
Observations:

1. Shaking caused significant damage, lateral spread, and settlement in areas of poor fill
2. Important Equipment kept in non-waterproof areas
3. Poor performance of Fill Areas and Slopes
4. Significant losses due to tsunami damage
5. Lack of electricity is a major setback

Recommendations:

1. Protect important equipment in watertight areas.
2. Test Important Equipment
3. Consider Ground Improvement in Fill Areas
4. Significant losses due to tsunami damage

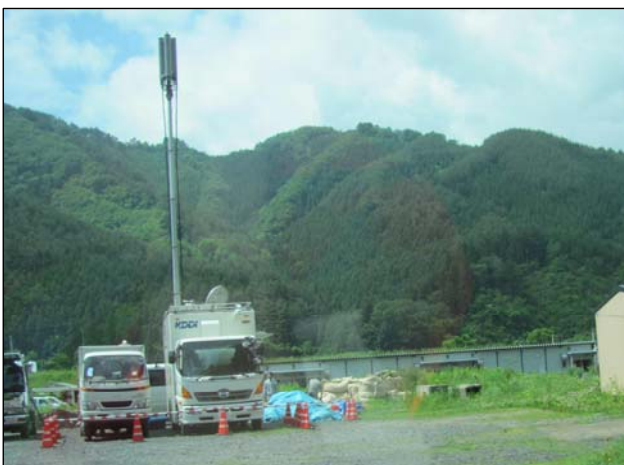
KDDI COW

KDDI Cell Site Rebuilt

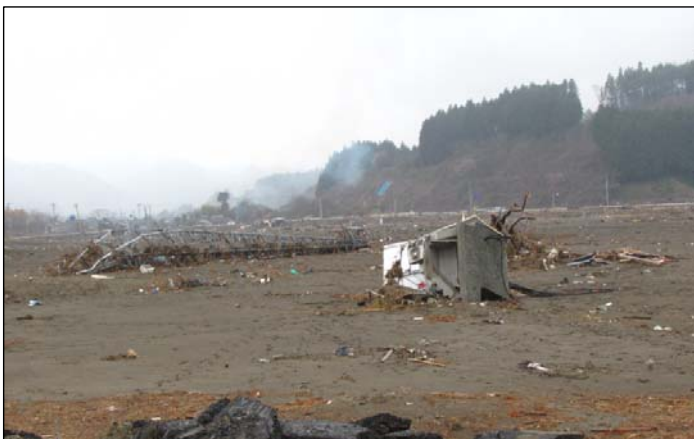
Rikuzentakata

- Almost 1,500 satellite terminals were deployed by a telecommunications service provider.
- Service restoration to wireless networks included 30 cell on wheels by one of the network operators.

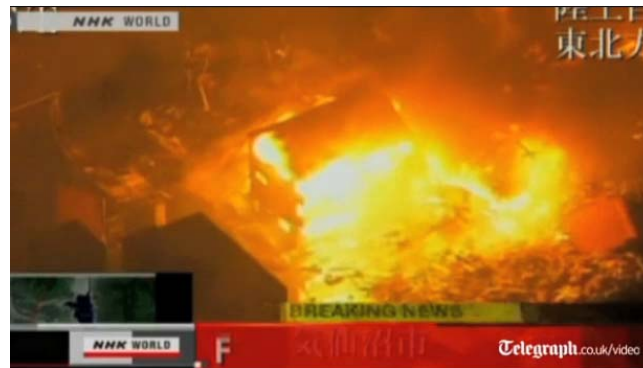
Kesennuma Fire

Video: Night of 3/11/2011 - 3/12/2011

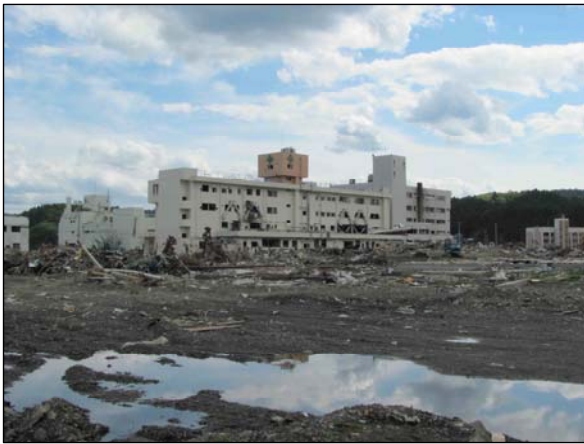
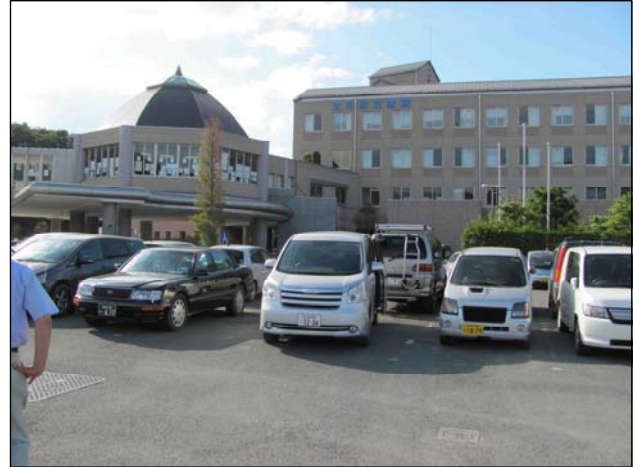
- Passed by one hospital totally gutted by tsunami,
- Hospital in Onagawa – ground floor inundated, back to operation
- How can we get more information
 - Hospitals not in tsunami zone (within 0.3g PGA zone)
 - Performance of lifelines within the hospital
 - Total number of hospitals within the impacted area
 - Total capacity
