# Piles for RC/Steel-frame buildings pulled up by tsunami at Onagawa Town, in the March 11<sup>th</sup> 2011 East Japan Earthquake

Kazuo KONAGAI, Takashi KIYOTA and Hiroyuki KYOKAWA  
IIS, University of Tokyo

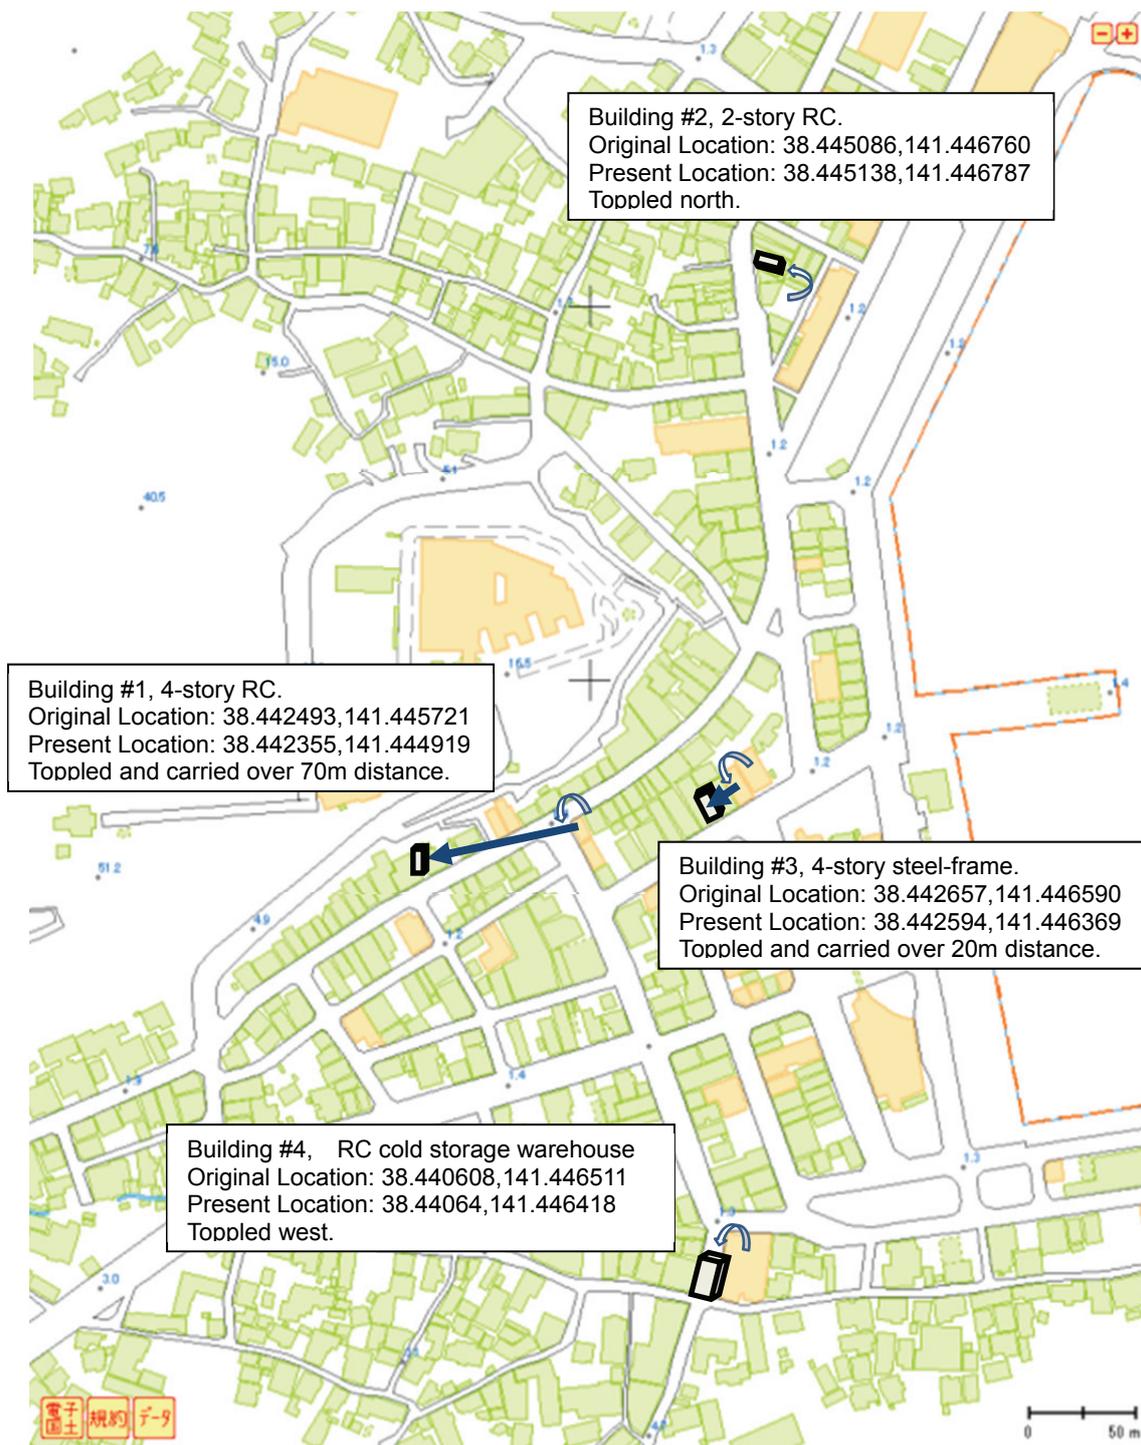
Fig. 2 Locations of uprooted pile-supported buildings in Onagawa (after Cyber-Japan<sup>2)</sup>).

Fig. 2 shows the downtown center of Onagawa, facing Onagawa Bay. There were at least four pile-supported buildings found toppled and /or carried over some distances. Piles are all of PHC (Pretension type centrifugal High strength pre-stressed Concrete) type,
