JAPAN SOCIETY OF CIVIL ENGINEERS

SITE INVESTIGATION AND ENGINEERING EVALUATION OF THE VAN EARTHQUAKES OF OCTOBER 23 AND NOVEMBER 9, 2011

February 2012

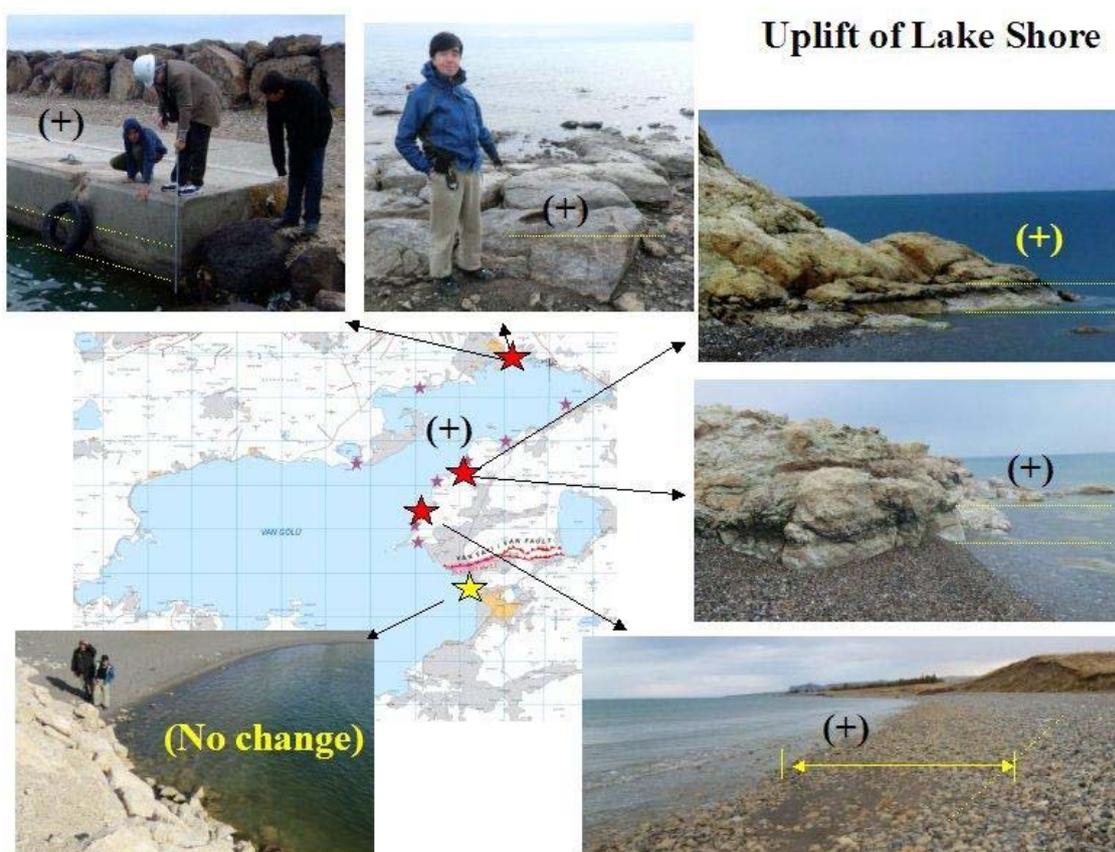
was uplifted by 30-40 cm and it is in accordance with the inference of the seismicity (Figure 5.3). This uplift observed along the northern part of the causative fault, i.e. on the hanging wall block. Based on the measurements by the authors on the coast of the lake in Erciş town, the land uplifted about 30-33 cm. The authors also measured a withdrawal of about 45 cm on the lake shore near to Amik Castle and Yeşilsu villas and slight uplift along the shore line between Dağönü and Mollakasım villages. All these locations are shown by red stars in Figure 5.3. Emre et al. (2011) observed uplifts at ten locations on the shore of Van Lake between Adilcevaz at the NW and north of Van at southeast. These uplifts range between 10 and 40 cm and their locations are shown by purple stars in Figure 5.3.

Figure 5.3. Views of uplift of the shoreline at several localities along the shore of Van Lake (Smaller purple and big red stars are the observations of uplifting reported by Emre et al., 2011 and by the authors of this report, respectively).

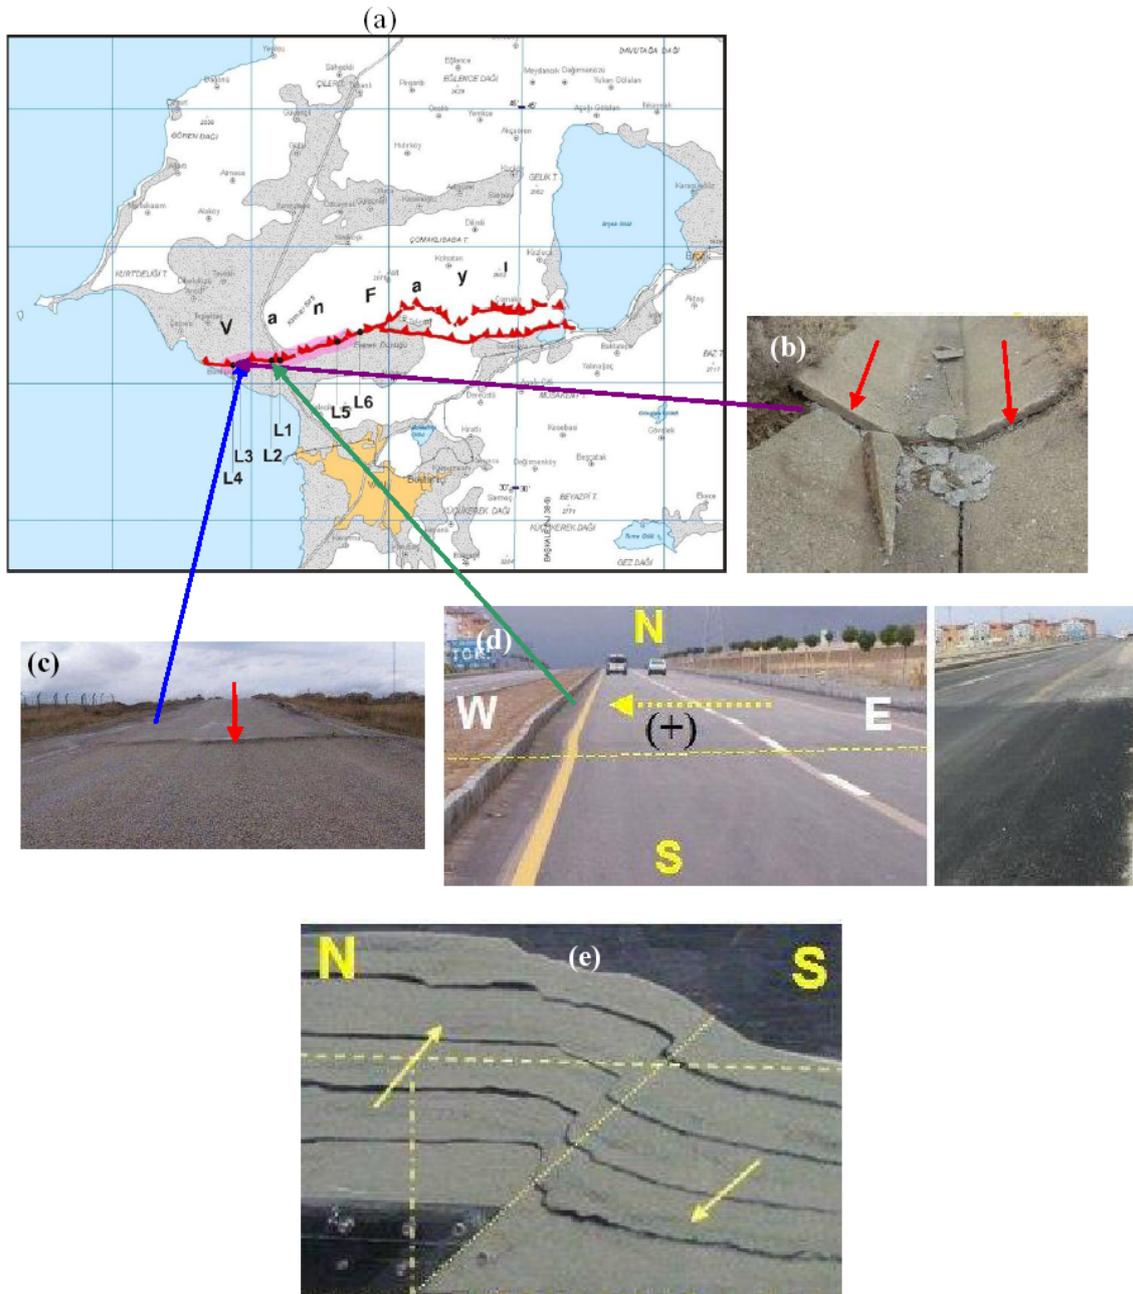
Although there was no clear well-defined fault scarp along the fault trace, some uplift of ground, roadways, compression of bridges, canals slope failure and extensive liquefaction and associated lateral spreading over the fault front. The three locations, where the authors have observed the traces of the surface rupture, are also shown in Figure 5.4. One of them is located at east of the road between Bardakçı and Topaktaş villages (NW of Zeve Akademi Houses). At this location, a displacement about 5-6 cm was measured in a concrete water canal oriented perpendicularly to the surface rupture and it was observed that the part of the canal on northern block trusted towards south (Figure 5.4b). At the second location, a deformation trending in N50E was observed on the asphalt pavement of the Bardakçı-Topraktaş village and an uplift of 6 cm was measured on the northern block (Figure 5.4c). The deformation of Van-Ağrı Highway in the close vicinity of Yüzüncü Yıl University Campus at about 7 km north of Van City also implied slight sinistral lateral movement of the fault and this part of the highway was repaired (Figure 5.4d). Akyüz et al. (2011), who extended their reconnaissance towards east, reported that they observed very thin cracks trending N75E on a stabilized road close to Aşit village and the terraces trending in E-W direction at the south of Gedelova (near west of Erçek Lake) should be possible trace of the thrust fault causing

Figure 5.4. (a) Map showing the surface rupture of the October 23, 2011 earthquake (Emre et al., 2011), (b-d) locations of the surface rupture observed by the authors, (e) a model showing the deformation caused by thrust faulting by Ohta and Aydan (2004).

As there was no well-defined fault scarp, some researchers claimed that the earthquake was caused by a blind thrust faulting. When ground near surface is quite soft, the deformation caused by thrust faulting would be diluted over a great area as seen in the picture (Figure 5.4e) of a model faulting experiment performed by Ohta and Aydan (2007).

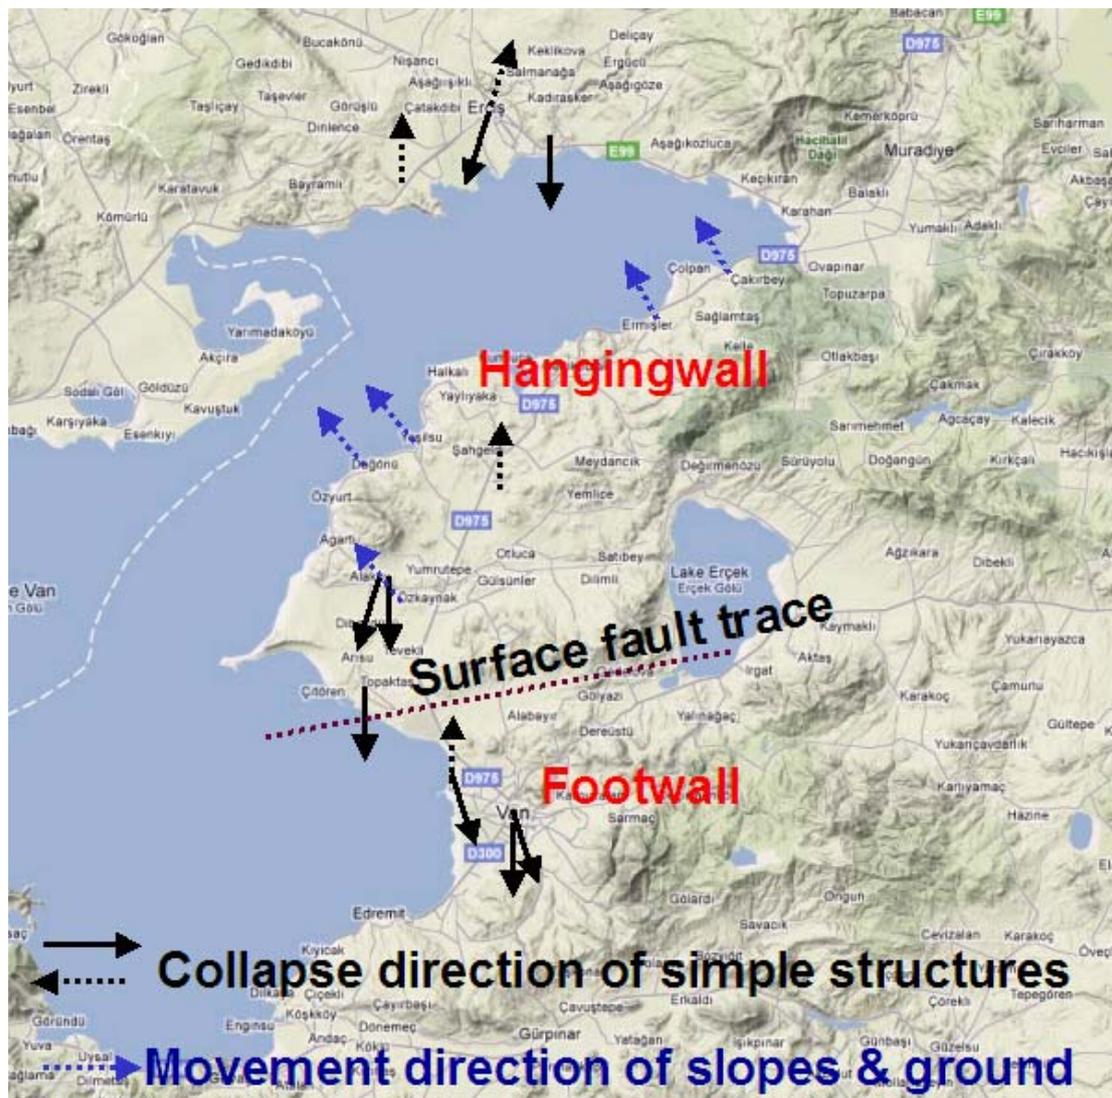
Distribution of collapse directions in the epicentral area is generally concentrated in north and south directions (Figure 6.14).

Figure 6.14. Collapse direction of simples structures and movement direction of slopes and ground in the epicentral area

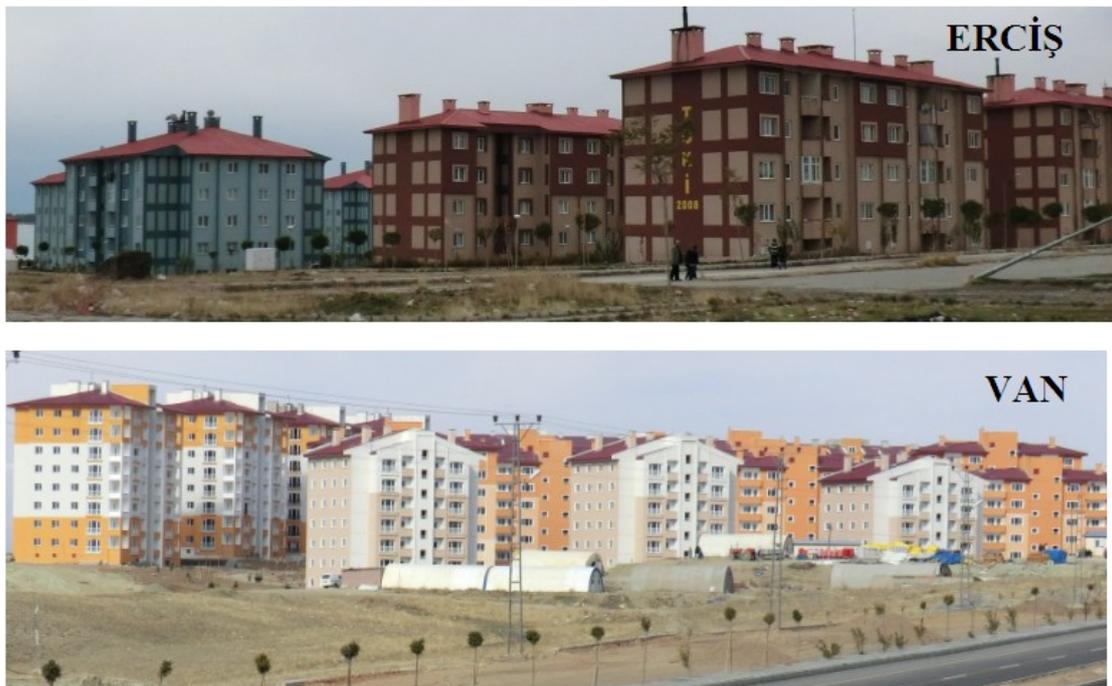
In recent years, TOKİ, which is a state owned construction company specialized in buildings, have constructed buildings in Van, Edremit and Erciş. These buildings are like honeycombs utilizing shear walls as the shear load bearing elements. This earthquake probably is the major event to test their structural performance during earthquakes. The story number of TOKİ buildings in Erciş is 5 while it is 8 stories in Van. They are generally built on a firm ground. Although the authors could not inspect these buildings in detail, the visual inspection indicated that there was almost no damage to the buildings (Figure 7.4).

Figure 7.4. Views of non-damaged TOKİ buildings.

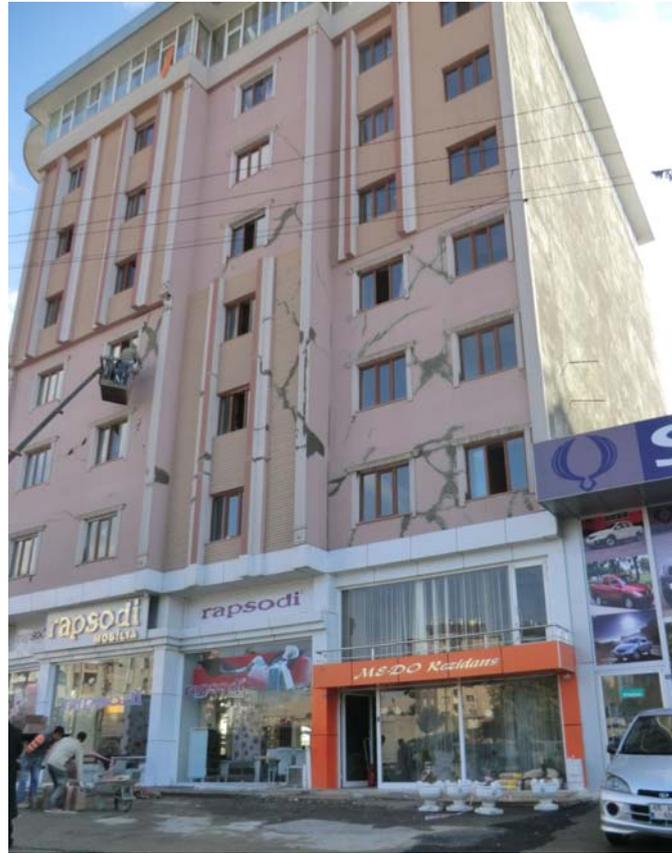
The authors noticed during their reconnaissance that some buildings were repaired by cosmetic non-structural methods such as re-plastering of cracked beams, columns, infill-walls and beam column connections, which had disastrous effects in the November 9, 2011 earthquake (Figure 7.5). Similar problem was observed in buildings

Figure 7.5. Cosmetic repairs applied to a damaged RC building in Van on November 5, 2011 after the Van-Erciş earthquake.

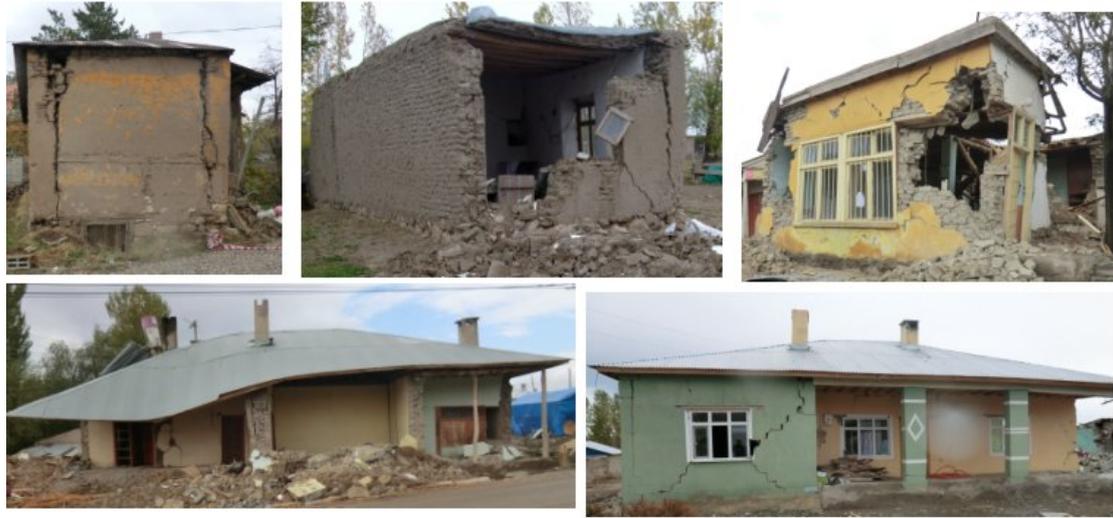
Buildings in rural areas and villages are of brick masonry or stone masonry type. Timber houses (hımsı in Turkish) are quite rare due to lack of forests in the earthquake affected area. This earthquake damaged many such buildings as seen in Figure 7.7. In addition to poor quality construction and inappropriate construction materials, the damage was caused partly by the settlement and lateral spreading of liquefied ground to buildings. Figure 7.8 shows some examples of geotechnically induced structural damage at Çelebibağı village of Erçiş.

Figure 7.7. Views of heavily damaged brick masonry buildings.

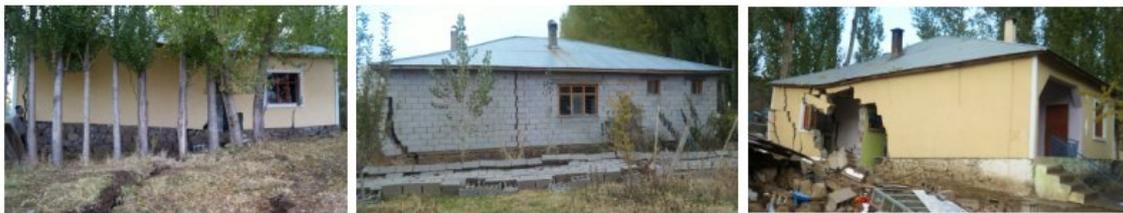
Figure 7.8 Lateral spreading induced damage to buildings in Çelebibağı village (Erçiş).

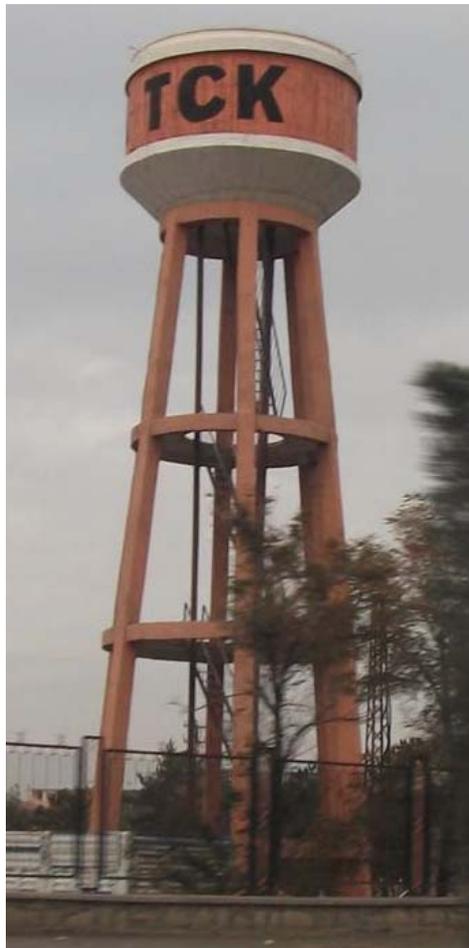
Directorate of Highways (TCK) of Turkey in Van city. No damage was observed at this water tower. The visual inspection of water tanks at other localities indicated that there was no damage. The water in this type of elevated water tanks may act as an active damper during ground shaking. As noted from Figure 6.8, the natural period of these structures are generally long. This may be additional factor why such structures are not affected by earthquakes in this earthquake as well as in previous earthquakes in Turkey.

Figure 7.10. Non damaged elevated water tank owned by the General Directorate of Highways (TCK) in Van city.

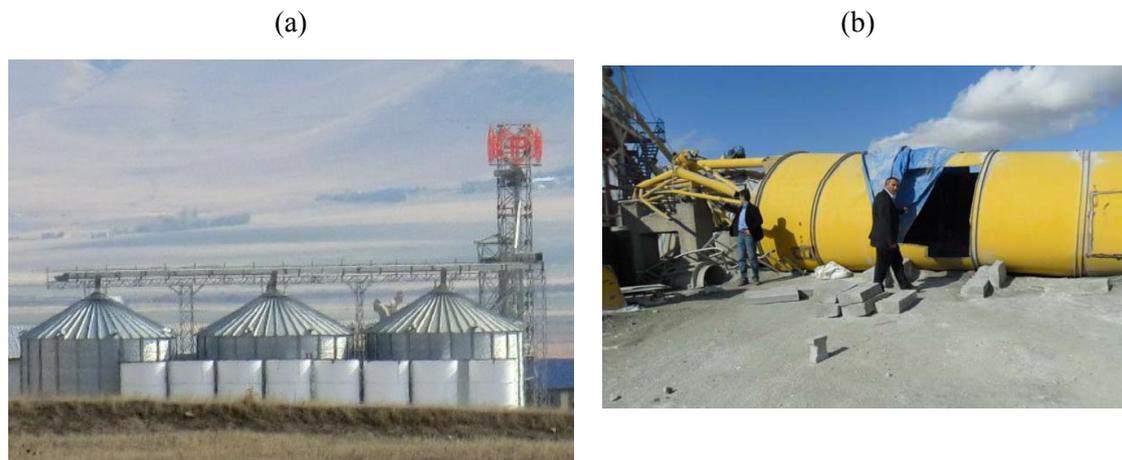
Although some silos observed by the authors were intact and did not suffer any damage (Figure 7.11a), KOERI (2011) reported that many cement and wheat silos, which were

full at the time of the earthquake, either fully collapsed or were seriously damaged (Figure 7.11b-c). Some of silos ruptured at their base due to bending or insufficient seating width of the supporting concrete.

Figure 7.11. (a) Non-damaged silos in Van and (b) collapsed cement silo in the Van Industrial complex (KOERI, 2011).

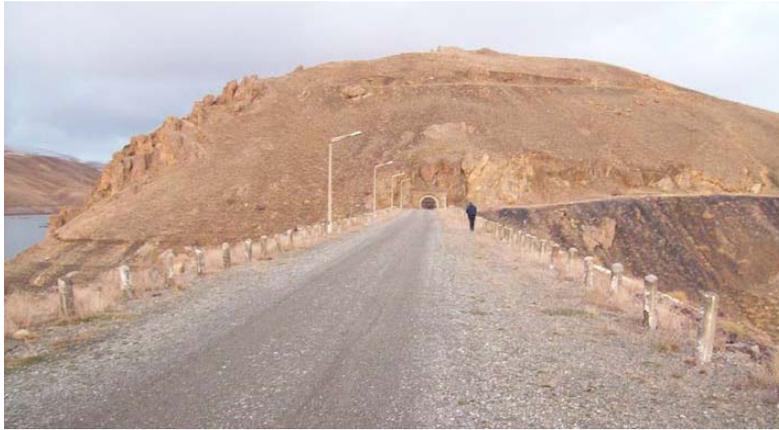
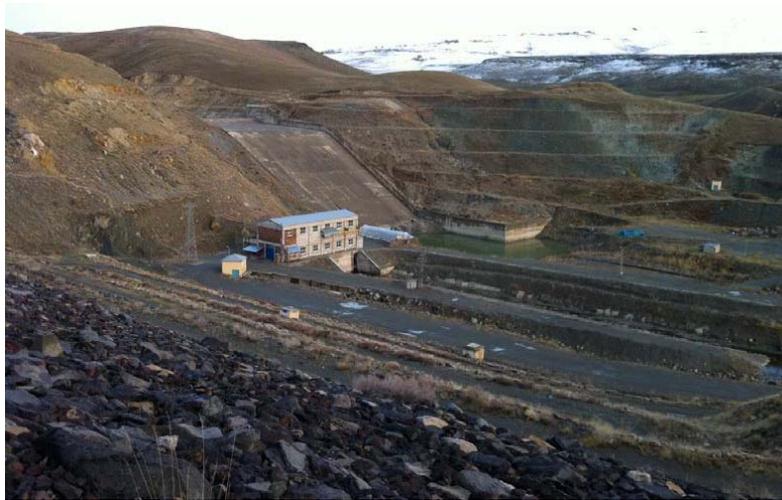
Figure 7.12. Views from (a) crest and (b) spillway of the non-damaged Sarimehmet Dam (after Çetin et al., 2011).

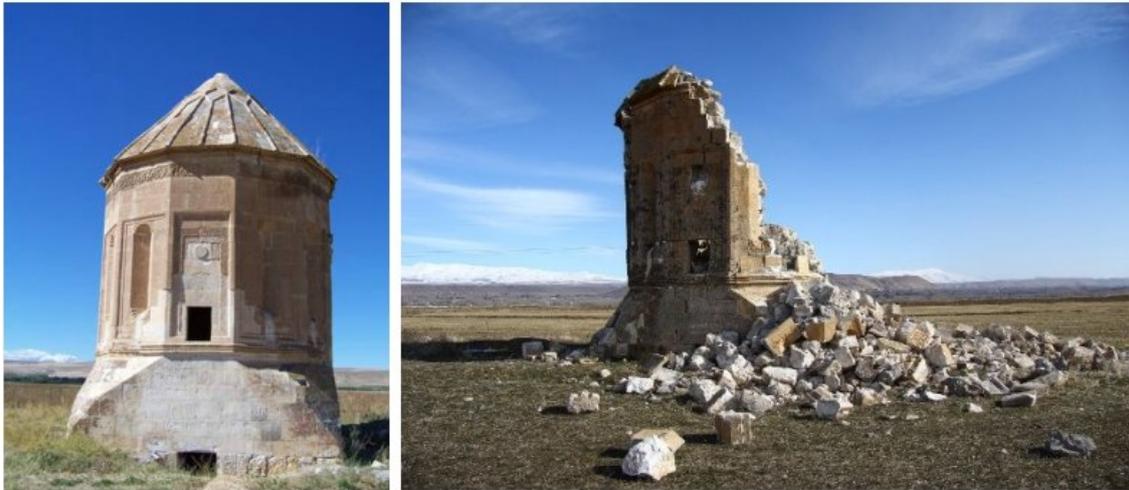
Karakoyunlu Türkmen State governed Azerbaijan and Iraq during a period between 1375 and 1468. Erciş served as the capital of Karakoyunlu Türkmen State and there are many historical remains from that period in Erciş and Provinces of Van and Bitlis. There are a number of several mausoleums (Kümbet in Turkish) built for the khans (king) and/or their aristocratic families. They are dodecahedral or cylindrical built on a cubic base. Two kümbets were damaged by this earthquake. Particularly the Kara Yusuf Pasha Kümbet (also locally known Zortul), which was built near Çatakdibi village of Erciş during the period of Cihan Şah, suffered very heavy damage by the earthquake as seen in Figure 7.16.

Figure 7.16. Heavily damaged Kara Yusuf Pasha Kümbet (pictures from Erciş Municipality and TRT-Haber, 2011).

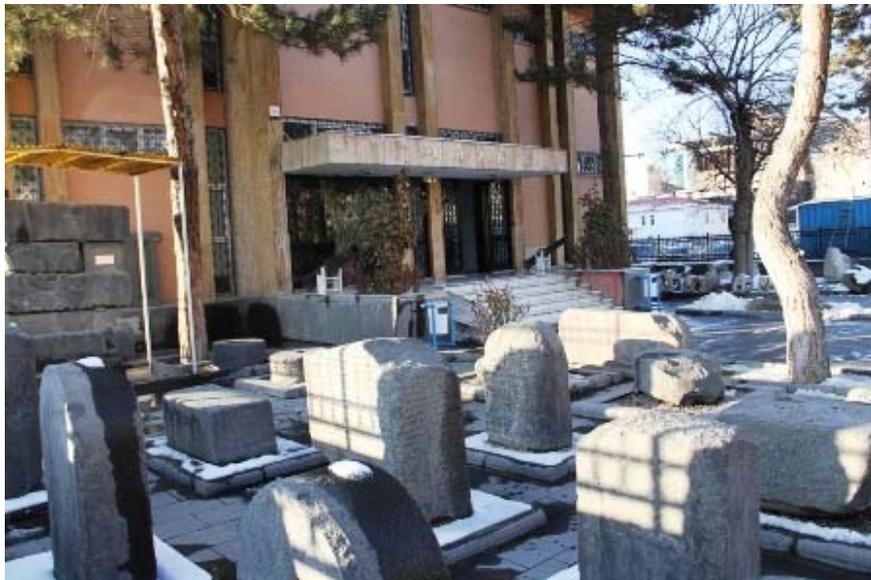
It was also reported that some stone monuments with cuneiform (originally developed by Sumers, who are of Central Asian origin) inscriptions of Urartu (probably related to Ural-Altaic origin) period in the Van Museum toppled as seen in Figure 7.18. The museum building also suffered some damage, some clay tablets were broken and some collections belonging to Urartu period were also damaged.

Figure 7.18. Stone monuments (toppled) Van Museum (Anadolu Ajansı, 2011).

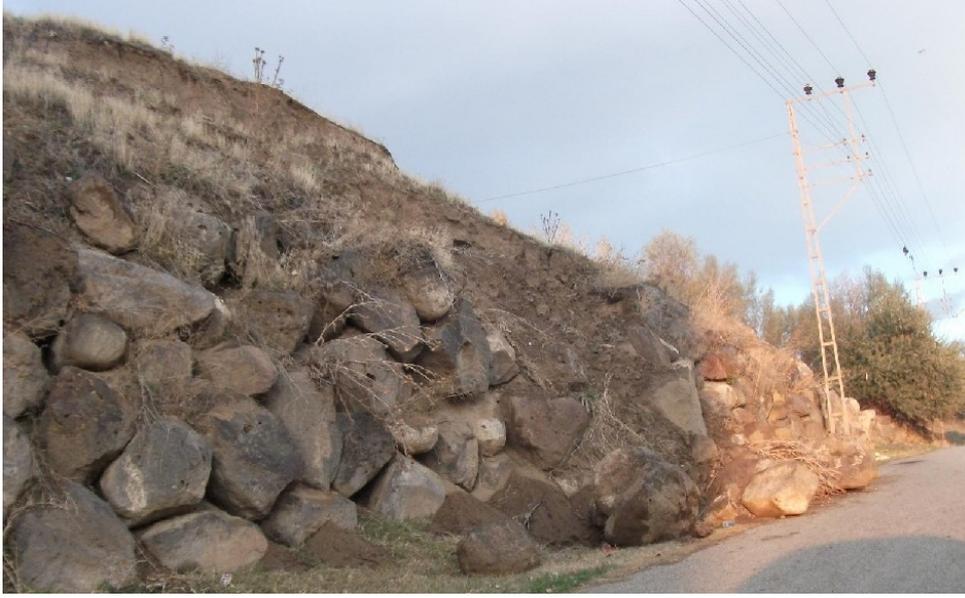
In Çelebibağ village, a stone wall of castle remains from the Urartu period collapsed towards South (Figure 7.19).

Figure 7.19. Toppled wall of Urartu castle in Çelebibağ village (Erciş).

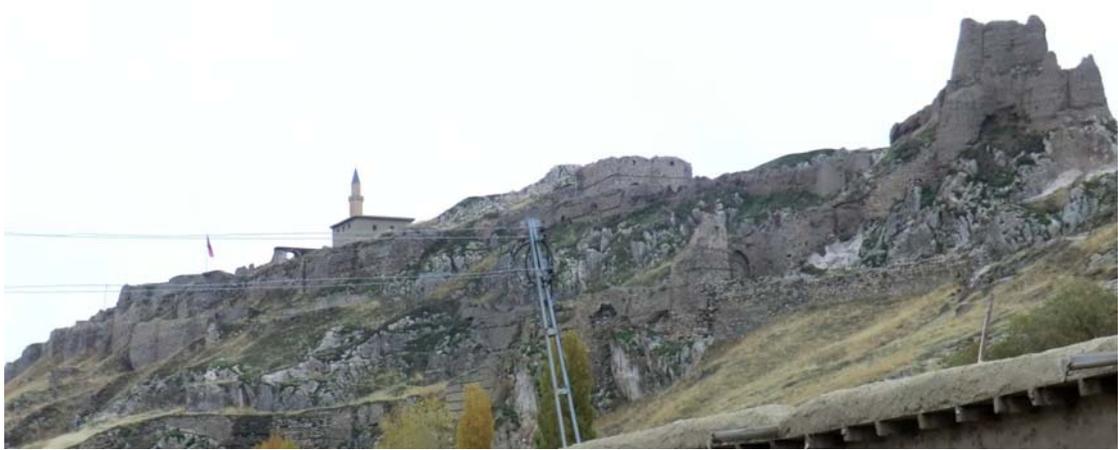
The Van Castle, which was built in Urartu period in 9th BC, did not suffer any damage during the October 23, 2011 and the November 9, 2011 earthquakes. It is built over a rock ground consisting of limestone (Figure 7.20). There are also some historical mosques and other historical structures to the south of the castle. There are three historical mosques, namely, Kayaçelebi, Hüsrevpaşa and Süleyman Han mosques, Hüsrevpaşa mosque was built in 1567 by the famous Turkish architect Mimar Sinan. The Kayaçelebi mosque was built in 1660 and lost its minaret during the October 23, 2011 earthquake (Figure 7.21). The November 9, 2011 earthquake caused more damage to the main compounds and minarets and the inner plastering of walls were fallen down. Süleyman Han mosque is on top of the hill within the castle and built by Magnificent Sultan Süleyman of Ottoman period and the earthquake did not damage it.

Figure 7.20. A view of Van Castle after the earthquake.

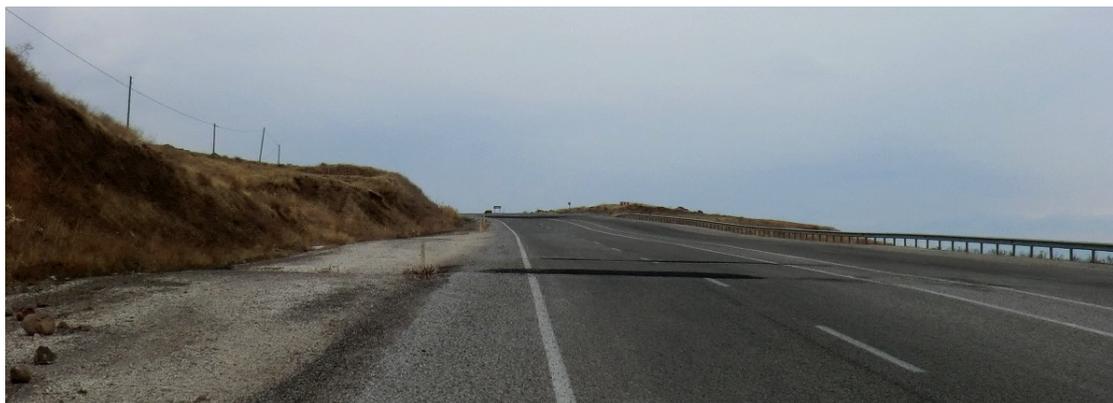
Embankment failures at several localities, the major ones were observed on the Van-Ağrı Highway. The embankment (highway itself), seen in Figure 8.2, settled and slightly moved towards Van Lake. Nevertheless, it could be used without any hindrance to traffic following some repairs the settled and fractured asphalt surfacing of the highway.

Figure 8.2. Embankment failure on the D975 Van-Ağrı Highway

Embankment failures were observed at several localities. Major embankment failures were observed on the Van-Ağrı Highway. Figure 8.2 shows one example of embankment failure. The embankment seen in this figure moved towards the lake and settled.

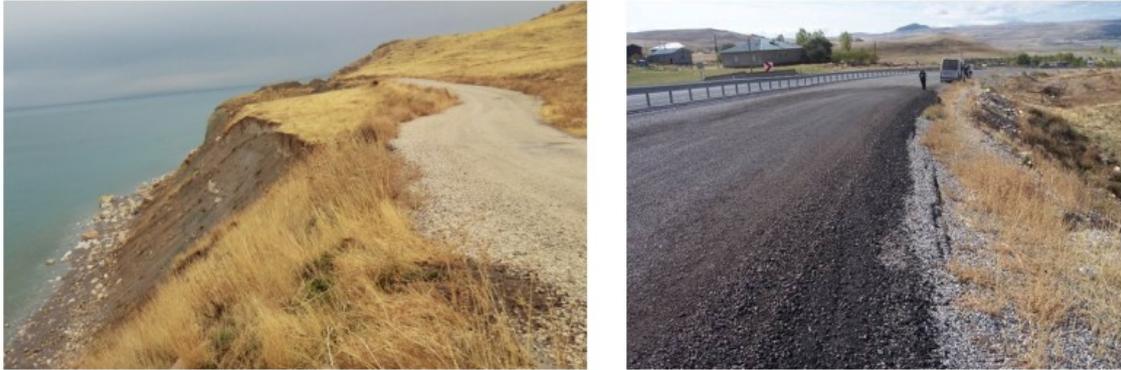
Figure 8.3 shows the damage to shoulder embankments on the roadway between Dağönü and Özyurt villages and D975 Van-Ağrı Highway near Gedikbudak. The repair

Figure 8.3. Failure of shoulder embankment of roadway and D975 Van-Ağrı Highway.

works were implemented as seen in Figure 8.3 and the roadway was re-asphalted

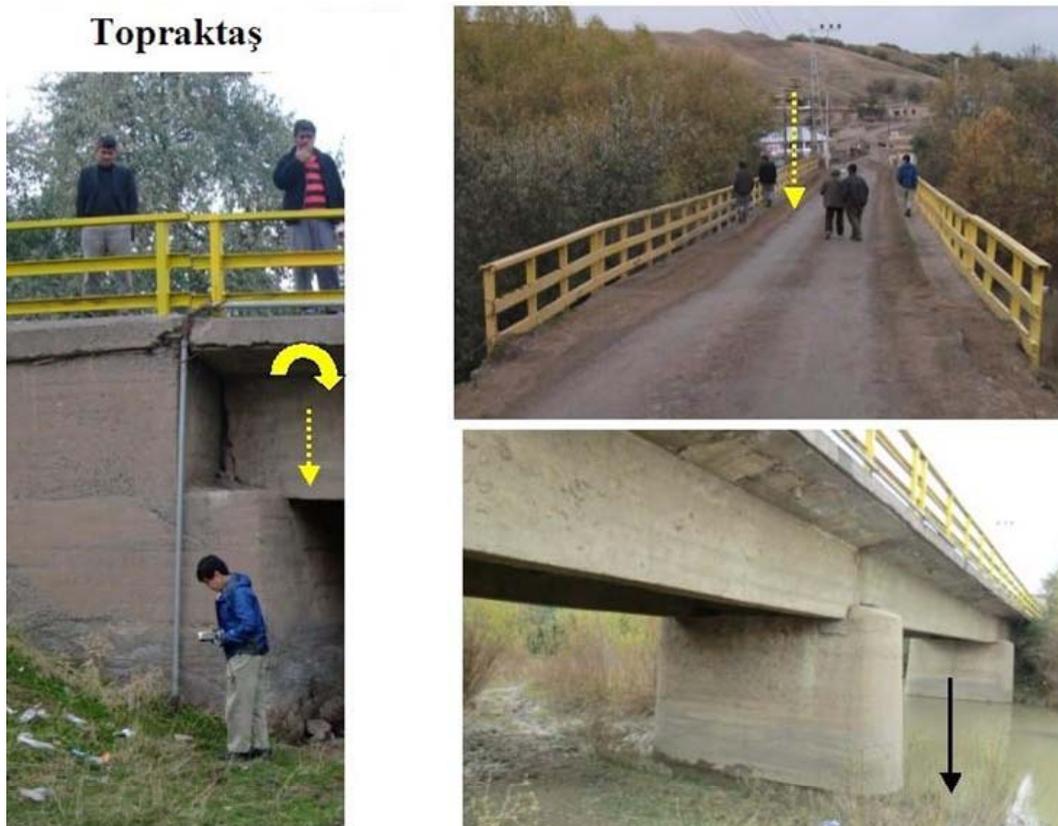
Roadway bridges are generally constructed using cast-in place technique. The earthquake caused very little damage to bridges. The damage to bridges was due to the settlement of piers and settlement and lateral deformation of their approach embankments. These type damages of bridges were observed along Van-Ağrı Highway and other roadways at Karasu and Zilan Rivers (Figures 8.5-8.8). The settlement of piers was probably caused the partial liquefaction in the vicinity of bridge piers.

Figure 8.8. Settlement of piers of the bridge near Topraktaş village over Karasu River.

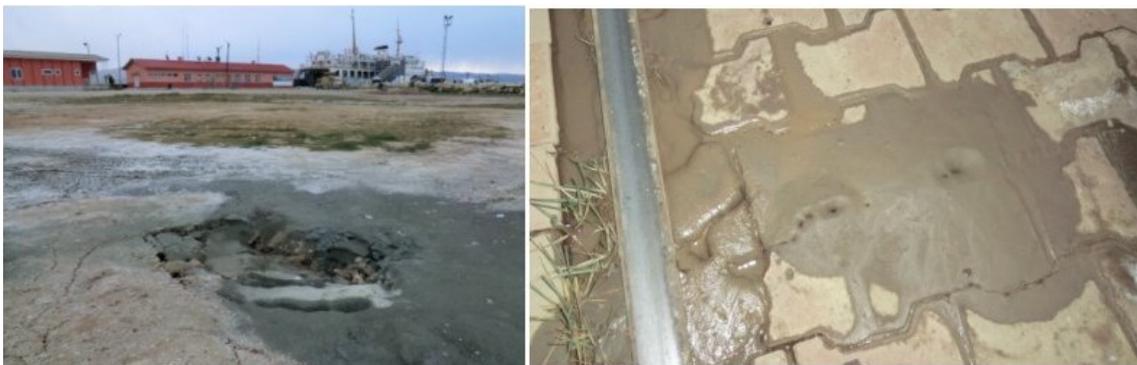
A major railway line of Turkish Railways (TCDD) connects Van Port to the railway line of Iran. This railway line connected to the rest of railway network of Turkey through a ferryboat line between Tatvan and Van ports. The ferryboat transports the entire train between Tatvan and Van. The railway line in Van province starts from Van Port and passes along the southern shore of Erçek Lake and exits Turkey at Kapıköy border gate. The earthquake caused no major damage to the railway and its bridges. However, ground liquefaction occurred at the Van port and railways were slightly deformed by ground liquefaction and its associated ground deformation (Figure 8.10). The interviews with the railway authorities at the railway station of Van Port informed the authors that the slight damage to railways at the port did not cause any disruption of train services.

Figure 8.10. Views of deformed railways and liquefaction at Van Port.

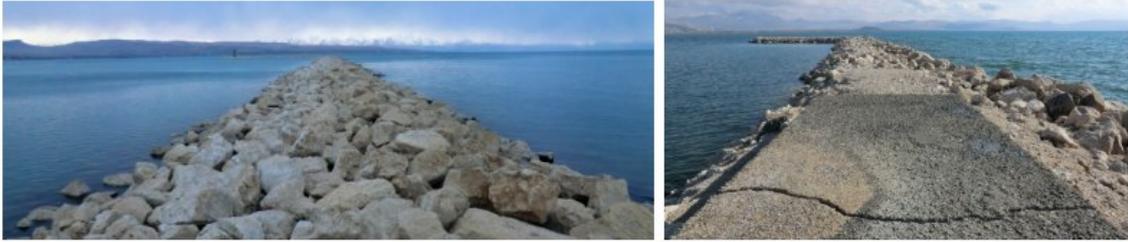
Breakwaters at the Van Port and Yüzüncü Yıl University (YYU) Port made of large stone blocks settled and deformed laterally as seen in Figure 8.12. The main reasons for such deformations may be related to the settlement of large rock blocks into lake-bottom due to ground liquefaction.

Figure 8.12. Settlement and spreading of breakwaters of Van and YYU ports due to liquefaction of foundation ground.

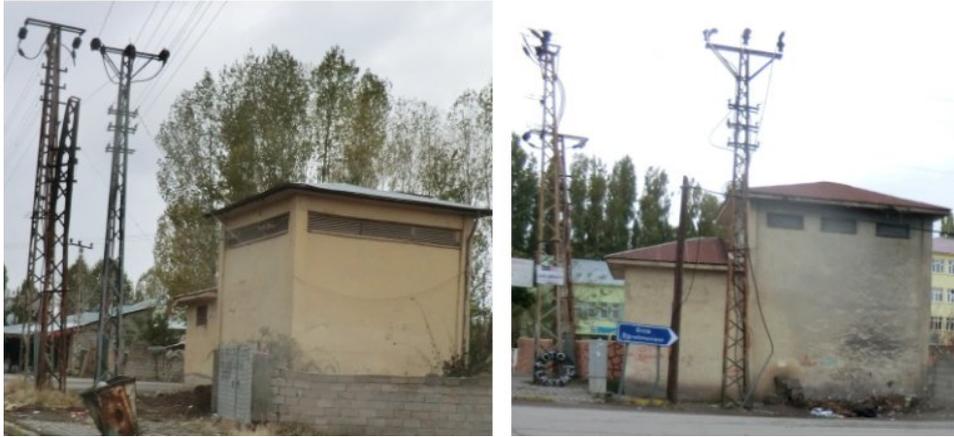
The earthquake did not cause the collapse of any of the sub-stations although some damage to some transformers of sub-stations occurred during shaking (Figures 9.3 and 9.4). A total of damaged 44 transformers were replaced and 12 transformers were added to the network in the epicentral area. However, the effects were minimal to these substations and they could be easily handled within a short period of time. Although most of transformers on the elevated utility poles were intact (Figure 9.5), some elevated transformers on pylons in the towns and cities were dislodged/fallen from their locations. An example of transformer damage by dislodging in Erciş is shown in Figure 9.6.

Figure 9.3. Non-damaged sub-stations in Erciş.

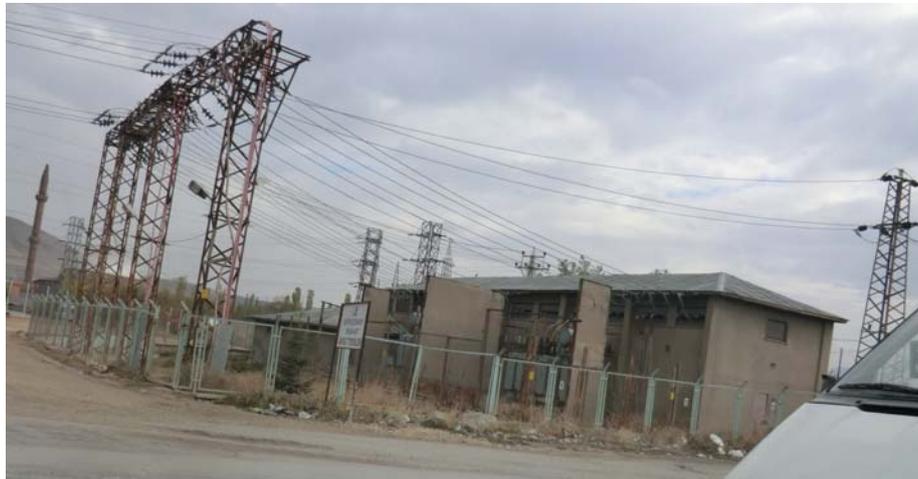
Figure 9.4. A non-damaged sub-station in Van.

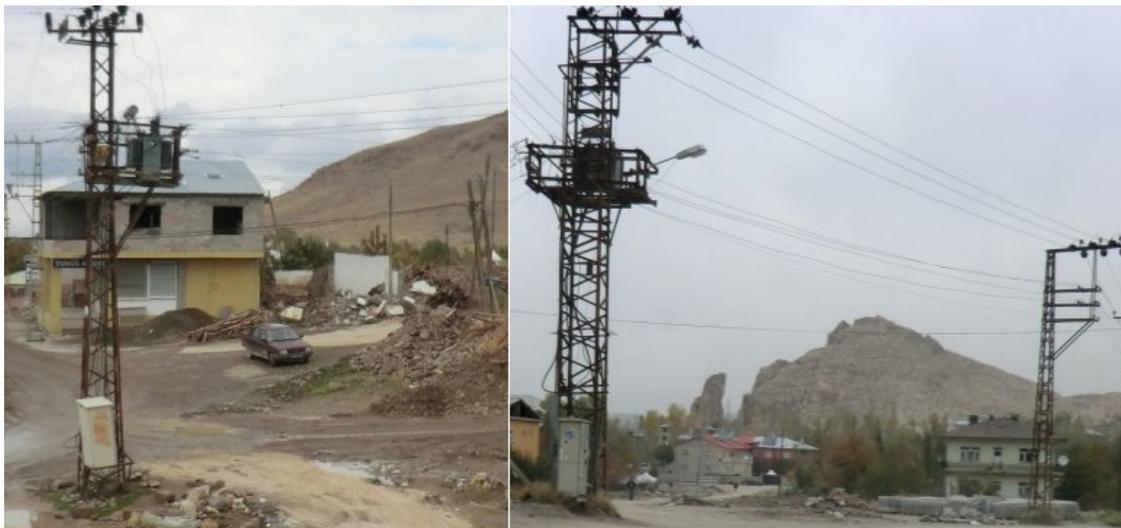
Figure 9.5. Non-damaged elevated transformers.

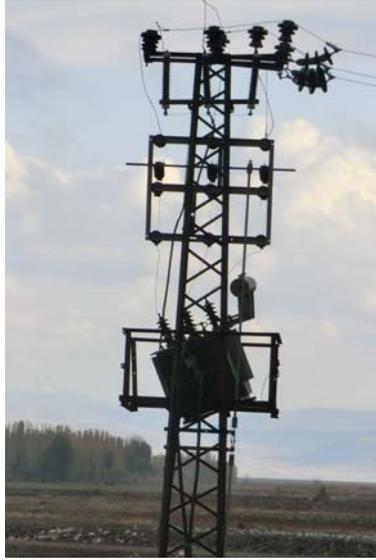
Figure 9.6. Dislodged transformer on a utility pole in Erciş.

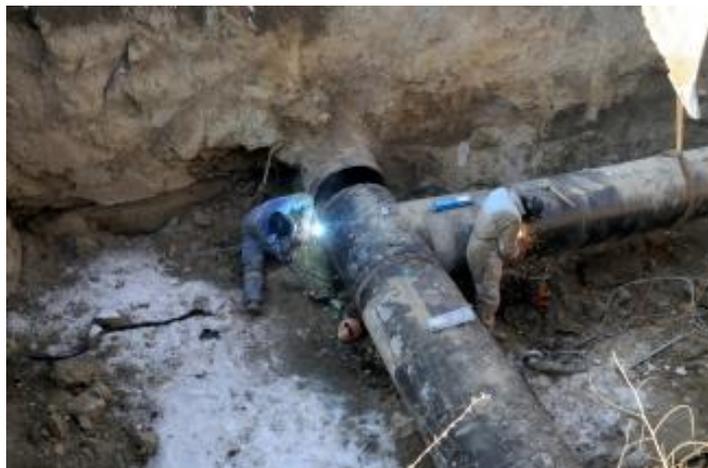
Water supply was stopped due to pipe damage in Van city following the October 23, 2011 earthquake. However, the damage to water supply network was quite limited by this earthquake. The November 9, 2011 earthquake caused more damage. The Van municipality had to change some major pipes with a diameter of 800 mm for a 225 m long connecting to No. 2 water reservoirs. This repair work was done on December 27, 2011 and water supply was shut-down for about 36 hours as a result (Figure 9.8) (Press Release of Van Municipality, 2011).

Figure 9.8. Repair work of water network of Van City (from Van Municipality, 2011).

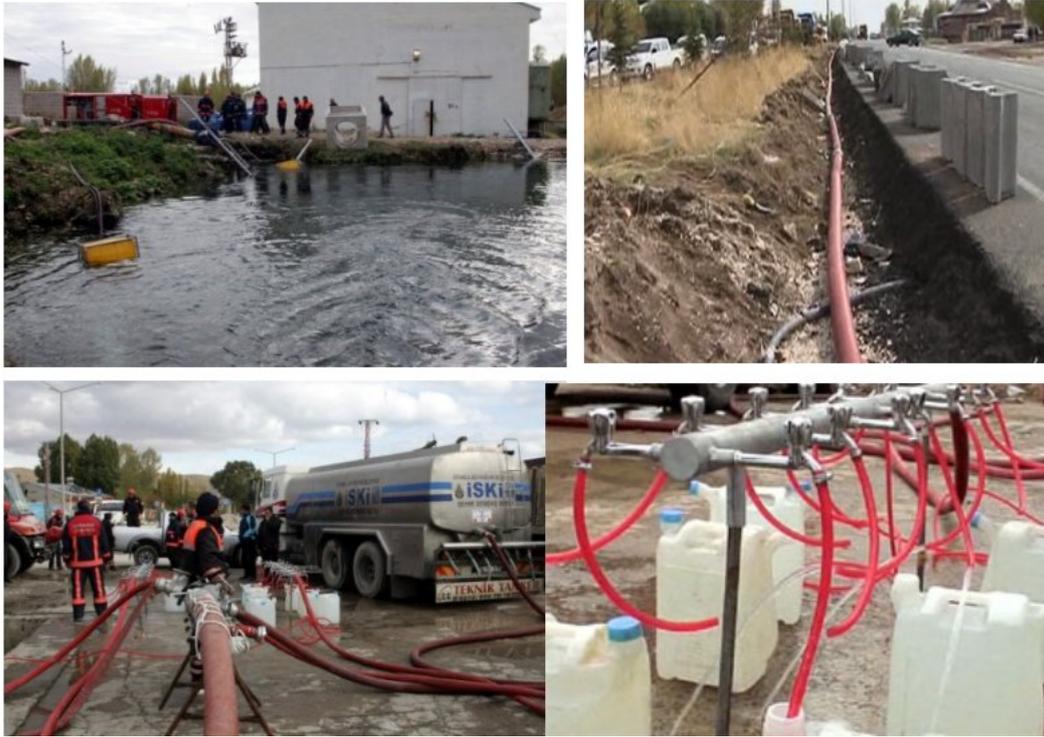
Figure 9.10. Temporary water supply system set up by İstanbul Municipality Water Department .

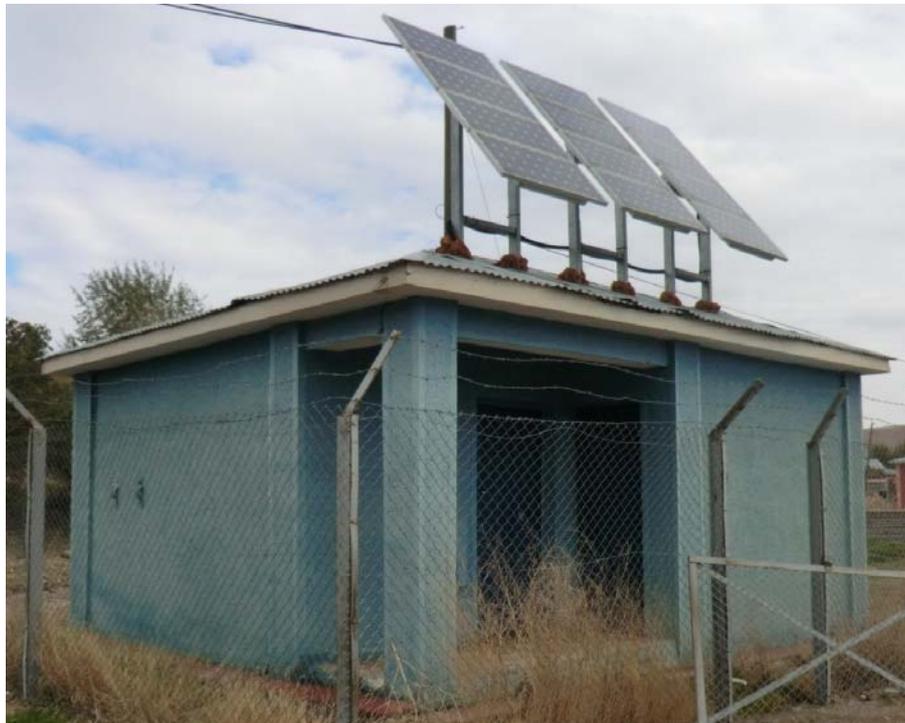
In some villages, there are some facilities to pump up the groundwater. Figure 9.11 shows such a facility in Alaköy village. The inspection of this facilities showed that there was no sign of damage to the facility.

Figure 9.11. A view of pumping facility in Alaköy.

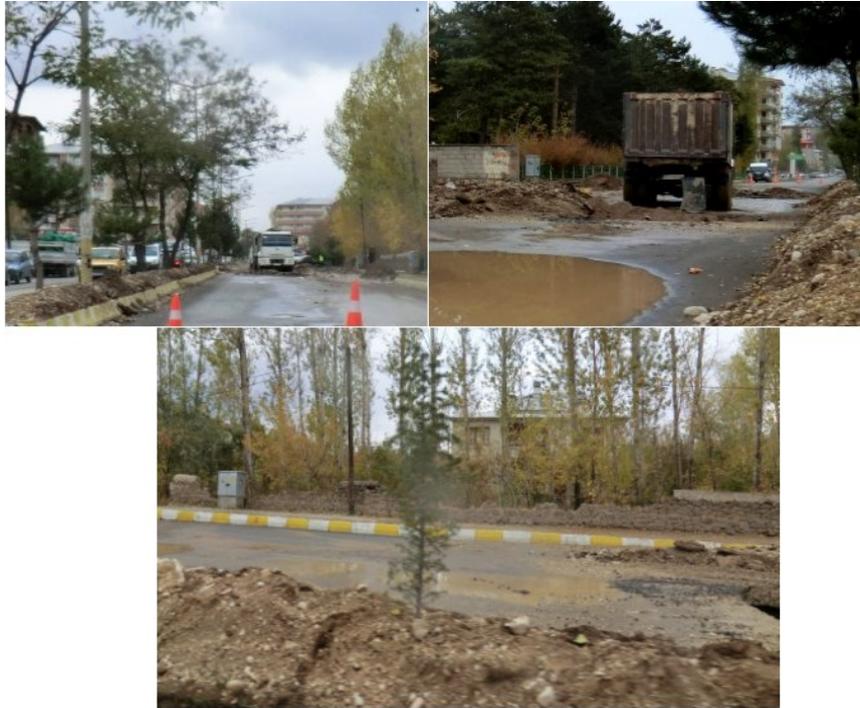
The diameters of sewage pipes are 1600 mm and 1000 mm beneath boulevards and streets of large cities, respectively. The sewage system of Erciş was damaged due to severe ground shaking and lateral spreading (Figure 9.12), while the sewage system of Van City was almost non-affected. The damage assessment of the sewage system is the most difficult item in the overall damage assessment of lifeline facilities as they are buried. The systems were checked systematically through water flow states at manholes in the cities, towns and villages. If there was any blockage, they were repaired. However, some damage may undergo unnoticed unless an indication of damage in the form of

Figure 9.12 Repair work of sewage in Erciş

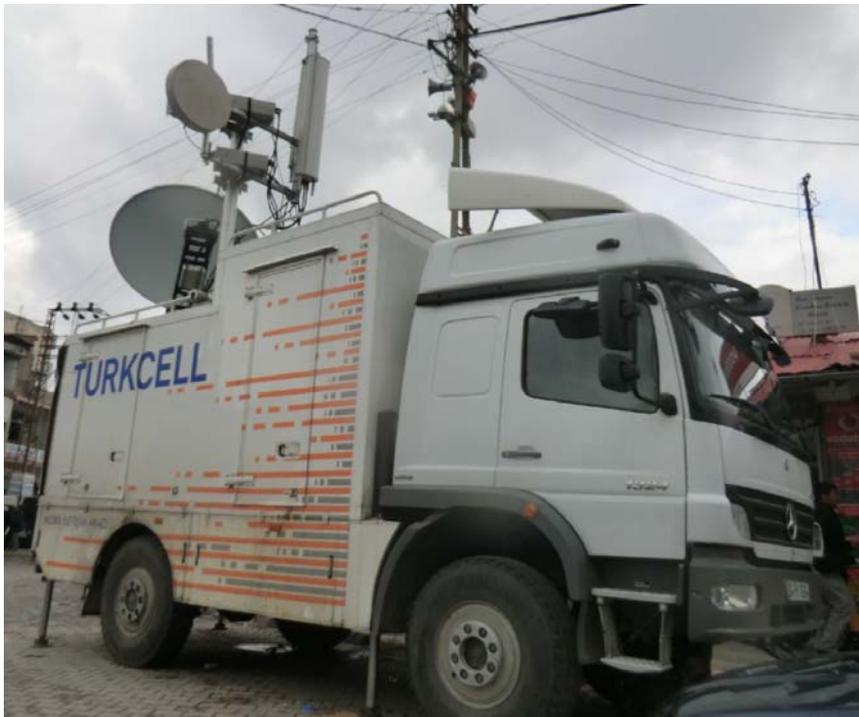
Figure 9.14. A view of a mobile telecommunication unit of TÜRKCELL in Erciş.

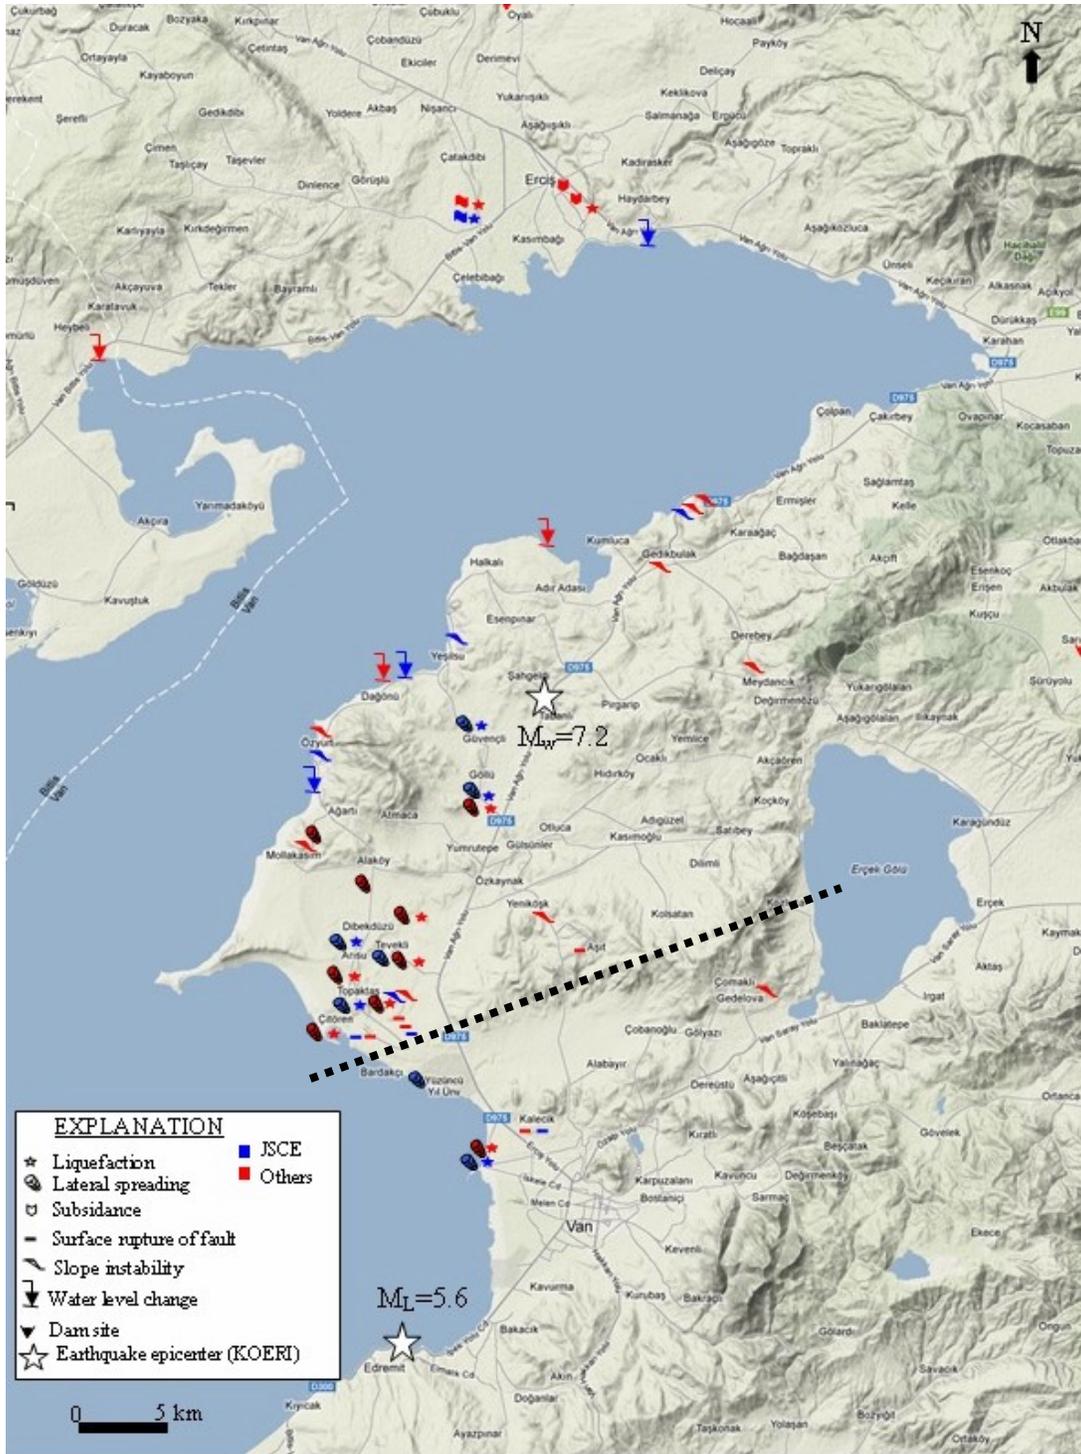
In this earthquake, liquefaction and associated ground deformations were evident and widespread sand boils and liquefaction fissures were observed particularly in Erciş Plain (Çelebibağı and Kasımbağı villages, and along Zilan stream) at the northern part of Van Lake and the flood plain of the Karasu River (Topraktaş, Arısu, Göllü, Tevekli, Çitören, Mollakasım Güvençli and Alaköy villages), Van Port and Esenkıyı at the north of Van city, and alluvial shore plains. Lateral spreading was quite extensive at Çelebibağı (west of Erciş) and Topraktaş (at NW of Van city) villages. Some of these liquefaction locations were visited by the authors during the reconnaissance and the information for the other liquefied sites were compiled from the quick reports of various investigators. The locations of the liquefied sites and associated lateral spreading are shown in Figure 10.11.

Figure 10.11. Map showing the geotechnical aspects, surface rupture of the Van-Erciş earthquake with water level changes in Lake Van.
