JAPAN SOCIETY OF CIVIL ENGINEERS

SITE INVESTIGATION AND ENGINEERING EVALUATION OF THE VAN EARTHQUAKES OF OCTOBER 23 AND NOVEMBER 9, 2011

February 2012

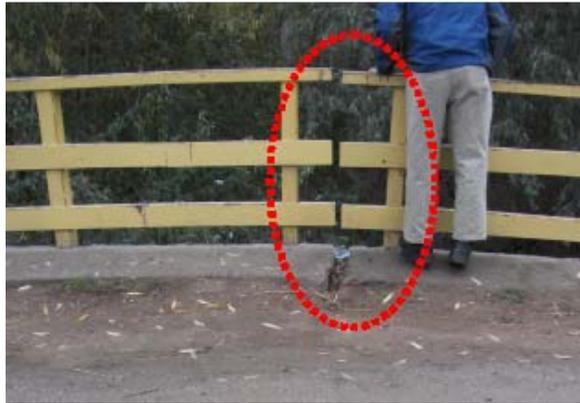
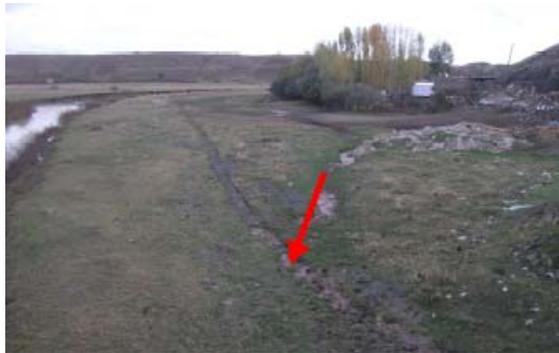
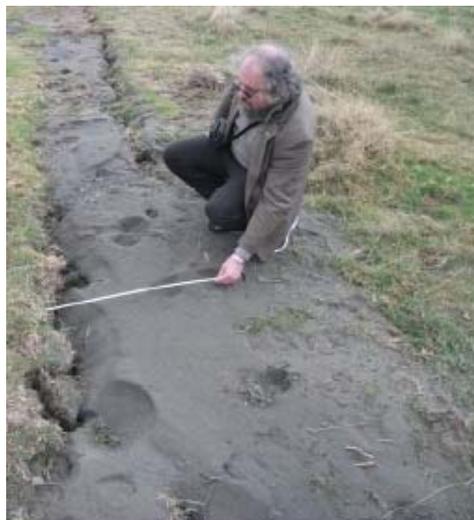
Settlement of a bridge at the southern entrance of Topraktaş village (Figure 10.13a) and sand boils and fissures and lateral spreading along the Karasu (Evlengaz) Stream flowing under this bridge were the clear evidences of liquefaction (Figure 10.13b,c). In addition, common liquefaction sand boils were also observed on a flat area about 1 km far from this village, between the stream and road (near Topraktaş-Arısu road).

Figure 10.13. Views from liquefaction in Topraktaş village: (a) a bridge settled due to liquefaction, (b) liquefaction fissures parallel to the Evlengaz Stream, (c) sand boil.

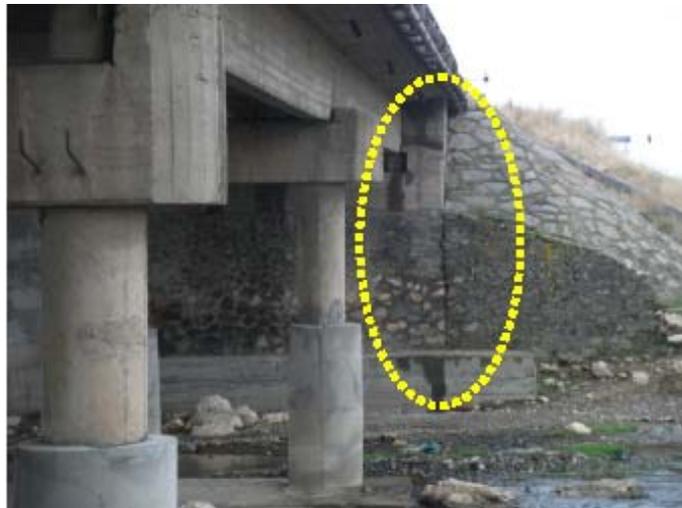
Figure 10.17. Crack and settlement on the right abutment of the bridge on the İrşat Stream between Erciş and Adilcevaz indicate due to liquefaction.

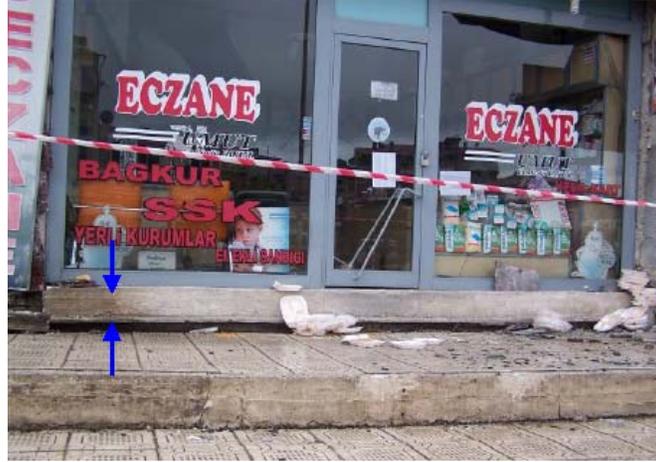
of Erciş) was 0.2g, it is expected that some partial liquefaction might occur. The settlement of some buildings (Figure 10.18), reported and observed in Erciş town, may imply partial liquefaction did occur. İTÜ (2011) also conclude that some settlements observed in the vicinity of Clock Tower in Erciş town are probably due to softening and collapsing of the soil ground.

Figure 10.18. Settlement of a building probably due to liquefaction in Erciş town (after JMO, 2011).

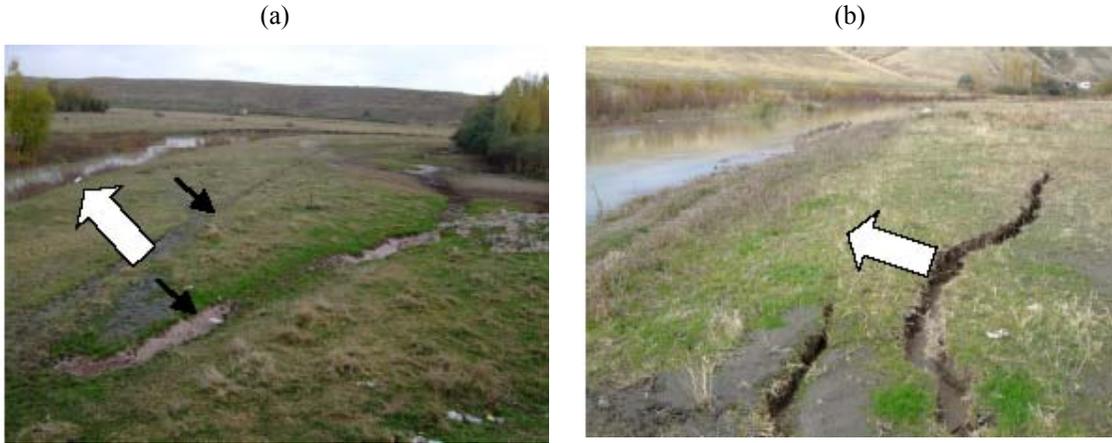
Lateral spreading occurred particularly along the left bank of the Evlangaz Stream near Topraktaş village resulted in ground cracks filled by the ejected sand with a direction of N75E parallel to the stream (Figure 10.22a). Based on the measurements by the authors between these cracks, a total displacement of 1 m due to lateral spreading was found at this locality. The lateral spreading cracks on the plain at the southern entrance of Topraktaş village occurred between the Topraktaş-Arısu road and the stream (Figure 10.22b). The total displacement at this location was measured about 80 cm and the trend of the cracks was N70W parallel to the stream. Except the bridge on the Evlangaz Stream (Figure 10.13a), fortunately, since there is no any settlement and structure in this area, no geotechnical damaged occurred.

Figure 10.22. Lateral spreading cracks parallel to Evlangaz Stream; (a) Topraktaş village and (b) near the road between Topraktaş and Arısu.

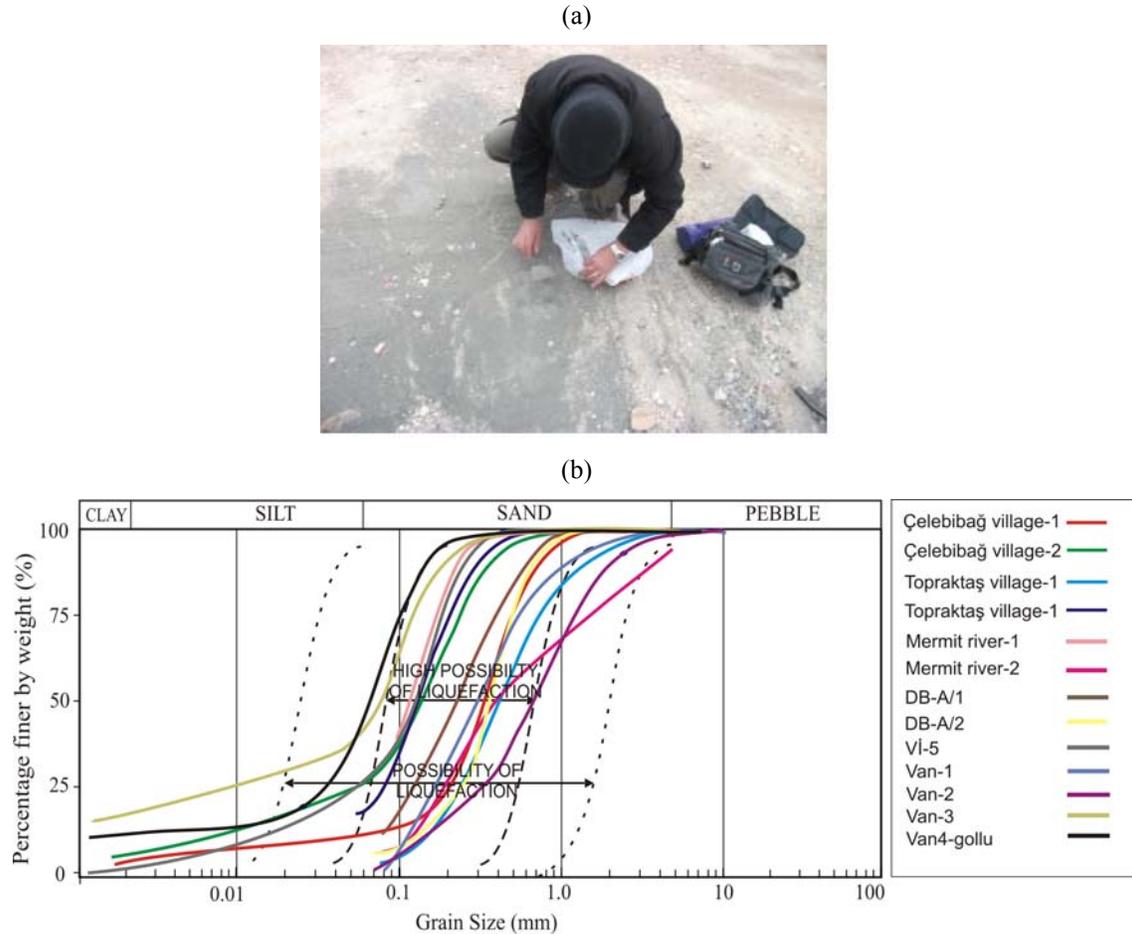
The authors have gathered some samples from sand boils observed during the reconnaissance (Figure 10.25a). Generally the ejected soils were in gray color and composed of sand, silty sand and sand with low amount of small pebbles. These samples were collected from Van Port, Çelebibağ, Topraktaş and Göllü villages. Besides, additional ejected sand samples were obtained from Dibekdüzü and Mermi meadow by Dr. Onur Köse of Yüzüncü Yıl University to be used in this study. Their grain size distribution analyses, using sieve and hydrometer methods, were carried out in the soil mechanics laboratories of Hacettepe and Pamukkale Universities. It is clear from Figure 10.25b that, although some samples have high fine content, they are still within the easily liquefiable bounds.

Figure 10.25. (a) Sampling from ejected sand (Van Port), (b) comparison of grain-size distributions of the samples obtained from liquified soils in various sites of the earthquake-affected region with known bounds for liquefiable soils (Port and Harbour Research Institute, Japan, 1997).

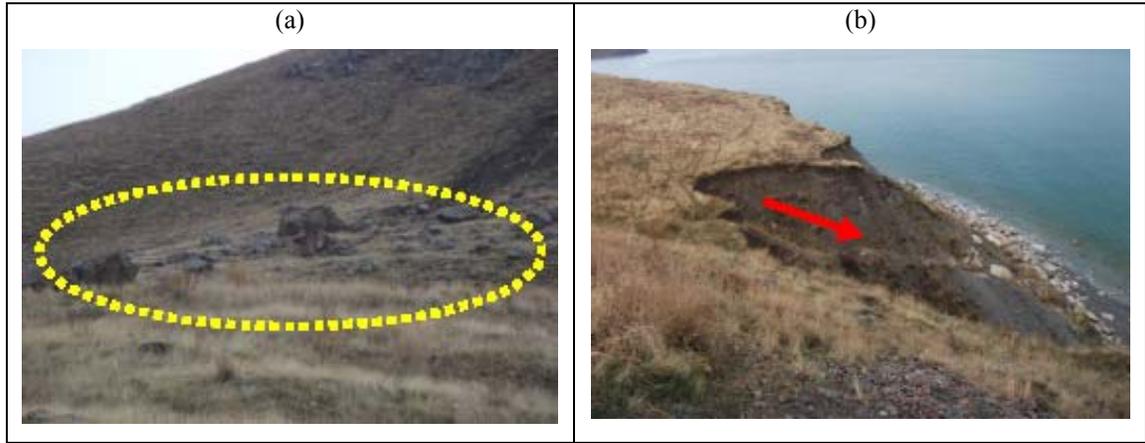
At some locations along the eastern lake shore at the north of Van, some slope instabilities, generally in the form of rock falls, also occurred. One of them is the local rock falls observed near to Özyurt village (Figures 10.11 and 10.30a). The other instability occurred in the

lacustrine terraces on the road between Dağönü and Mollaksım villages (Figure 10.30b). However, these instabilities did not affect the road parallel to the lake shore. In addition to these, some instabilities in old landslide areas at the east of Çomaklı and Meydancık villages which were identified from the tension cracks by Emre et al. (2011) and rock falls from the crown of the Özyurt landslide complex (YTÜ-DBAM, 2011) were also reported.

Figure 10.30. (a) Rock falls near to Özyurt village, (b) sliding between Dağönü and Mollakasım

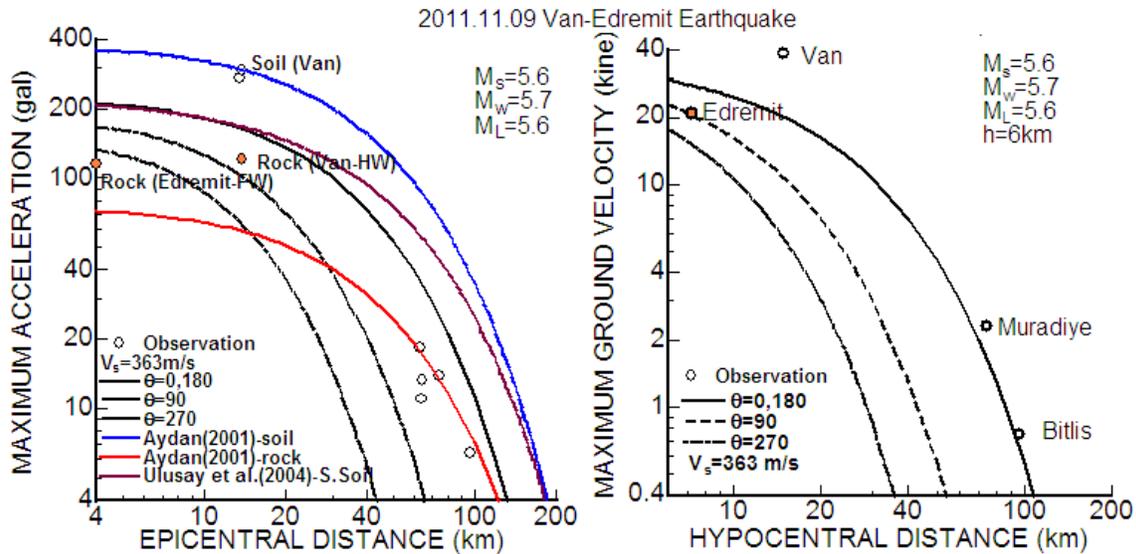
Figure 11.6 shows the attenuation of strong motions recorded by the ERD and KOERI with the empirical relations of Aydan (2001), Aydan and Ohta (2011a) and Ulusay et al. (2004). The maximum ground acceleration on soil is well predicted by the attenuation relation proposed by Aydan (2001) while the relations by Aydan and Ohta (2011a) using the shear velocity of Van strong motion station and Ulusay et al. (2004) underestimated the maximum ground accelerations by 30-40% less.

Figure 11.6. Comparison of some empirical attenuation relations for maximum ground acceleration and velocity with observations

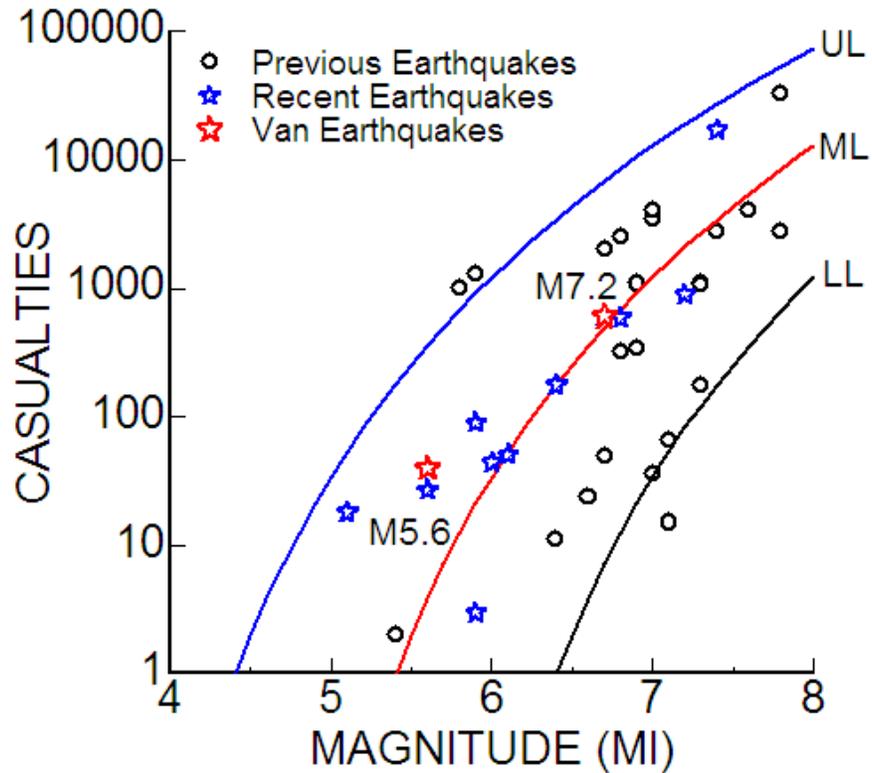
This earthquake resulted in the loss of 40 lives as it happened at 21:23 in the evening. On the other hand, the 23 October 2011 Van-Erciş earthquake resulted in the loss of 604 people and occurred at 13:41 on Sunday. Figure 11.8 shows the relations between local magnitude and casualties. The estimations for upper (UL), mean (ML) and lower (LL) limits are computed from the following function proposed in this article using the data from various catalogues for Turkey (i.e. Ergin et al. 1967; Soysal et al. 1981; Eyidoğan et al. 1991).

The values of constants A and c are 2 and 7, while the values of constant B are 3.5, 4.5 and 5.5 for UL, ML and LL, respectively. The main reason for such large ranges may be related to the time of earthquake, quality of buildings and ground conditions.

Figure 11.8. Relation between local magnitude of earthquakes and casualties.

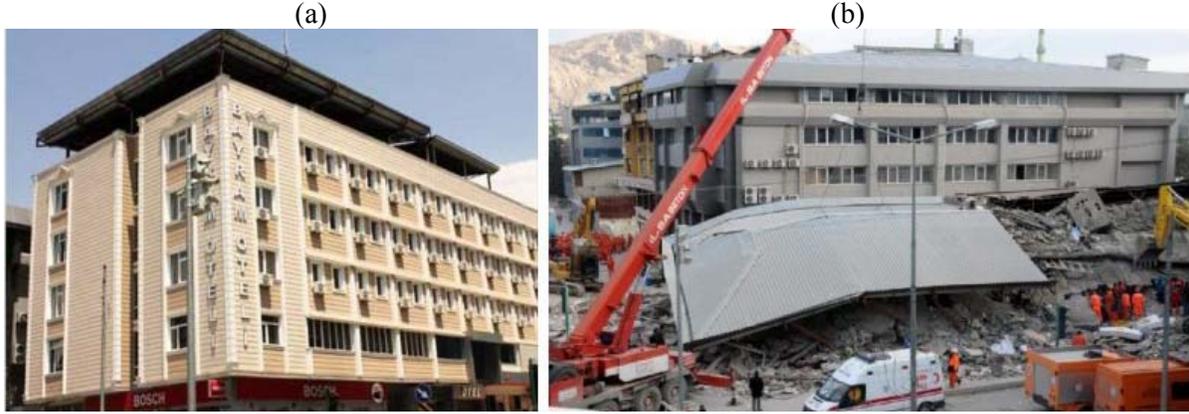
This earthquake caused the collapse of the 30 reinforced concrete buildings, most of which had already suffered substantial damage during the 23 October 2011 earthquake (Figures 11.9- 11.11). Fortunately, 23 of the collapsed buildings had been evacuated due to the damage caused by the earlier earthquake. However, two hotel buildings were open during this second earthquake and some of the people staying there lost their lives (Figure 11.9). This earthquake also caused additional damage to some buildings. The collapsed hotels had cracks following the October 23, 2011 earthquake and they were cosmetically repaired. The authors noticed such non-structural repairs in the city of Van during their reconnaissance for the October 23, 2011 earthquake (Figure 11.12).

Figure 11.9. Views of Bayram Otel (a) before and (b) after the Van-Edremit earthquake (Anadolu Ajansı, 2011).

The major causes of the heavy damage to reinforced concrete buildings were basically similar to the previous observations during previous earthquakes in Turkey:

- (a) Quality of construction materials,
- (b) Lack of implementation of design codes (bars, stir-ups, proper column-beam connections, tie-beams, good foundation etc.),
- (c) Existence of soft-floor (weak-floor),
- (d) Pounding,
- (e) Lack of ductility,
- (f) Poor integrity of RC frame with in-fill walls,
- (g) Quality of workmanship,
- (h) Poor ground conditions.

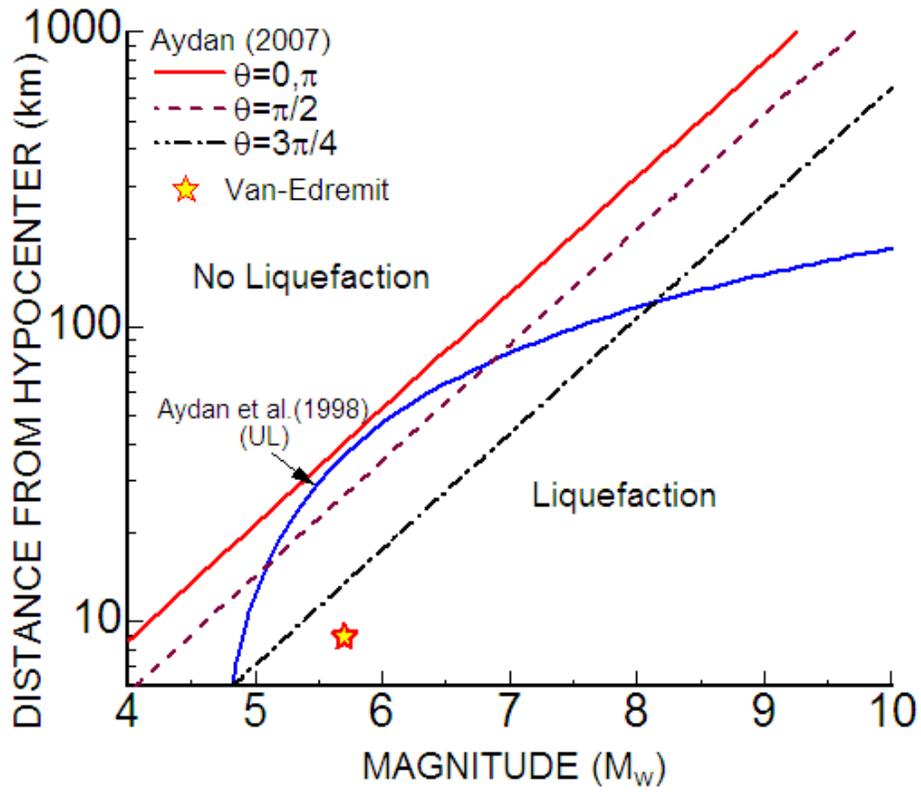
Figure 11.14 shows the empirical relations between earthquake magnitude (M_w) and hypocentral distance of liquefaction location proposed by Aydan et al. (1998) and Aydan (2007) with the observation in this earthquake. The observation is within the proposed empirical limits. However, it is also noted that despite the smaller magnitude (M5.6) of this earthquake, it caused ground liquefaction at a location where previously liquefaction has also occurred and this is the first time for liquefaction occurred during an earthquake with a magnitude smaller than 6 experienced in Turkey.

Figure 11.14. Comparison of empirical relations for magnitude and liquefaction limits with observations at liquefied site (Van Port) performed in the earthquake region.
