SEISMIC PERFORMANCE ASSESSMENT OF EXPANSION JOINTS FOR WATER LIFELINES

Key facts:

- Hazard Type: Earthquake
- Date of the disaster : March 11, 2011
- Location of the survey: Shiroishi Interchange, Miyagi Prefecture
(38.039N, 140.63E)
- Date of the field survey (if any) : May 29-30, 2011
- Survey tools (if any) : none
- Key findings:
 - 1) Expansion joint failures of large-diameter buried pipelines of 1200mm and 2400mm water mains.
 - 2) The failure mechanism of these joints are investigated based on numerical analyses and field survey results.
 - 3) The expansion joints which were vertically settled before the main shock, have reduced deformation allowances for the seismic responses

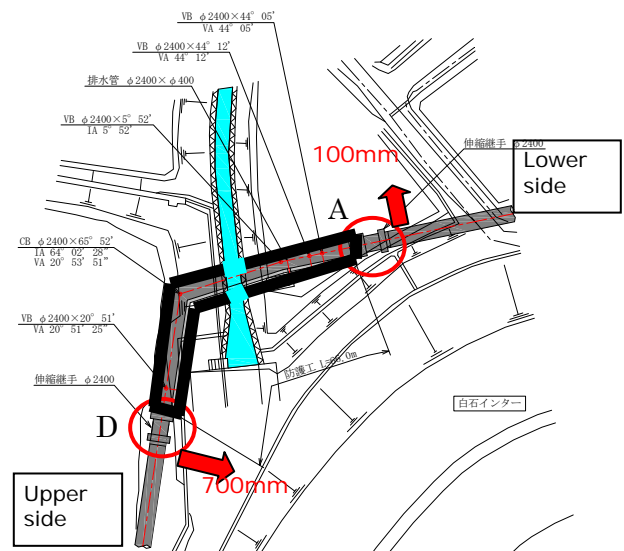
Photo 1 Water leakage from expansion joint.

Photo 1 shows the large-scale water leakage from the expansion joint in the 2400mm diameter water pipeline immediately after the main shock. The accident occurred at both sides of the concrete encased pipeline under-crossing a water stream, as shown in Figure 4. It must be noted that this leakage occurred at the same time from both expansion joints. The concrete encased structure moved 700mm in the anticlockwise direction at site A and 100mm at site B.

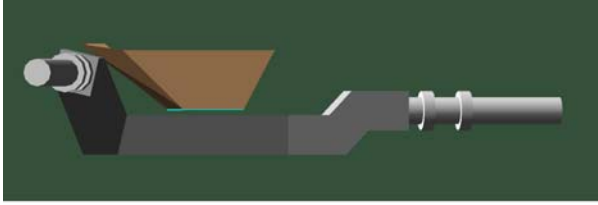
Fig. 5 Three-dimensional illustration of under-crossing concrete encased structure.

According to site observations, there were no ground changes triggering liquefaction, ground slippage or uneven settlement. As shown in Figure 5, this under-crossing concrete encased structure has an unstable configuration and is not symmetrical even in the two-dimensional plan view.

(1) Asymmetrical shape of a structure can produce unstable responses. Actually, in this example, rotational motion caused simultaneous destruction of the expansion joints. Special attention should be paid to the seismic design of asymmetrical structures.

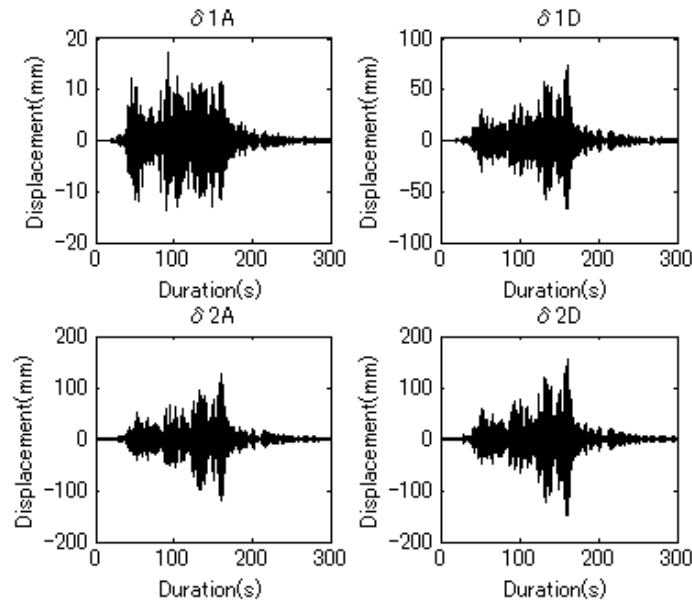
Fig. 7 Excessive displacement between structural response and ground displacement at expansion joint points A and D, where δ_1 is axial displacement and δ_2 is transverse displacement to the pipe axis.

In the numerical analysis, the spring modulus was randomly modified from the original value to smaller ones in order to obtain the largest responses that can exceed the limit boundary of the expansion joint. Figure 7 shows the excessive displacements between the ground responses and the structural responses in the axial and transverse directions at points A and D in Figure 6. δ_{1A} and δ_{1D} are the responses in the axial direction, and δ_{2A} and δ_{2D} are the responses in the transverse direction, respectively. These figures show that the maximum response appears in the transverse direction of point D, as shown by δ_{2D} . This result does not conflict with the observation that the largest movement at the encased concrete structure occurred at point D in the transverse direction. The second largest response is given by δ_{2A} , which might support the observation that both expansion joints were simultaneously destroyed by the main shock. Figure 8 is the rotational response of the concrete encased structure. These structural responses as shown by the triangular and square marks in the multiple limit state diagram for the expansion joint failure modes in Figure 9. In this figure, three different performance limit curves are shown as boundary conditions of the joint failure. Here, two modified performance curves were prepared for reduced allowance conditions which correspond to existing settlement before the earthquake. The numerical results suggest that the expansion joints at the site might have produced an existing settlement equivalent to 1/3 to 2/3 of maximum performance before the earthquake.

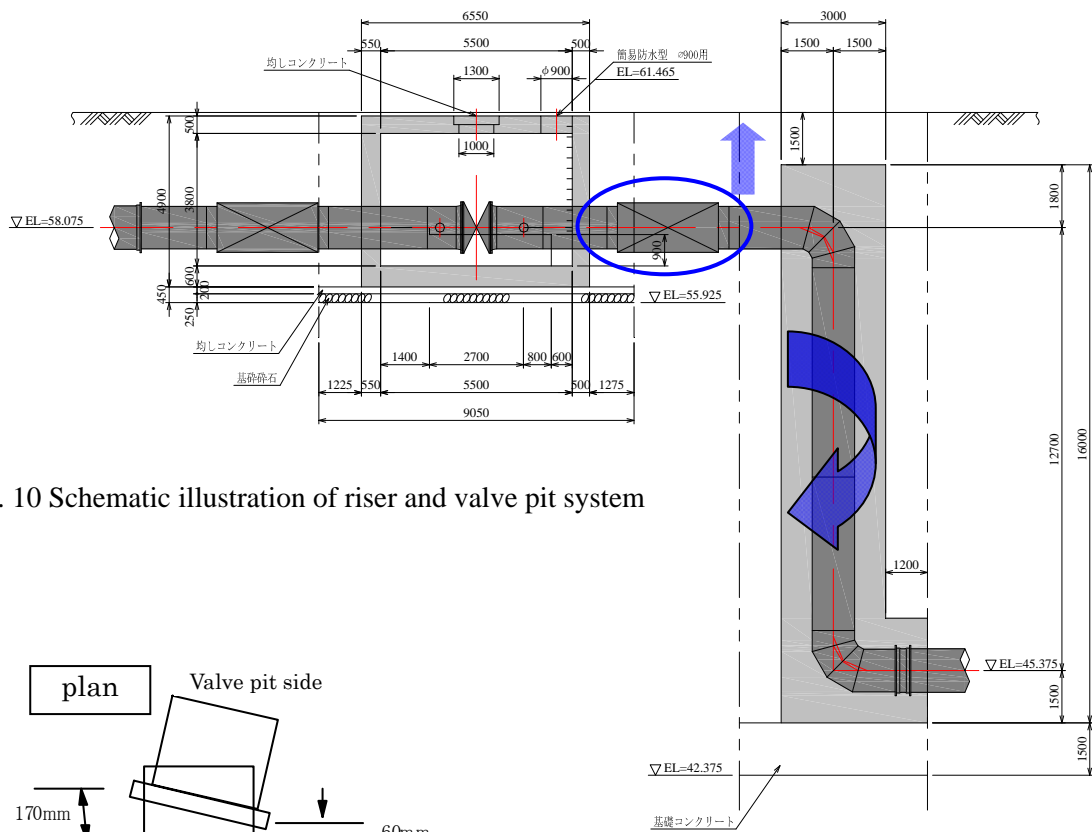
Fig. 10 Schematic illustration of riser and valve pit system

The expansion joint, which is located between the valve pit and the riser structure as shown in Figure 10, had a potential risk of uneven settlement, so that the expansion joint was forced to absorb vertical displacement. As a result of this settlement, the residual allowance for the seismic effect was limited. Based on the site investigation on April 7th, 2011, different vertical settlements were measured at the two ends of the expansion joint, as shown in Figure 11. This suggests that the joint had rotated to an angle of 3.5 degree before the earthquake. Using the site soil conditions shown in Figure 12, the seismic response of the concrete riser was analyzed with a single-degree-of-freedom system as follows.

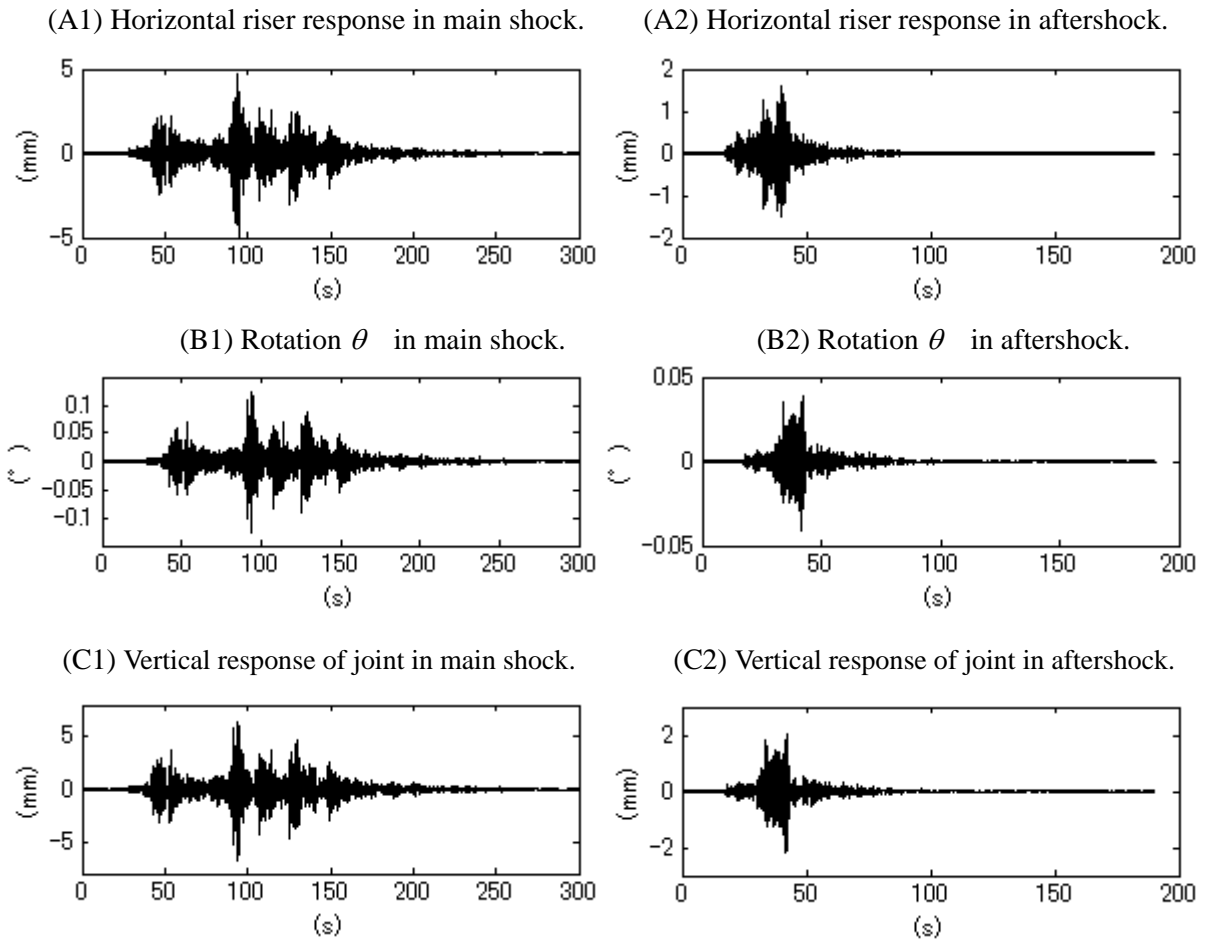
Fig. 14 Seismic responses of riser and expansion joint in main shock and aftershock.

in which x_Q, x_G, x_{si} and θ are base-rock ground motion, structural and surface ground responses, and rotation angle, as shown in Figure 13, and, k_i and l_i are the spring constant and the length at the i -th point from the gravity point. I_G and k_R are the rotational rigidity of the riser and its rotational stiffness for the surrounding soil and structural interaction. Figure 14 shows the seismic responses of the riser and the expansion joint in the main shock and the aftershock. In the main shock, the maximum rotation is less than 1 degree, which is not sufficient to destroy the expansion joint. This response led to a small leak from the joint since the pre-existing settlement had already produced rotation of 3.5 degree in the expansion joint. According to the fabricator's specification shown in Figure 15, the allowable maximum angle is 6 degree, so the main shock could not cause large-scale leakage immediately after the main shock. However, one month after the first small leakage, the hydro-blasting effect had worked on the sealing ring, reducing the thickness of the bolt diameter and the ring itself. As a result, when the second shock occurred in the aftershock of April 7th, the sealing ring had already been worn out, and could easily be broken by a small impact. This is a reason the expansion joint suffered a leakage failure in the aftershock.

In the second example, the pre-existing settlement played an important role in initiating small leakage from the sealing ring, which caused hydro-blasting that reduced the metal portion of the sealing elements. This result suggests that the allowable displacement of the expansion joint should be designed not only for vertical settlement under ordinary construction conditions but also for excessive displacement by future earthquakes.
