Preliminary report of geotechnical and structural damage along the surface rupture in Nishihara Village caused by the April 16th, 2016 Kumamoto earthquake

Key Words: *The 2016 Kumamoto earthquake, Surface rupture, Structural and Geotechnical damage, Prefectural road 28*

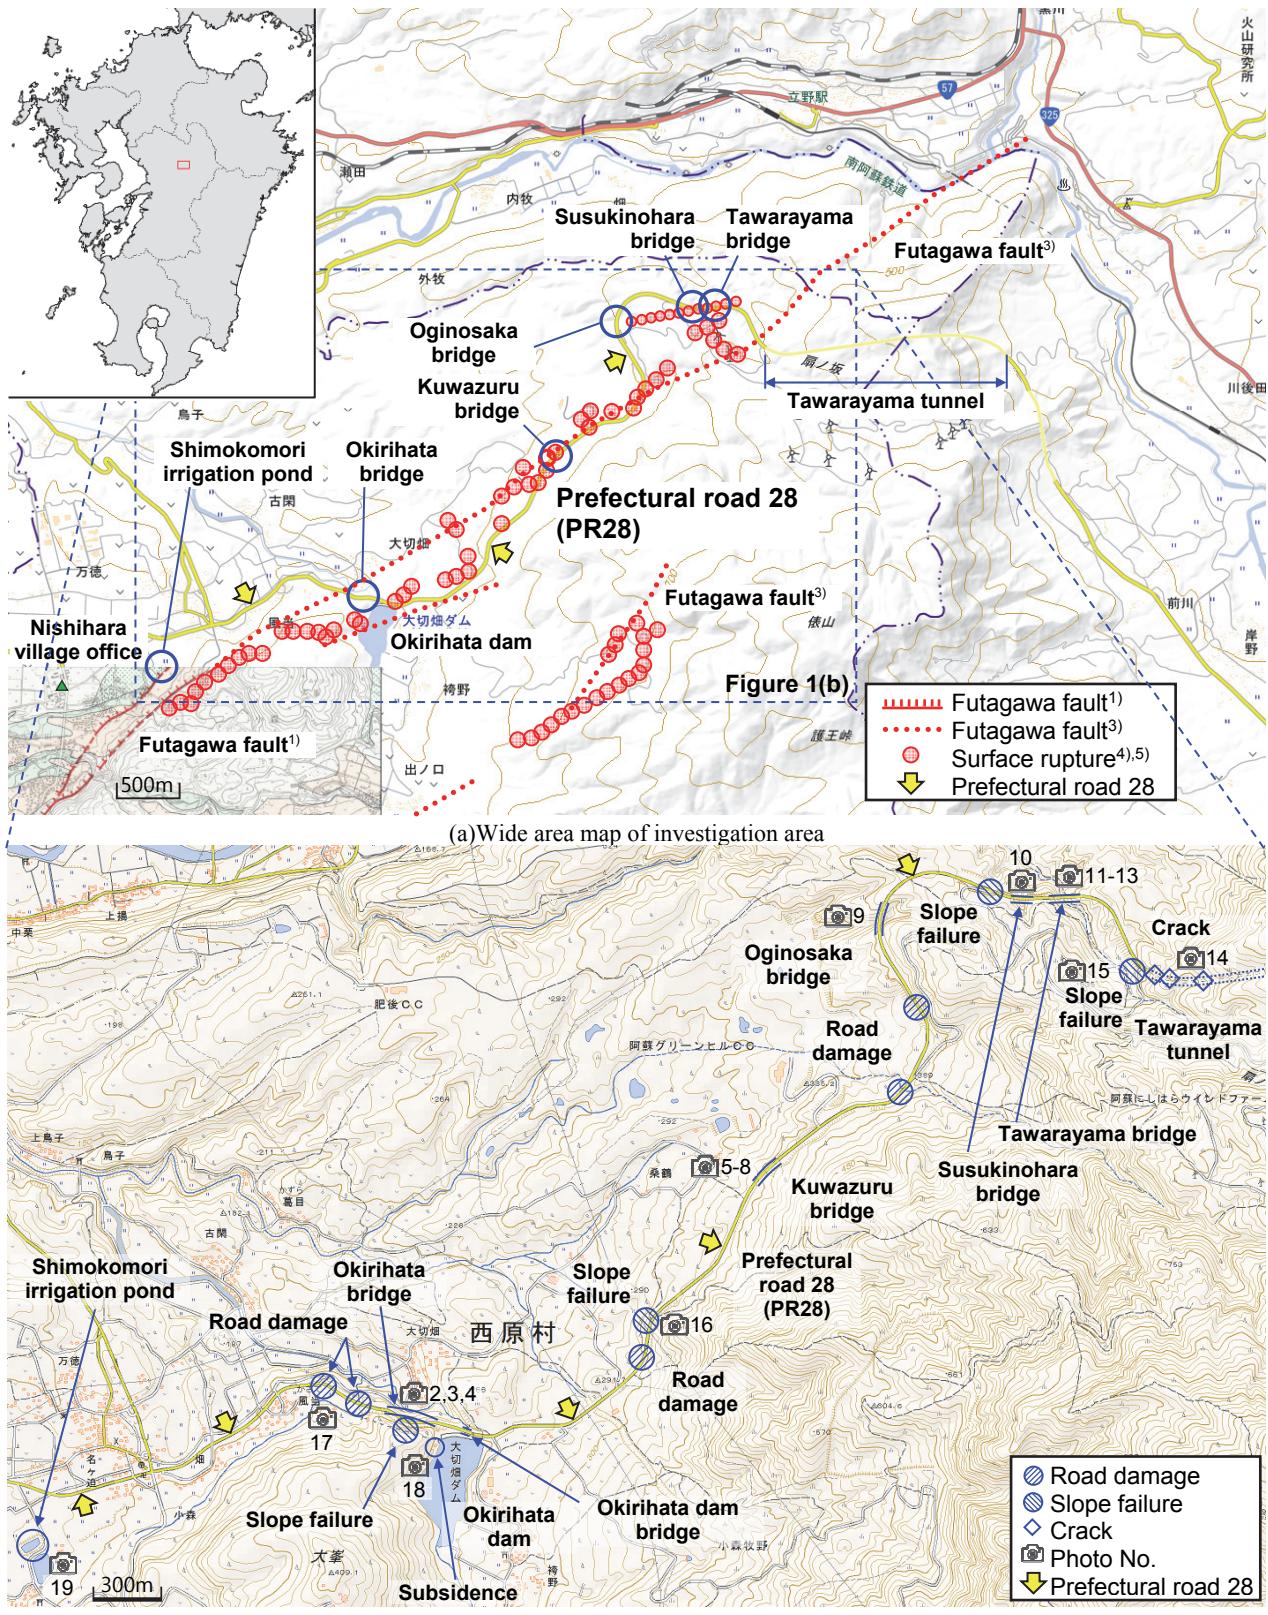
Figure 1 Locations of geotechnical and structural damage along Prefectural Road 28. The base map on a scale of 1/25,000 is from the Geospatial Information Authority of Japan.⁶⁾

Figure 1 shows our survey locations in Nishihara village. Red broken lines and red dotted lines are the

Futagawa fault traces shown in two published active fault maps^{1),3)}. Red-shaded circles are the locations of surface ruptures mapped by Geological Survey of Japan/AIST⁴⁾ and Shirahama *et al.*⁵⁾.

Six bridges and a tunnel were found damaged along PR28. Blue-hatched circles in Figure 1 show locations of these investigated structures and slope failures. Table 1 shows the types and lengths of the investigated bridges.

Surface ruptures appeared near east of the bridge⁵⁾ (see Figure 1(a)). Because the surface ruptures extend towards the bridge the damage to the bridge might have been affected by the fault rupturing.
