Damage investigation of 2019 the Off the Yamagata Prefecture earthquake, $M_j6.7$

Key Facts

Key Words: *Off the Yamagata Prefecture earthquake, Earthquake damage investigation, tile roof, Aerial photograph, Site amplification characteristics*

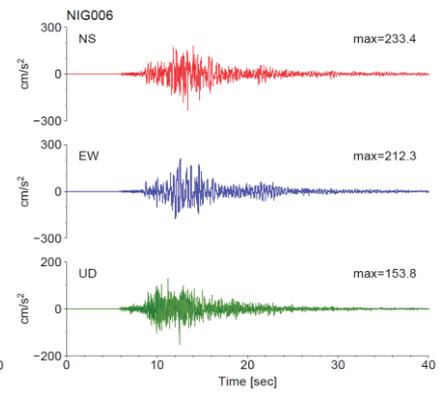
Fig.6 Observed acceleration wave-forms and acceleration response spectra (h=0.05) of NIG006.

Observed acceleration waveforms and acceleration response spectra are shown in **Fig. 6**. Peak ground acceleration (PGA) of horizontal components were greater than 200cm/s². Calculated seismic intensity was 5- by observation records. Acceleration response spectra reached 800cm/s² at a period range of about 0.1s to 0.5s.

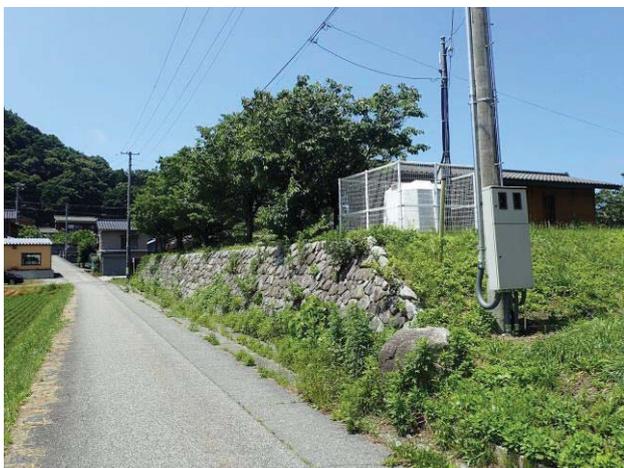
Photo 1 The seismic station of NIG006 that observed seismic intensity 5- (N38.45075, E139.496175).

Kangawa is located in the south of our investigation area. Seismic station of NIG006 has been installed at corner of Kangawa purification center. Hypocentral distance is about 17 km. **Photo 1** shows NIG006.

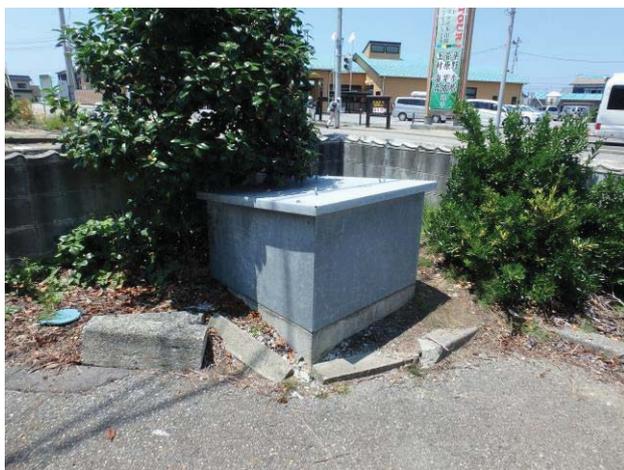
Photo 3 Fuya station that observed seismic intensity 6+ (N38.514105, E139.534208).

Fuya is located in the river mouth of the Ohkawa river. JMA instrumental seismic intensity meter has been installed at Sanpoku branch second office of Murakami City. **Photo 3** shows situation of Fuya station. A building of a one-storied house seen on the further side of the Fuya station is the Sanpoku branch main office. There is no major damage as far as we investigated.
