RECONNAISSANCE REPORT ON THE EARTHQUAKE IN OSAKA-FU HOKUBU ON JUNE 18, 2018

Key Facts:

Key Words: *earthquake in Osaka-fu Hokubu on 18 June 2018, reconnaissance report, earthquake ground motion, source effect, lifeline damage, civil life*

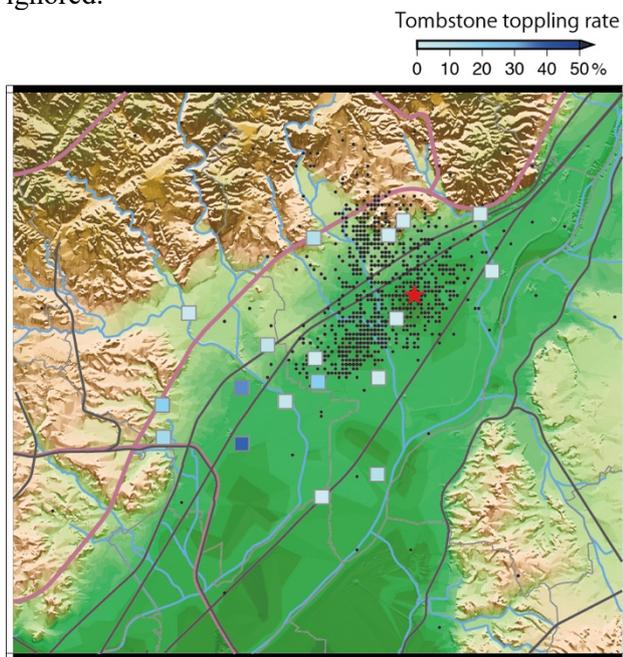
results from the day following the main shock and other later days. For general tombstone types, the toppling rate is defined as the number of tombstones with a pole stone that toppled divided by the total number of tombstones in the target graveyard. **Fig.10** shows the tombstone toppling rate on the map. Although Takatsuki City is thought to be immediately above the hypocenter, tombstone tumbling was practically negligible there (almost 0% toppling rate). Conversely, the toppling rate in the central part of Ibaraki City was 10%–30%. Furthermore, areas with high toppling rates do not always overlap with back marsh, ⁷⁾ which is regarded as soft ground. This implies that it is difficult to understand the earthquake ground motion near the hypocenter only by seismic distance and simple site amplification. The influence of the radiation characteristics as the source mechanism and particularly directivity can therefore not be ignored.

Fig.10 Tombstone toppling rate near the hypocenter

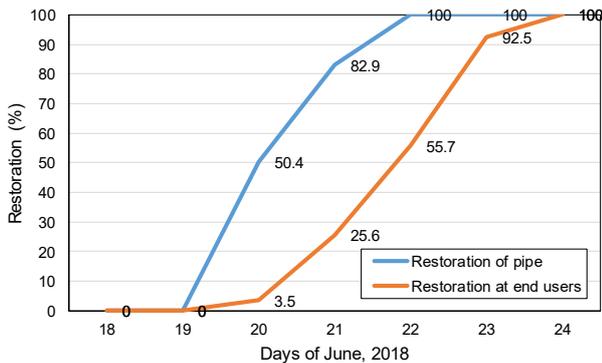
When the city gas supply stops, the gas company first closes the gas meter of each customer. Next, to investigate the leakage of the gas pipe within the shutdown area, the company divides the small block into smaller blocks. The company then investigates and checks gas leakages, and in the case of gas leaks, the company digs the pipe and repairs it. After repairing the pipe, the company then restarts the governor. The opening operation of the meter was performed in the presence of the customer. A considerable number of workers are required to follow this protocol. A total of 5,100 people worked to restore the gas supply, including 2,400 Osaka Gas officials, workers of new entrants, such as electric power companies that retail gas within the Osaka Gas providing area, and 2,700 support workers from other gas companies. Among those supporters, the electric power companies that entered the gas business through the liberalization of energy were also included. Immediately after the earthquake, the prospect of restoration was slated to occur between June 26 and 30. However, because the damage of the low-pressure pipes on the site was minor, restoration of the pipeline was completed on June 22 and the opening work to the customer ended on June 24. **Fig.21** shows the process of restoring the city gas.

Fig.21 Osaka Gas restoration process (restoration number 111,951 households)

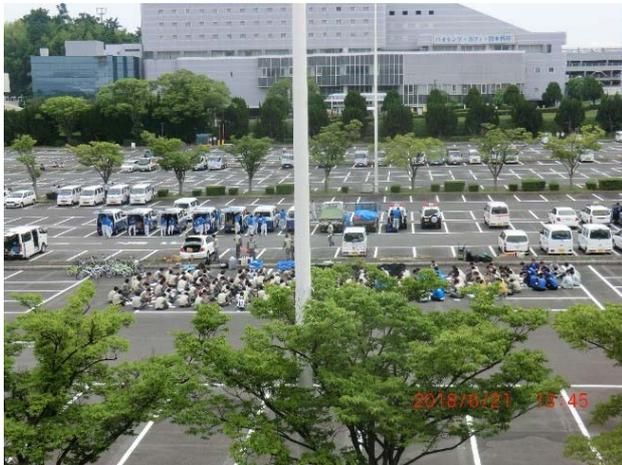
Osaka Gas established front-line bases at eight locations, including parking lots and parks adjacent to the shutdown area to make restoration activities more efficient, and adjusted the number of support vehicles and workers. **Fig.22** shows the state of the front base using the parking lot in Expo Memorial Park. The candidate sites of these frontline bases were preliminarily listed in advance. Facilities in other prefectures, such as Shiga Prefecture, were used to accommodate the support workers.

Fig.22 State of the front base of Osaka Gas (Expo Park parking lot)

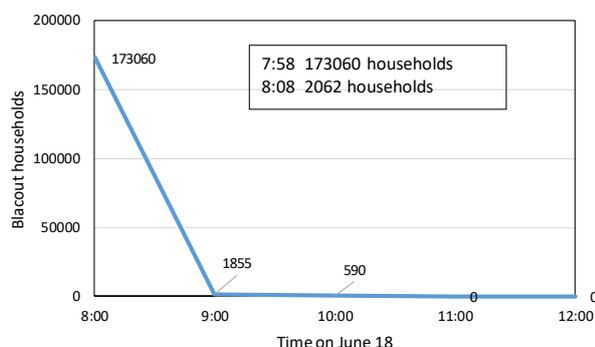
Kansai Electric Power Company (KEPCO) reported that there was no trouble in nuclear, thermal, and hydropower power generation facilities due to the earthquake. A total of 173,060 customer power outages occurred in Osaka Prefecture including Toyonaka City (~95,000 customers), Minoh City (~41,000 customers), Suita City (~25,000 customers), Ikeda City, Settsu City, Takatsuki City, and Ibaraki City and in Hyogo Prefecture including Nishinomiya City and Itami City. However, the number of outages decreased to 2,062 customers 10 minutes after the earthquake occurred. The restoration was then completed at 10:43 on the same day. Fig.24 shows the KEPCO restoration process.¹⁵⁾

Fig.24 Electric power recovery process (maximum blackout number = 173,060 households) (from Kansai Electric Power Co.)

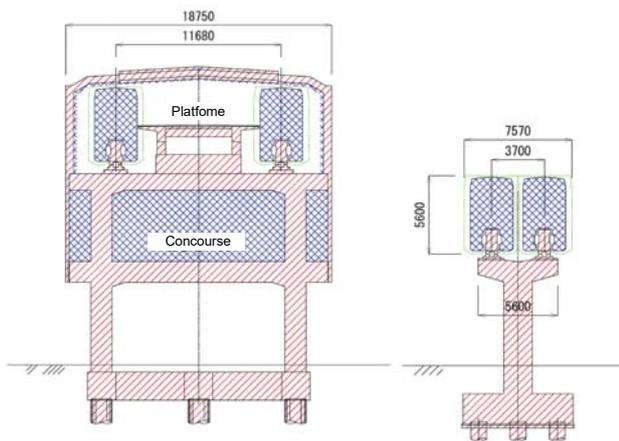
Facilities constituting the Osaka monorail are roughly classified into an infrastructure section and a transport section (Fig.25). The road administrator (Osaka Prefecture) constructed and maintained the infrastructure section as subsidiary facilities for traffic, piers, and girders of the overhead bridge and basic structure of stations as road structure. In addition, the outside of the infrastructure included facilities necessary for operations, such as trains and a signal system. These are operated and managed by a

Fig.25 Infrastructure (red) and transport section (blue) on Osaka Monorail

Between 1997 and 2007, the bridge piers were reinforced and measures were taken to prevent the steel rail girder from falling near the infrastructure section. Measures were taken to prevent the PC rail girder and station girder from falling from 2006 to 2014. Following this earthquake, damage was not observed in the infrastructure sections in which these measures were taken.

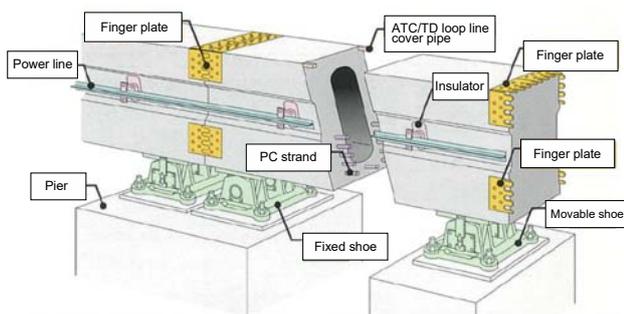
Fig.26 Configuration of the PC rail girder (from Osaka Monorail)

Concrete peeling at the end of the PC rail girder (**Fig.26**) and loosening of the bearing anchor bolt were observed in the affected part of the infrastructure section (**Fig.27**), but were determined to be minor. There was also damage to the locking devices and limit switches, insulators that support the electric lines, and some parts of the trains.

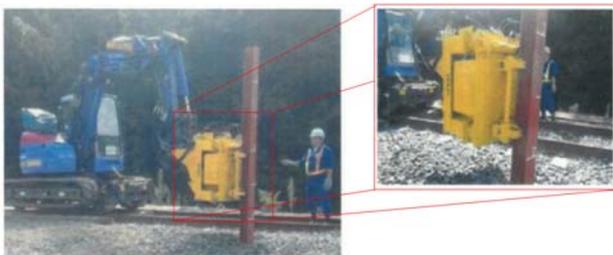
Fig.30 Situation of compacting use of the improved backhoe (from JR West)

arch bridge, H-shape steel girder, and filled land, required repair. The connections of these various sections received different shake magnitudes. Track deformation was recognized around Kakegusi immediately after the earthquake. The repairs were performed and the absence of abnormality was confirmed by visual inspection, therefore the operation was restarted. After the start of operations, because a larger sway was confirmed than usual, it was decided to repair this part and to run slow operations in that section. The part was compacted using the improved backhoe (Fig.30) and the slow operation was terminated on July 17.

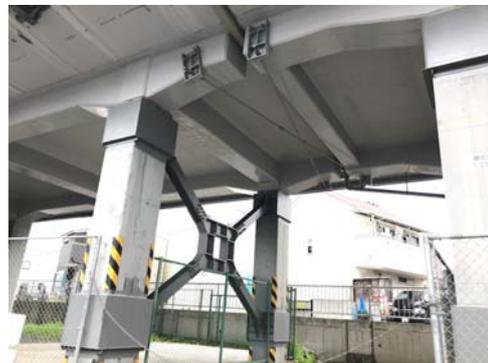
Fig.32 Situation of Tokaido Shinkansen Seismic Retrofitting (taken on June 19, 2018)

Surveys were also conducted along the Tokaido Shinkansen viaduct running between Ibaraki and Takatsuki, where many houses were damaged. However, because various kinds of seismic retrofitting measures (Fig.32) had been made, no damage was observed.

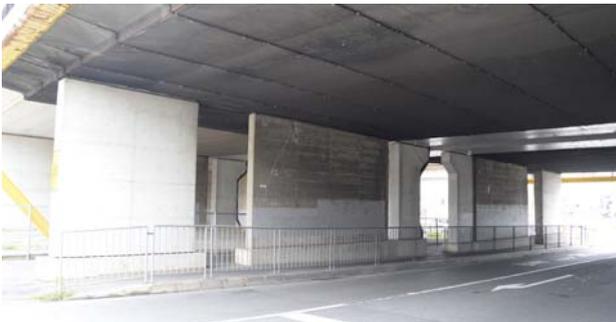
Fig.34 Rocker pier added to both sides of the original intermediate piers at the widened part (taken on June 21, 2018)

The rocker pier supports only the vertical force and the horizontal force is supported by the rigid frame pier and the abutment at both ends of the girder. Between Ibaraki and Takatsuki, piers were added during widening construction in several sections (**Fig.34**). When the girder was widened after opening, rocker piers were added to both sides of the original bridge piers, in addition to the bridge piers at the time of opening in the intermediate piers. In the 1995 Hyogoken Nanbu earthquake, severe damage occurred in the rigid frame pier in the viaduct with the rocker bridge piers. Thus, a seismic reinforcement, namely, a rubber bearing and damper, were installed at the bearing of the viaduct end. The stopper was installed in the transversal direction of the bridge (**Fig.35**). Shear cracks due to the earthquake were found in the initial constructed piers (**Fig.36**). In terms of the seismic reinforcement part of the rigid frame pier, a steel bracket on the stopper in the transversal direction hit the pier head (**Fig.37**). It is therefore understood that it moved in the transversal direction of the bridge within the allowable displacement. Although no damage was found on the rocker piers of the widened part, and no girder settlement was found even at the pier part where the oblique crack occurred, a vent for vertical support of the girder was set up when the site was revisited on July 11.
