Reconnaissance survey on geotechnical damage caused by February 6, 2023, Kahramanmaraş Earthquake, Türkiye

Key Facts

Key Words : Kahramanmaras Earthquake, geotechnical damage, liquefaction, lateral spread, landslide, inundation, settlement

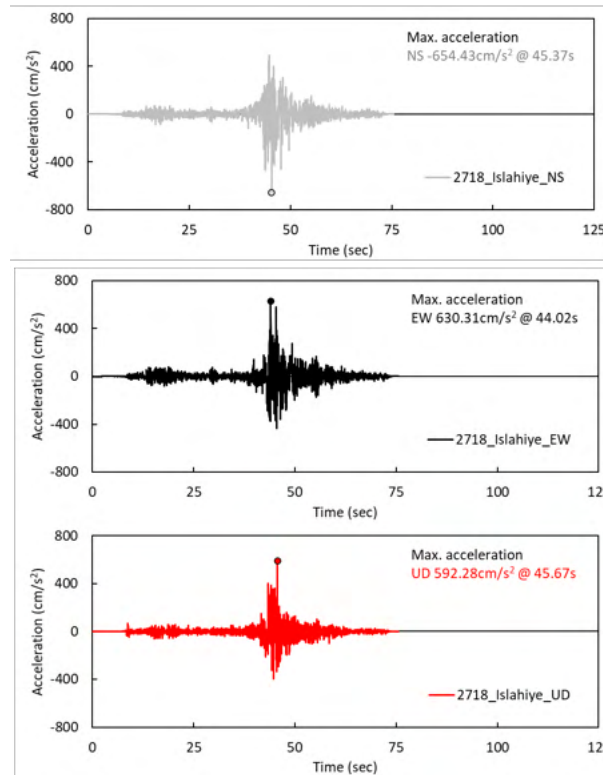
Nearest recording at Station 2718 around 3 km distance from the landslide is shown in Fig. 9 and maximum recorded acceleration is 654 cm/s^2 . Both

Fig. 9 Recorded strong motion¹⁾ at Station 2718 (37.00777N, 36.6266E).

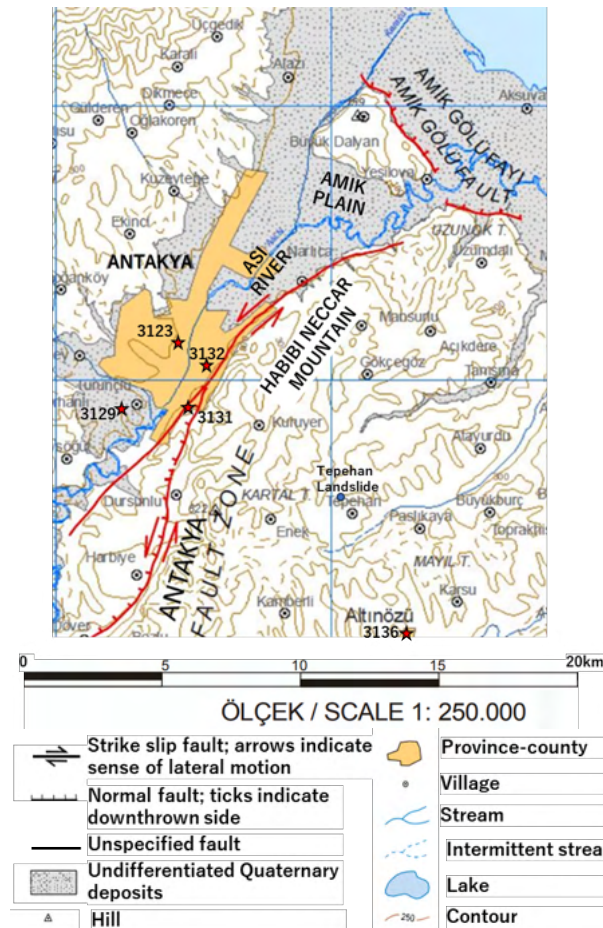
Antakya district (shaded with yellow in Fig. 16 based on Emre et al. (2012)²⁰) is located to the east and west of the Asi River, in the valley that continues south after crossing the Amik Plain. The boundaries between the mountainous areas in the north, composed of rocks with different geological ages, and the plain is represented by the faults (Fig. 16). The region located between the Asi River through the skirts

Fig. 16 Location of Antakya City and active faults in the region²⁰) with the location of the strong motion stations (marked with a red star).

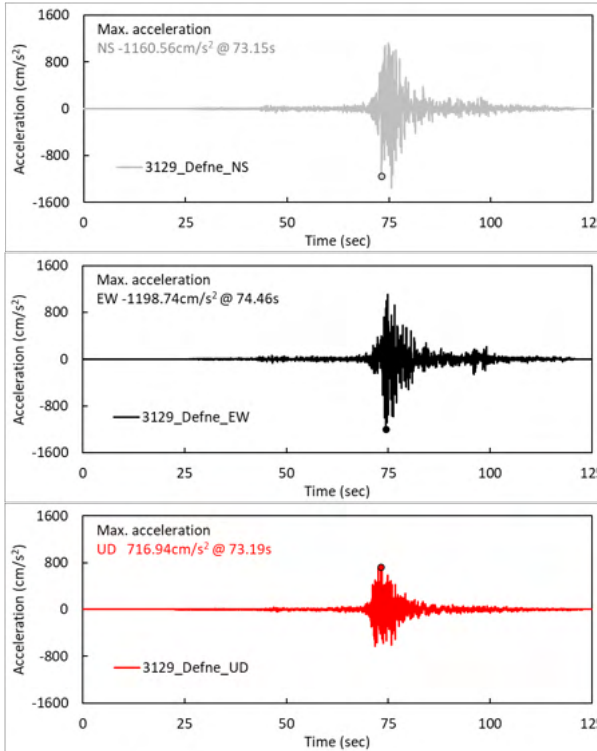
Fig. 18 Recorded strong motion¹⁾ at Station 3129 (36.19117N, 36.6266E).

A list of the maximum absolute accelerations recorded in the region and the time history of Station 3129 are given in Table 2 and Fig. 18, respectively. While highest maximum absolute accelerations were observed in the basin region (i.e. Stations 3123, 3129), getting closer to the mountain region (i.e. Stations 3132, 3131) maximum absolute accelerations were smaller.

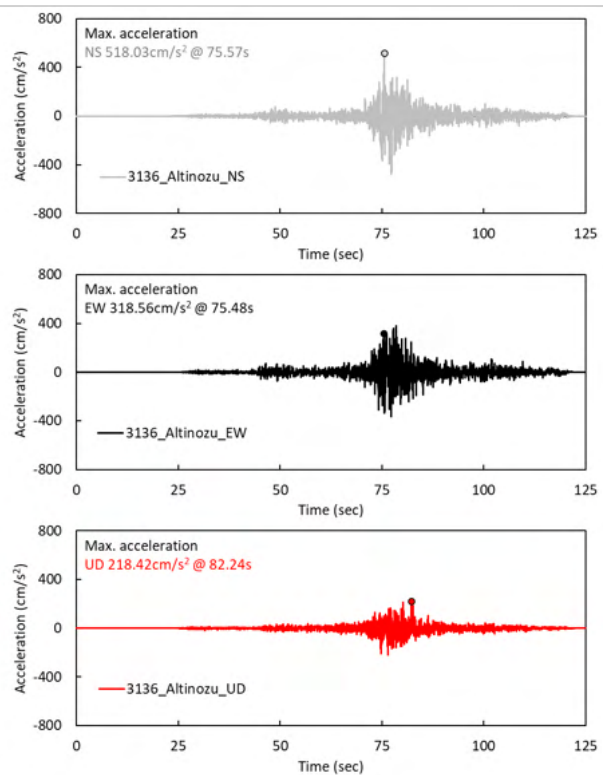
Fig. 20 Recorded strong motion¹⁾ at Station 3136 (36.11593N, 36.24722E)

Although there was not any station at the landslide location, the nearest station is Station 3136 (location shown in Fig. 16) in Altinozu, at 5.49km southeast of the Tepehan landslide. The recorded strong motion at this station is shown in Fig. 20.

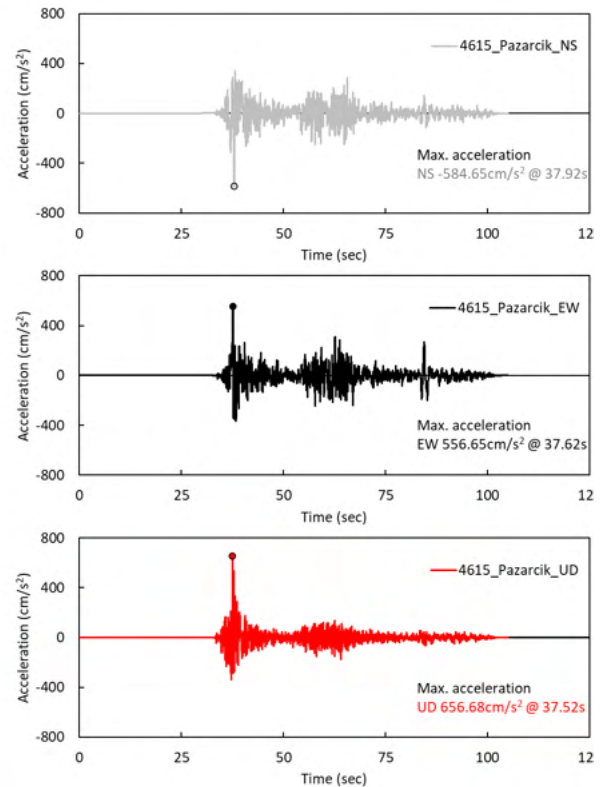
The strong motion recorded at Station 4615, which is about 11.7 km north of the damaged embankment is given in Fig. 22 with maximum absolute accelerations of 585 cm/s^2 NS and 657 cm/s^2 UD.

Fig. 22 Recorded strong motion1) at Station 4615 (36.7088N, 37.1123E)
