A preliminary report of *Kermanshah* Earthquake M 7.3, Iran earthquake of November 12, 2017

Building damage

Toshikazu IKEMOTO
Masakatsu MIYAJIMA
Abdolhossein FALLAHI
Farzad TALEBI

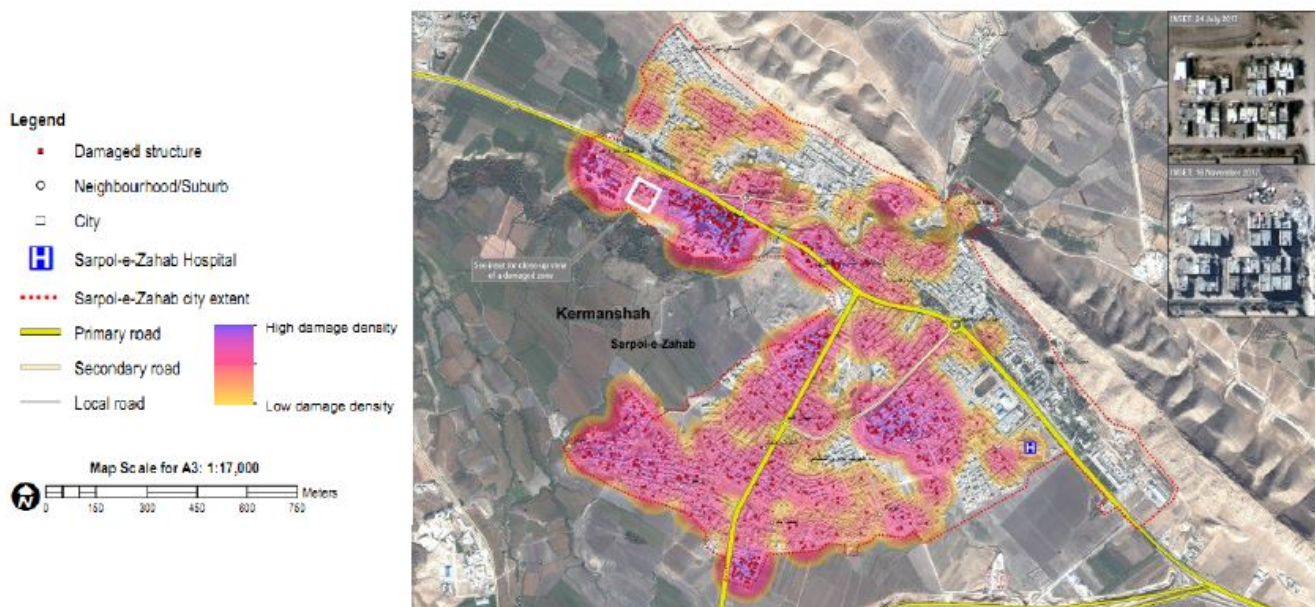
Damaged structures and related density map in Sarpol-e-Zahab (<https://unitar.org/unosat/>)

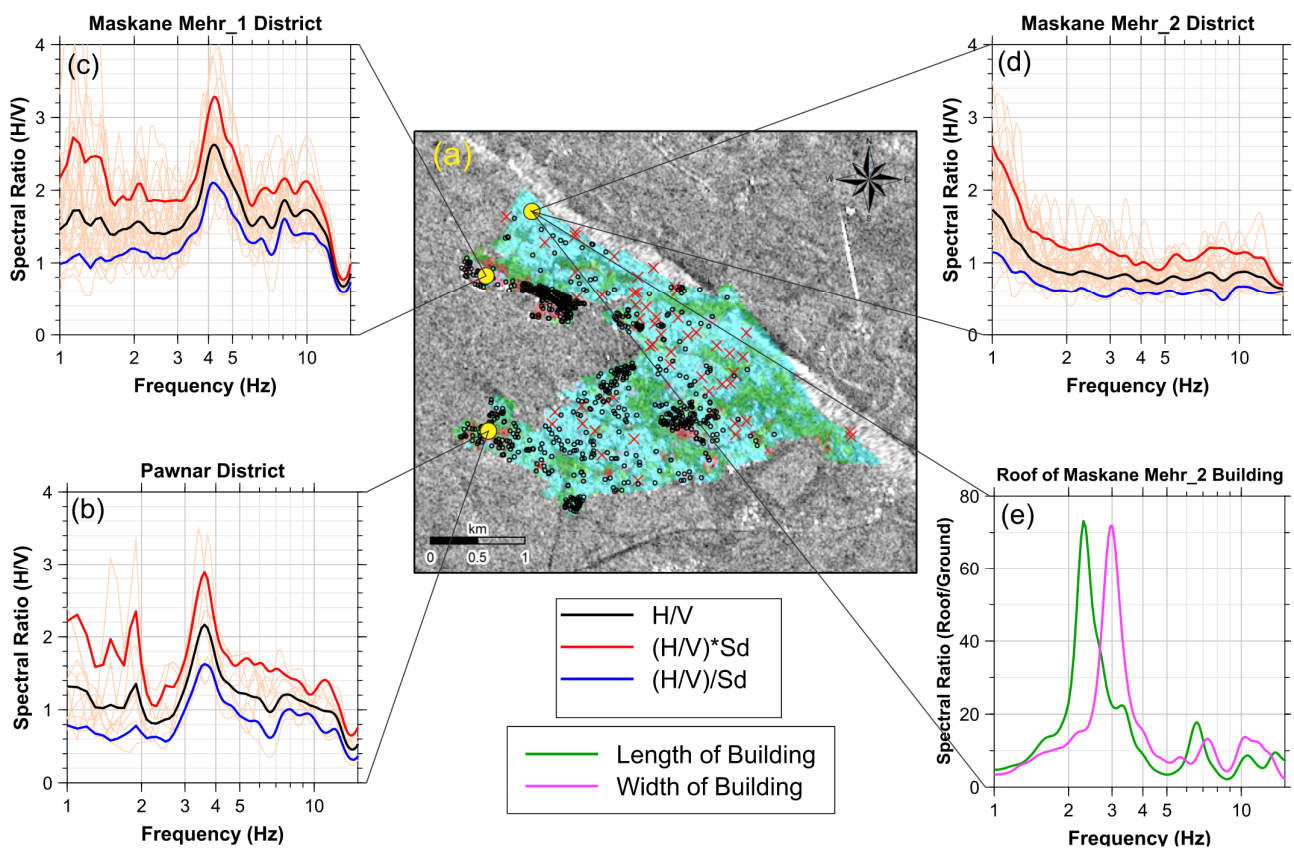
Fig. 1. (a) Location of microtremor measurement points in Sarpole-Zahab city which have been shown by yellow circles; (b), (c) and (d) Obtained spectral ratio (H/V) (black curve), spectral ratio multiplied by standard deviation (red curve), spectral ratio divided by standard deviation (blue curve) in Pawnar, Maskane Mehr_1 and Maskane Mehr_2 districts, respectively; (e) computed spectral ratios along length (green curve) and width (magenta curve) at the roof of a 4-story building in the Maskane Mehr_2 district.

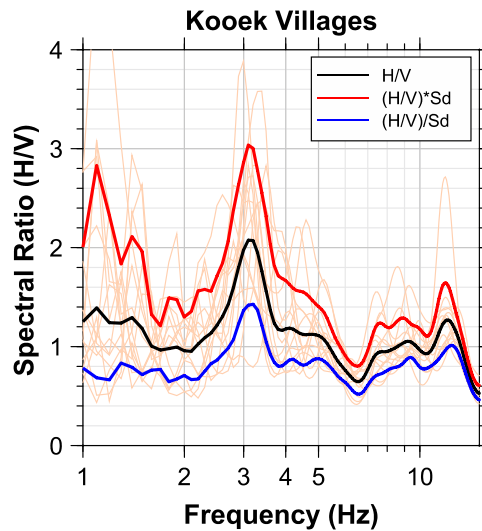
Fig. 2. Obtained spectral ratio (H/V) (black curve), spectral ratio multiplied by standard deviation (red curve), spectral ratio divided by standard deviation (blue curve) in Kooek villages site.
