# Preliminary Damage Survey Reporting Seminar of JSCE at University of Tokyo

## Nepal Gorkha Earthquake, 2015

Earthquake Engineering Group  
Ehime University Team  
JSCE, JGS, JAEE and ATC3 delegates

Shinichiro Mori, Prof., GPI

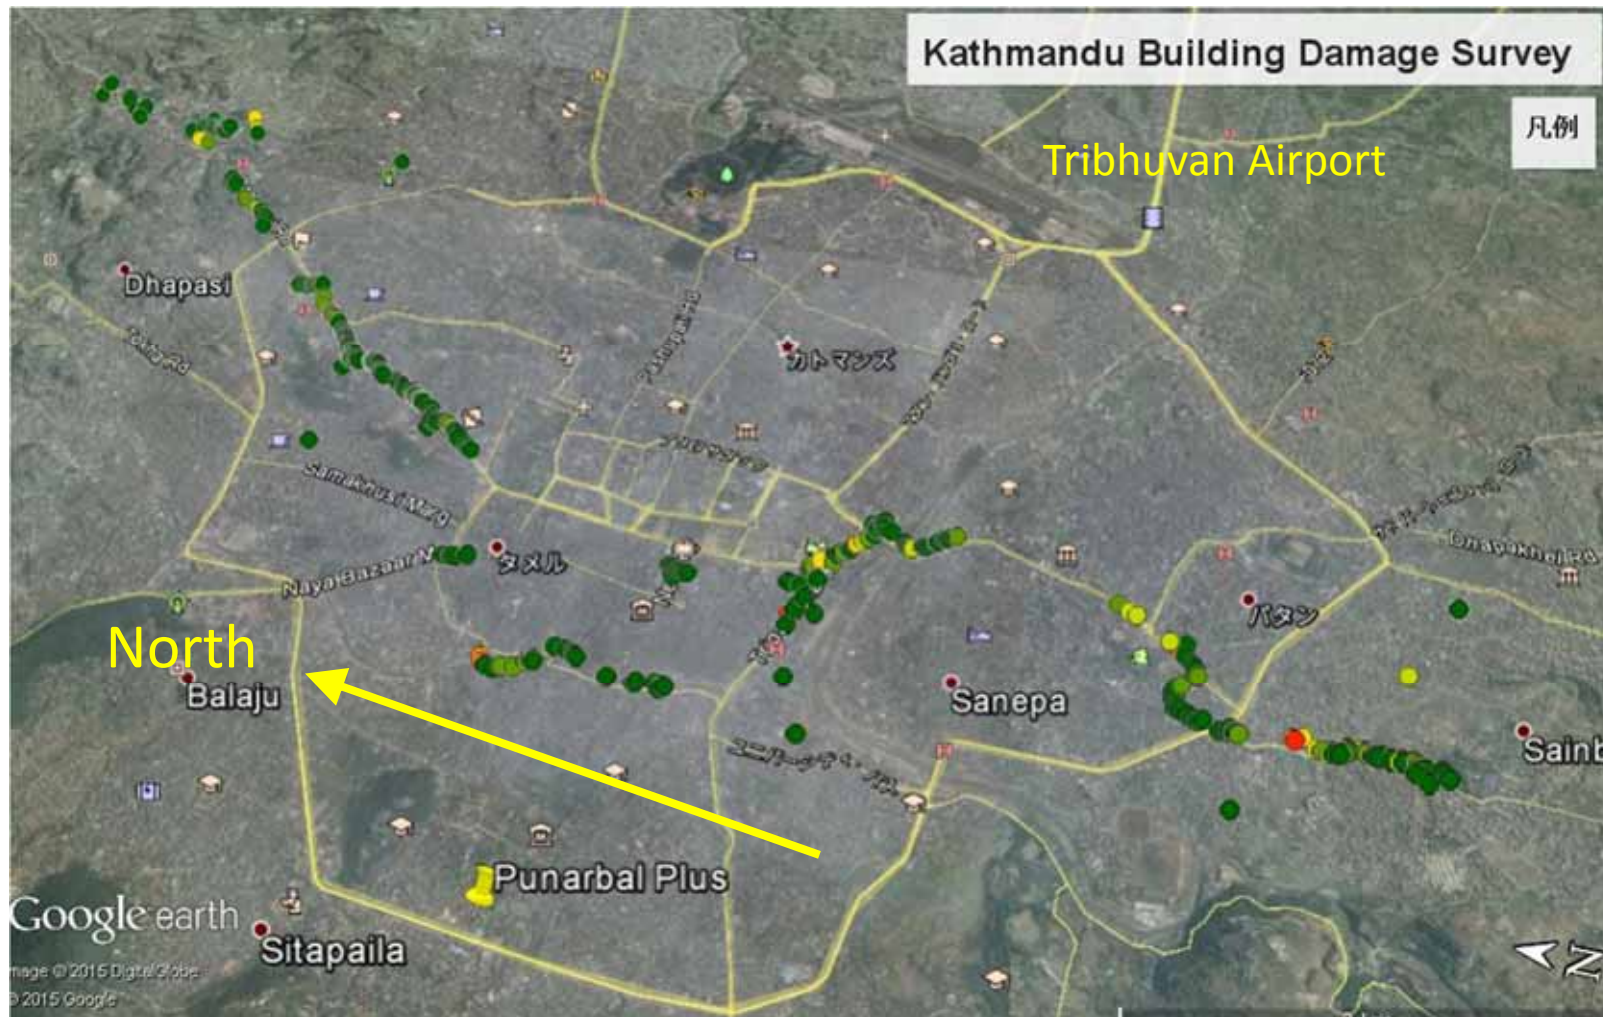
Along the N-S street. Most classified to Grade 0, 1 and 2. Grade 3, 4, 5 are few.

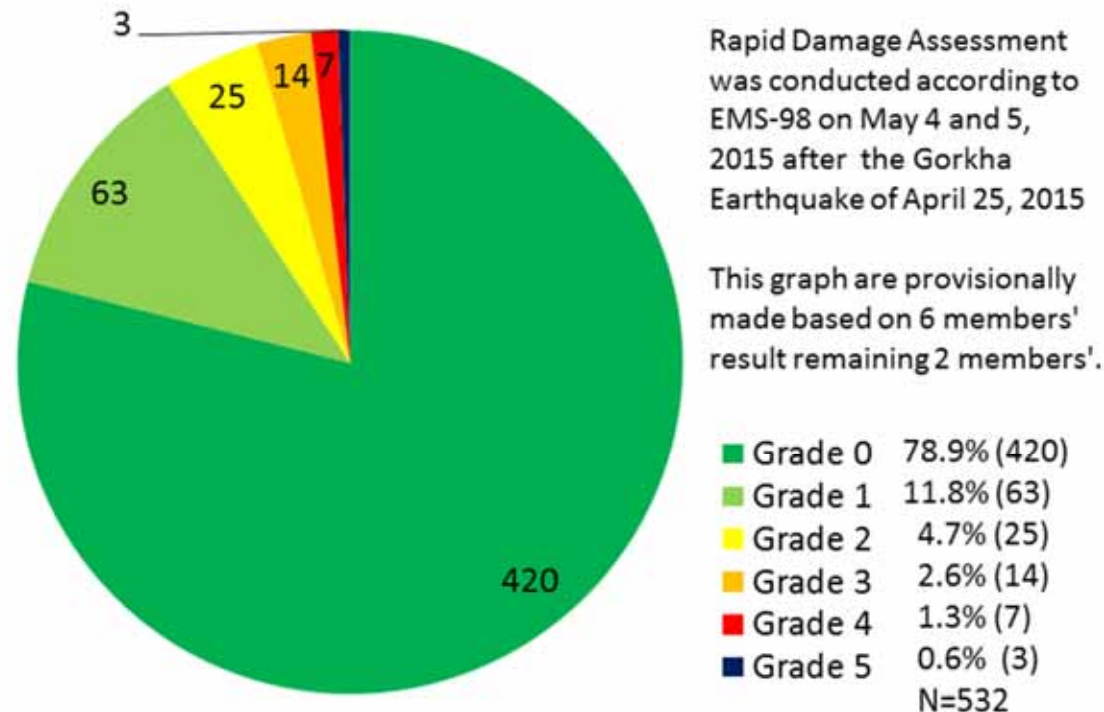
Along N-S main roads across Kathmandu Municipalities,

No or Slight Damage  
(Grade 0 and 1)

Provisional Result of Exhaustive Rapid Damage Assessment on Buildings along continuous North-South main roads across Kathmandu by Ehime University Team, as of May 13, 2015

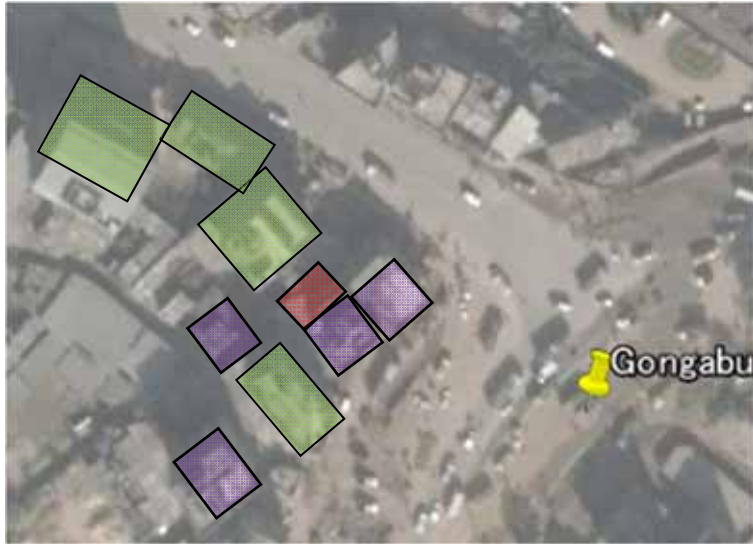
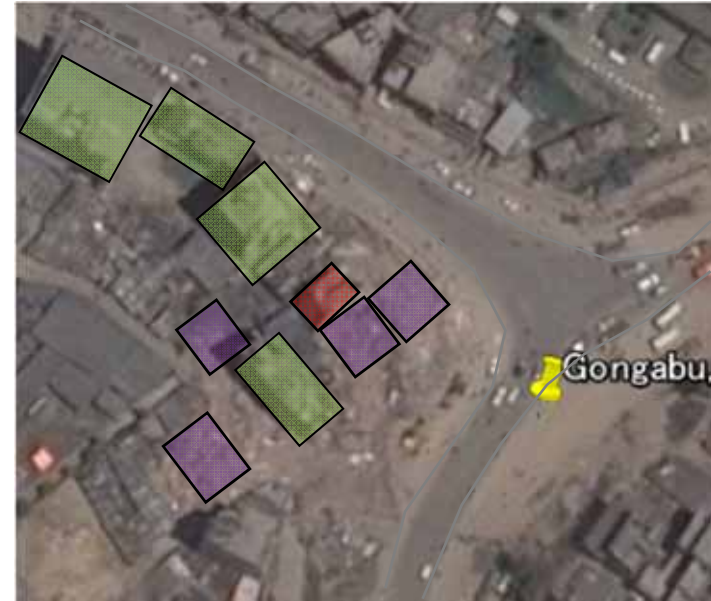
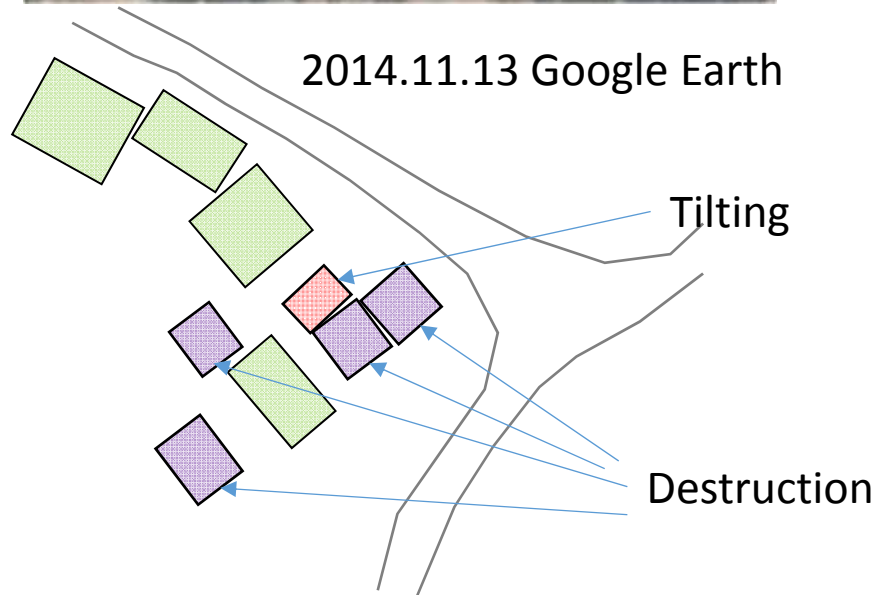
# Gongabu, KTM

A tilting 5-story RCIW building surrounded three destroyed buildings in Gongabu. Widely known by media news.

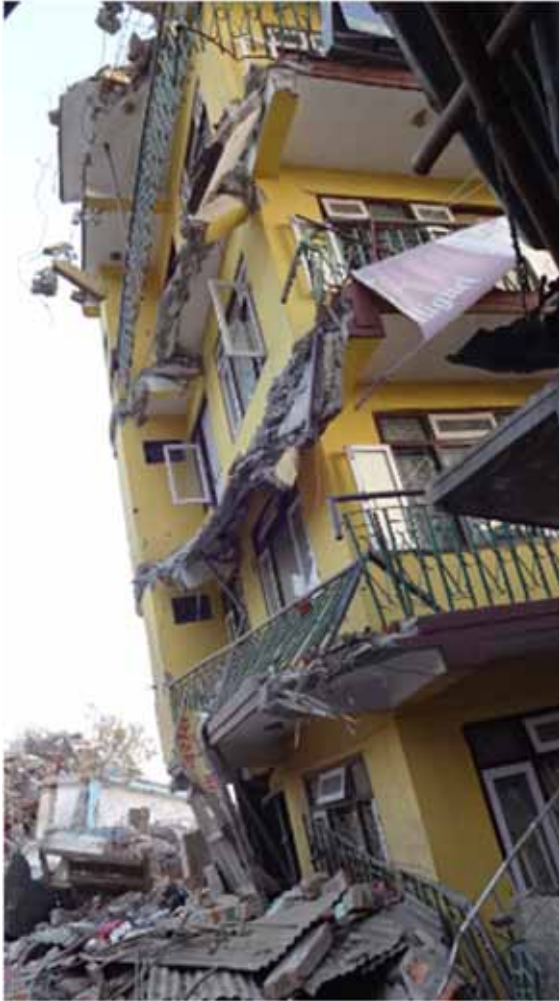
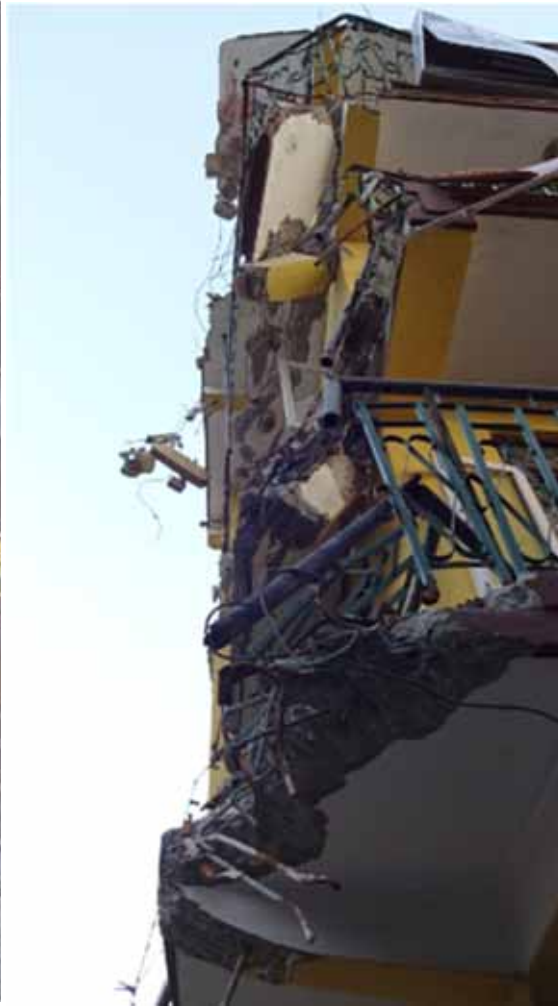
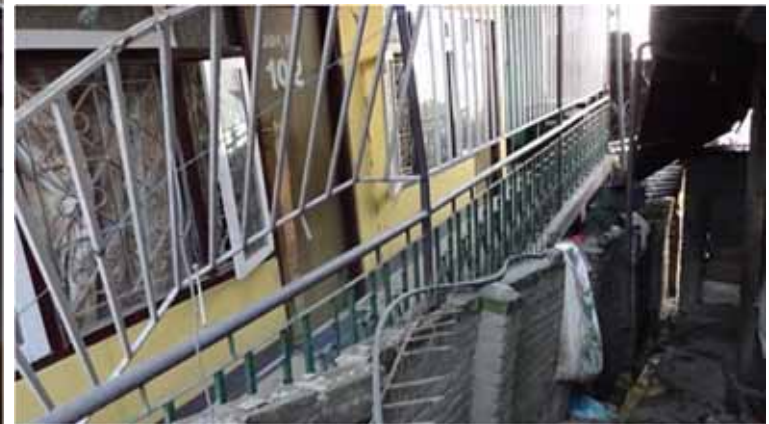
# Gangabu, KTM

The first story columns were crushed in the front side and survived in the rear side. Accordingly the building tilted.

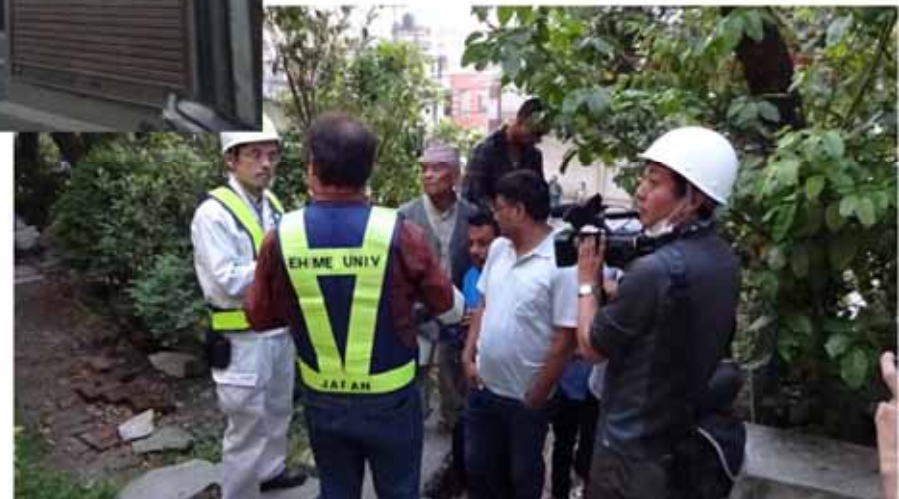
Normal buildings around the Park Horizon suffered no damage. According to our interview to local people regarding their behavior during the quake, seismic intensity there would have been 4 to 5- in JMA scale, or 7 in MMI scale.

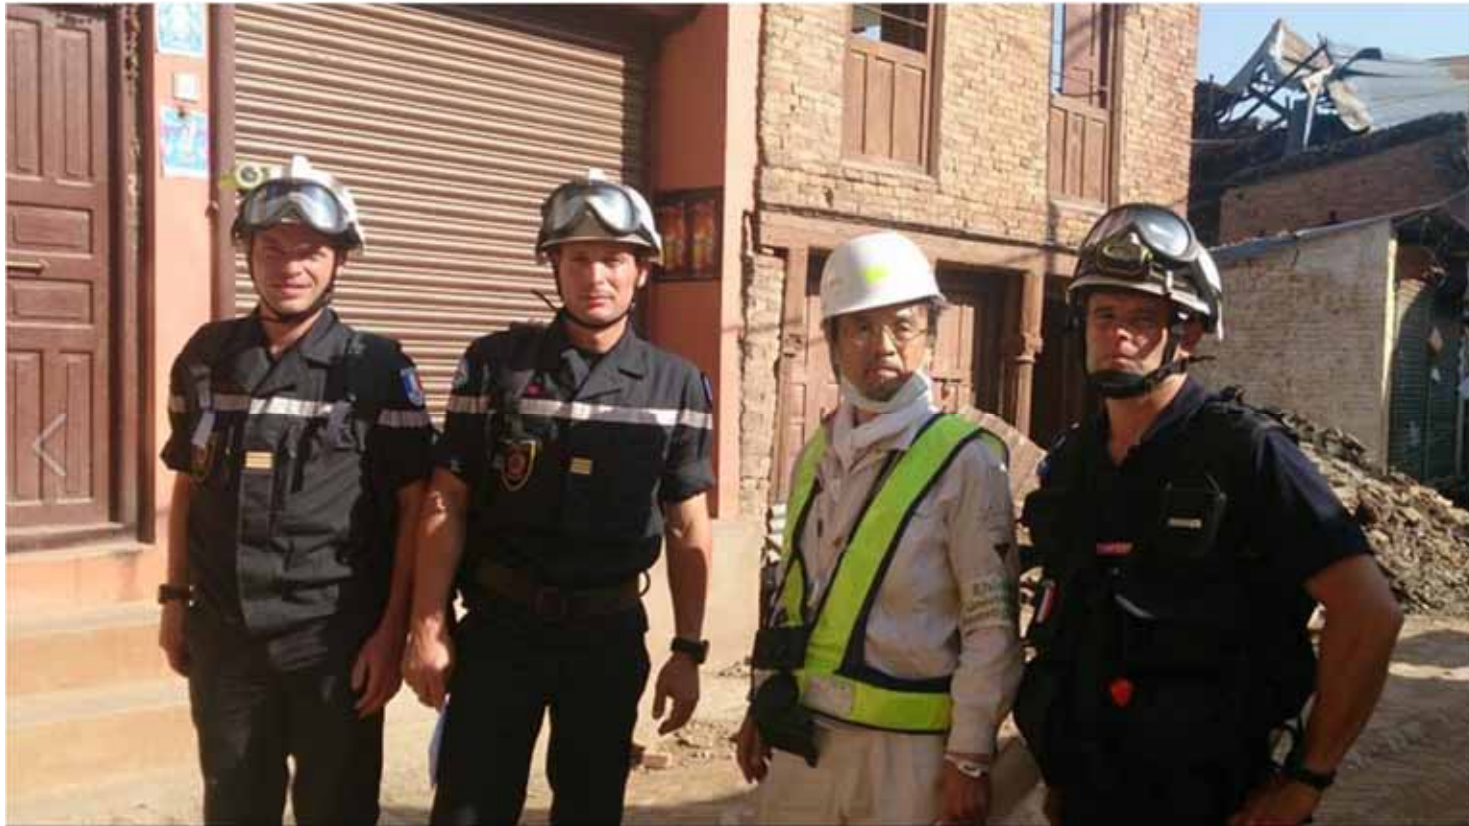
# An other damage assessment team in Sankhu

I came across a group of French Embassy gentlemen in Sankuh Town by chance! I individually taught them the way to assess damage to a reinforced concrete building in Nepal from the structural engineering point of view because they are laypeople. I have expected they consider my advice. Their assessment was a bit conservative.

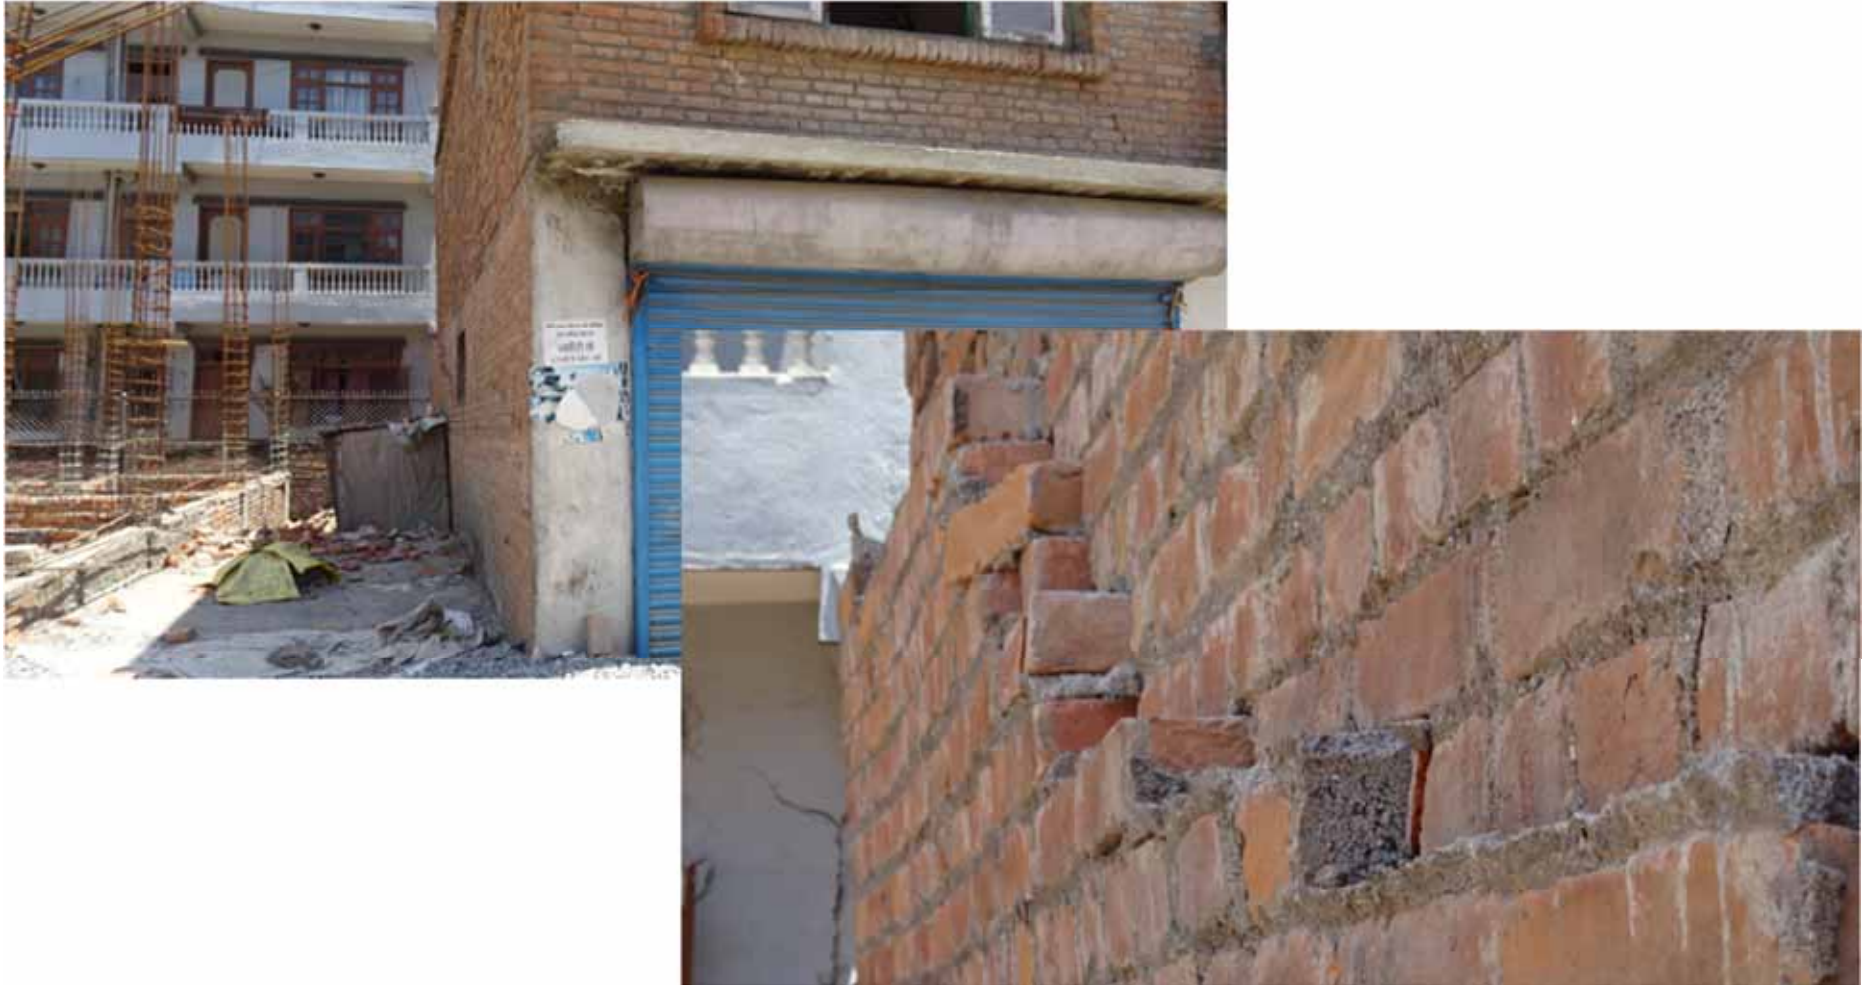
# Sobhabhagawati, KTM

A RC build may have helped old masonry buildings against collapse.

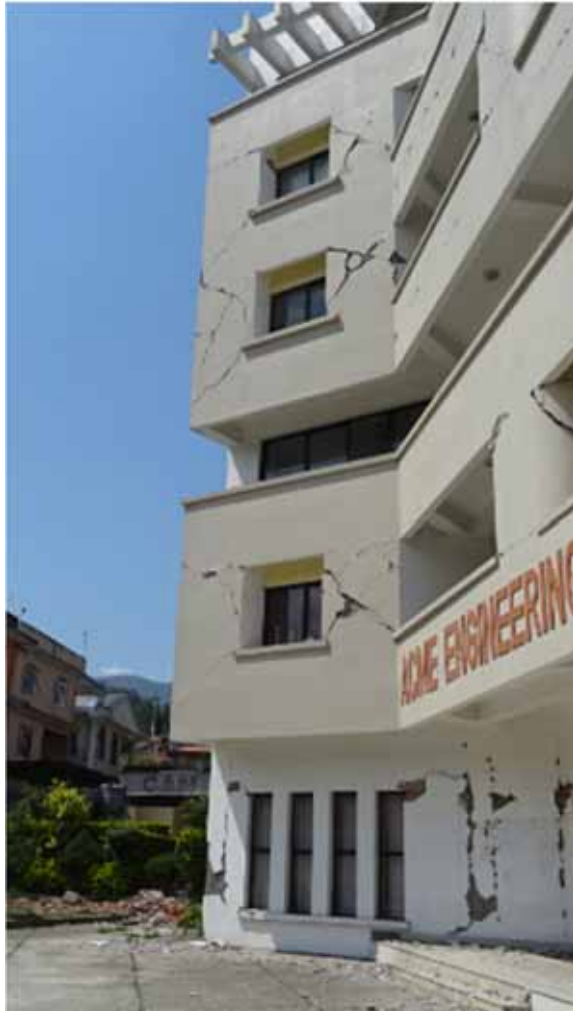
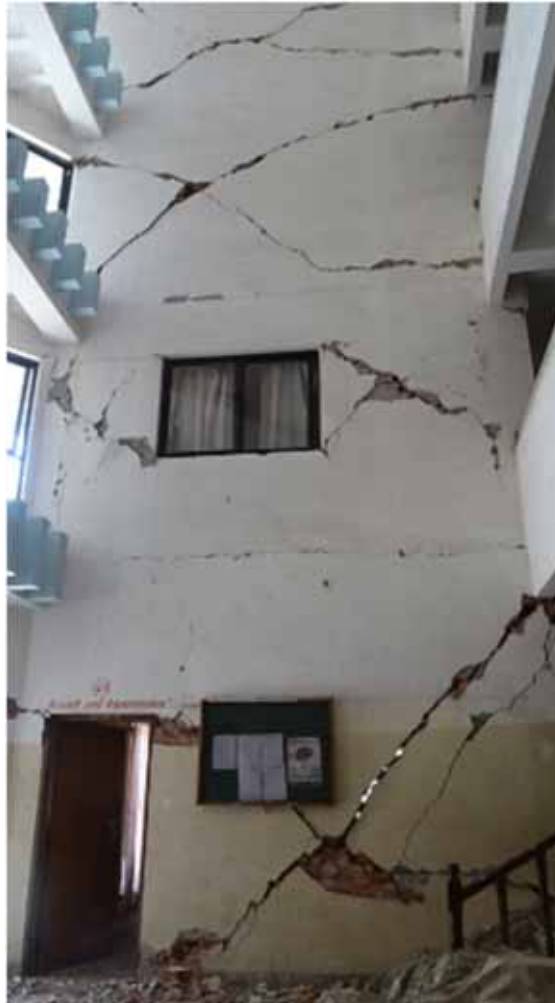
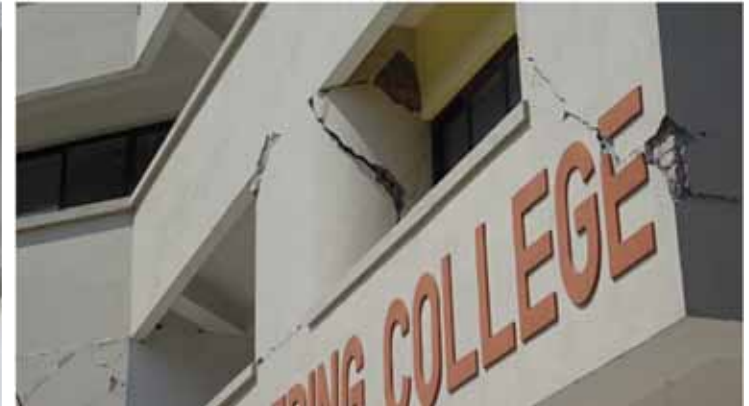
# A damaged 5F-building (G1) in Pulchowk, KTM

Damage: Cracks on the nonstructural internal brick walls. Bending cracks at the head of columns of the first story resulting delamination of plaster. **Slight damage.**

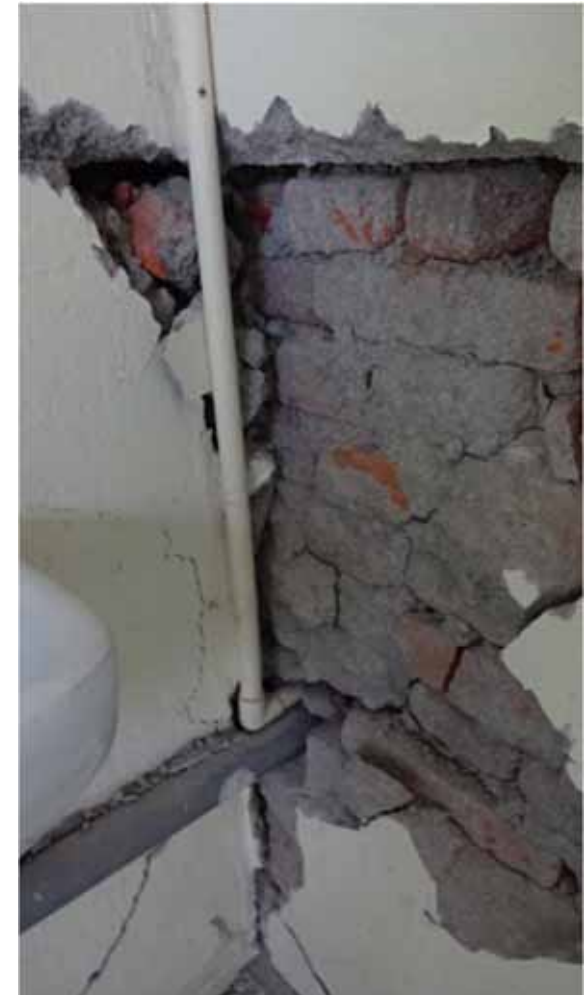
# Liquefaction and associated damage

Mortar was not good
