Geotechnical Damage caused by M7.5 Noto Peninsula Earthquake of January 1, 2024

(Updated version from EERI QQB presentation on Feb. 23, 2024)

Takashi KIYOTA¹, Jun KURIMA¹, Takaaki IKEDA², Masataka SHIGA²

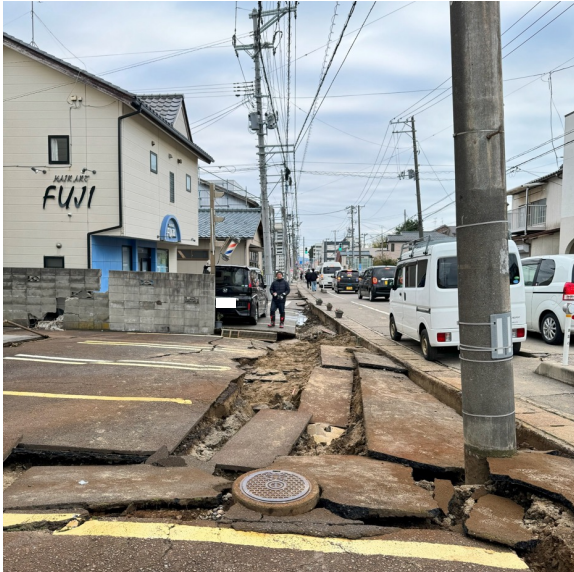
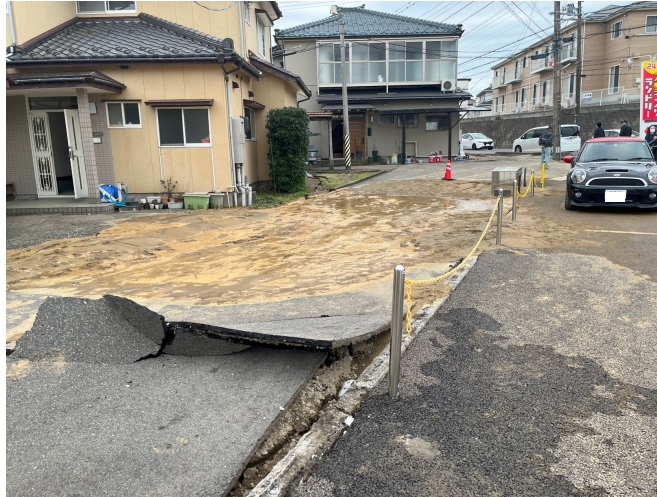
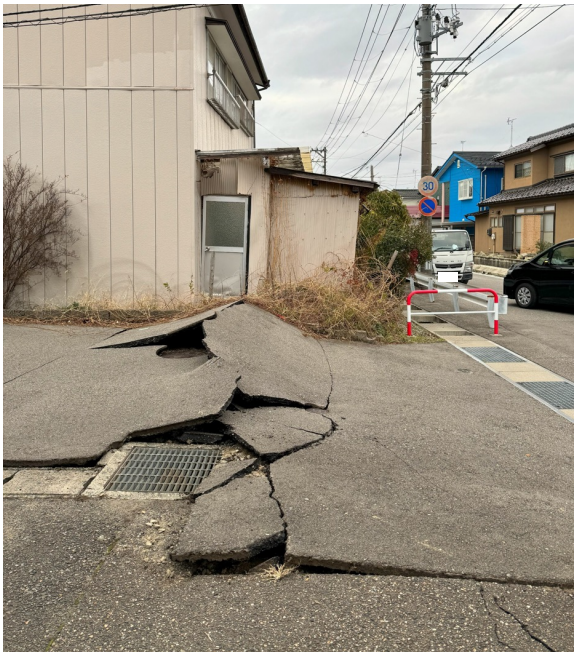
- The middle to tail end of Niigata dune slopes showed many open cracks or sand ejecta
- Thick pavement or small channels may block larger sliding

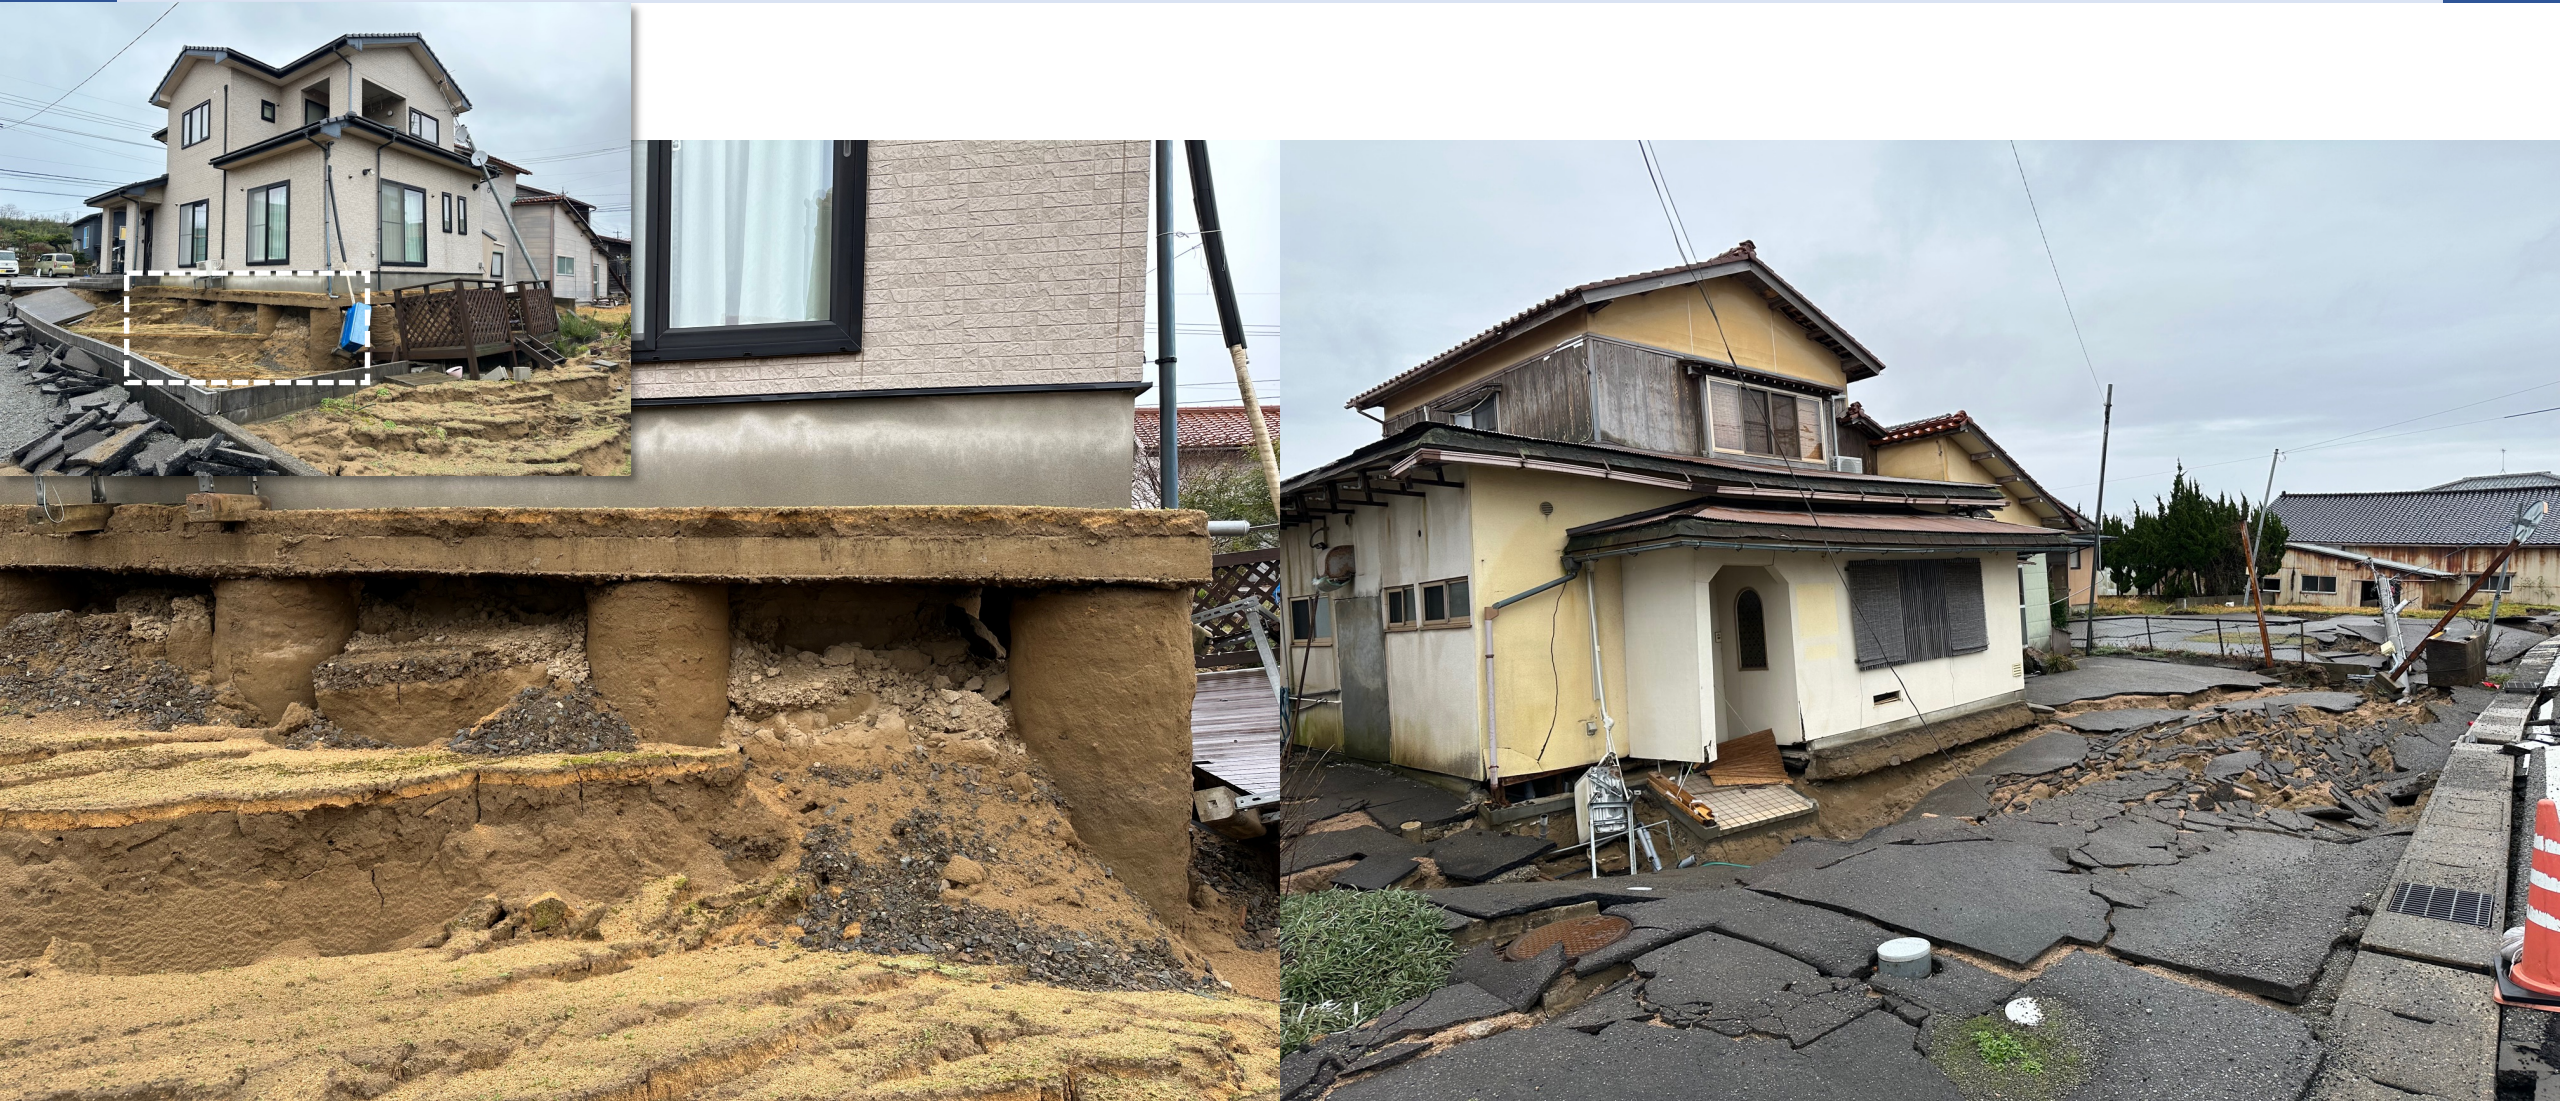
A two-stories house with cement mixing improvement has stood without apparent tilting while other houses inclined several degrees and had serious damage to the base ground

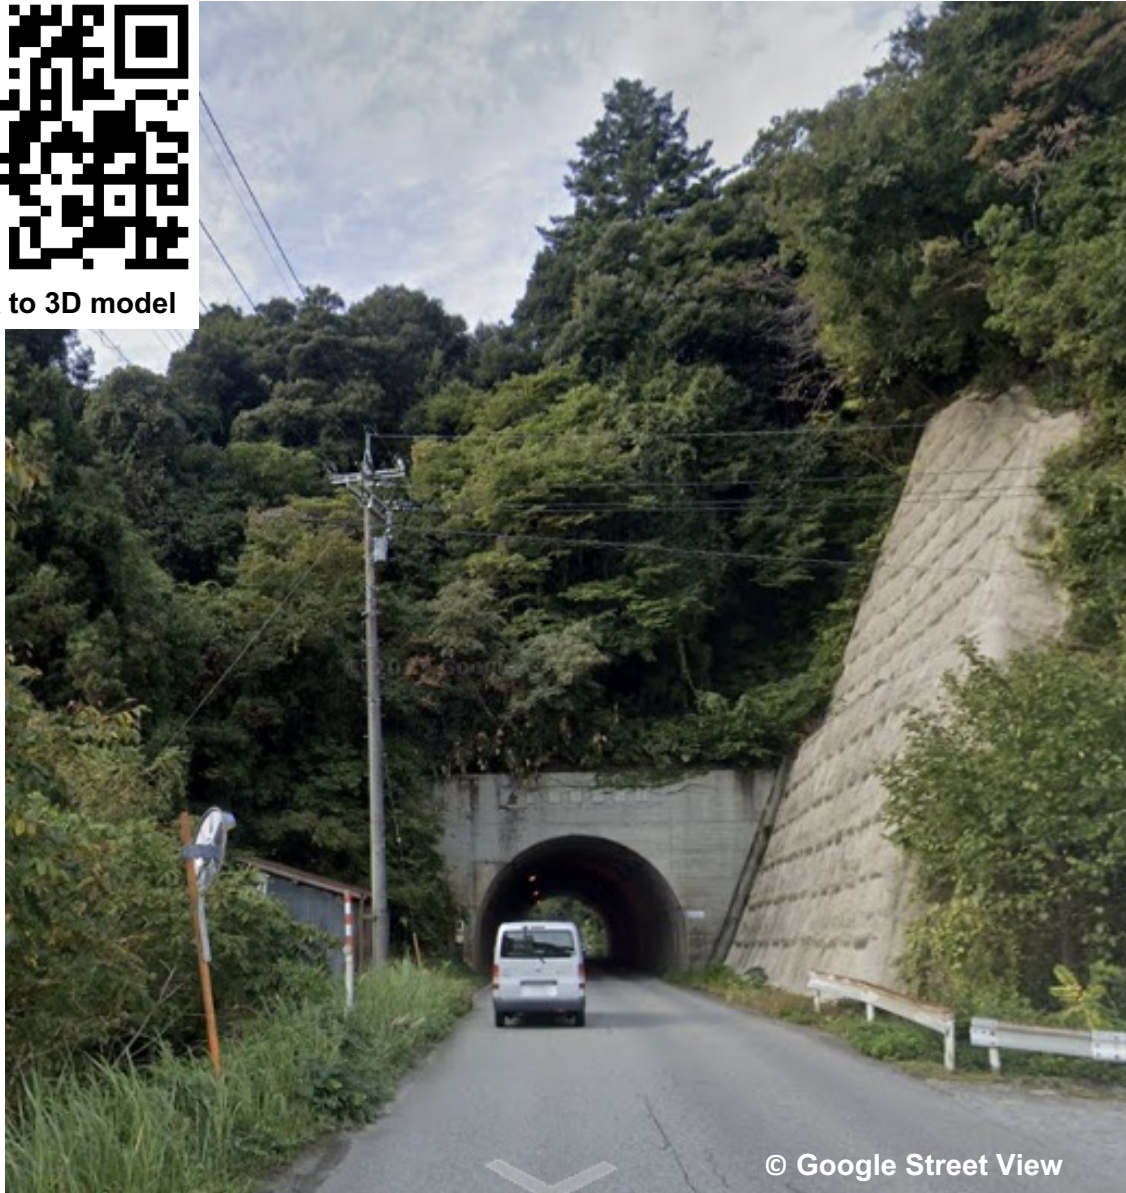
East Exit of Ushitsu No.3 Tunnel

More than 2,000 landslides, which are mainly composed of pyroclastic ([Abe et al., 2024](#)), made access to remote areas difficult
