SITE INVESTIGATION OF THE AHAR-VARZEGHAN EARTHQUAKE IN NW IRAN OF AUGUST 11, 2012

Key facts:

- Hazard type: Earthquake
- Date of disaster: August 11, 2011
- Location of the survey: East Azerbaijan County, Iran
- Date of the field survey: August 26th - 31st, 2012

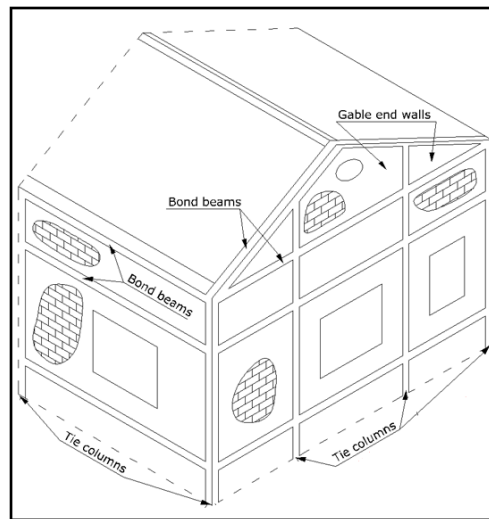
Figure 9 Structure of half reinforced masonry building

Half reinforced buildings are comprised of tie columns and bond beams filled with masonry walls and covered by ordinary joist concrete beams. This type of buildings has grown to be used in villages after promotion by the Housing Foundation of Iran.

These buildings showed much better behavior in the course of the recent earthquake and there was not observed any total collapse in them. However, most of these buildings tolerated some minor damages and few of them even involved serious damages. The main reason for the damages can be mostly attributed to the following factors:

1. Lack of construction of suitable connection detail of tie columns and bond beams. Or missing some tie columns amid long walls.
2. Use of poor quality concrete and providing low diameter reinforcement. Also, compaction of concrete during construction is not done as appropriate.
3. Construction of a specified map required by the Housing Foundation for use of loan according to the code of practice of Iran (Code No 2800) and addition of some rooms without tie columns and bond beams later.
4. Lack of a proper connection of surrounding beam and columns to the filling walls. This factor is responsible for the utmost of the damages in these buildings.
