SINKING OF HILL ROAD DUE TO GRAVITATIONAL DEFORMATION AND RATE OF SINKING AT PAGLAJHORA SINKING ZONE IN DARJEELING HIMALAYA IN INDIA

Yoshinori KAWAMURA ¹and Takayuki MAYUMI ²

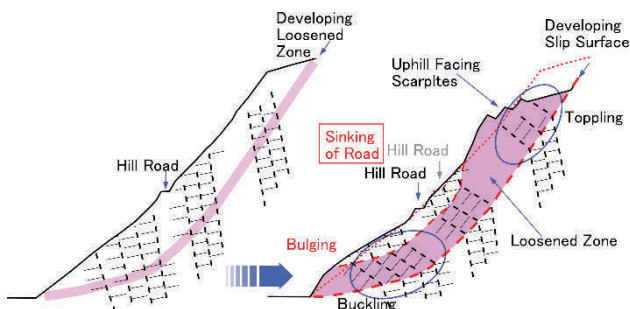
Figure 2 Development of Gravitational deformation²⁾

Gravitational deformation also involves loosened zones of fractured bedrock, where bedrock creep proceeds with toppling at the shoulder and buckling at the middle and toe as shown in Figure 2. The loosened zones often form water passage for fissure water. At the toe of slopes where loosened zones appear to the surface, groundwater spring / seepage are often observed.

Gravitational deformation often starts from relaxation of hill slope due to unloading or stress relief. Along with relaxation, facilitated by fractured zones of bedrock, loosened zones develop underground mainly parallel with slope surface as well as at the flanks of deformation blocks. In loosened zones, bedrock creep proceeds slowly but steadily and downward deformation of a block follows, which results in sinking of hill loads²⁾. In several decades, sinking of hill roads by gravitational deformation may reach a height of several tens meters, such as shown in Figure 2.

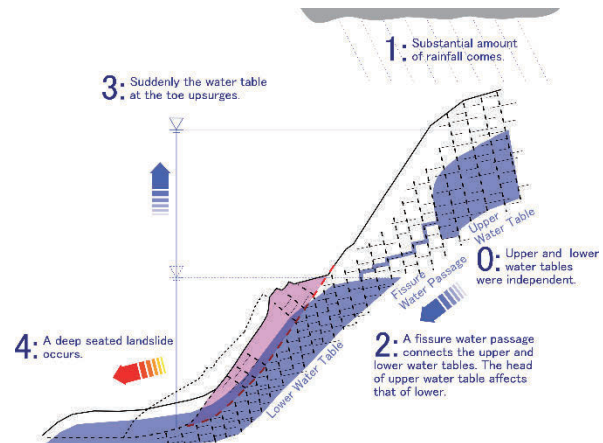
Figure 3 Possible Mechanism of Deep-seated Landslide²⁾

Triggering a deep-seated catastrophic landslide may require strong force to destabilize large parts of a bedrock slope. Figure 3 shows a possible process of generating pressured fissure water strong enough to cause such landslide²⁾:

- The lower water table formed by fissure water behind a gravitational deformation slope is independent from the upper one, which may lie in upper slope far behind the lower one.
- Due to abundant provision of water to the fissure in upper slope by substantial rainfall, a fissure water passage connects the upper and lower water tables. Then the head of the upper affects the lower.
- The head of the lower water table at the toe of the slope drastically surges, up to the head of the upper one less resistance loss.
- A deep-seated catastrophic landslide is triggered by such strong water pressure.

Interestingly, a peculiar hole similar to that of Figure 4 was reported at the trace of the deep-seated landslide¹¹⁾. It is thought to be made by the strong water pressure explained in Figure 3 as well.

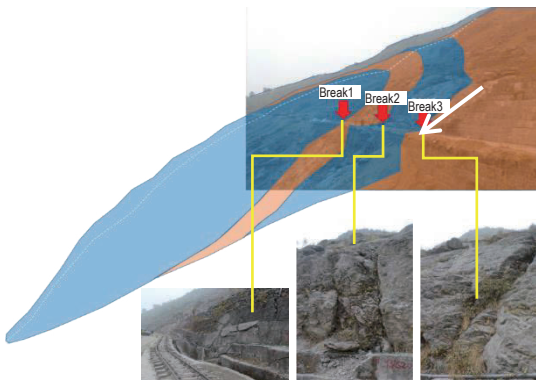
Figure 7 Gravitational Deformation in Layered Structure²⁾

Figure 7²⁾ explains the deformation in three layers. Bending and sinking of NH55 and the railway track of DHR have been observed as shown in Figure 8²⁾.

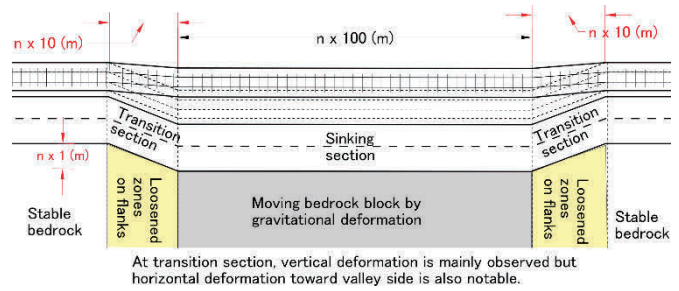
Figure 10 Typical Form of Road Sinking in Paglajhora (no scale)

A typical form of road sinking in Paglajhora Sinking Zone is explained in Figure 10.

A sinking section often has transition sections on both sides at the boundaries with neighboring stable sections. Sometimes it is found only on one side. By comparing the map reading result in Figure 6 and the actual site conditions, it is understood that the transition sections correspond to the loosened zones at flanks of the gravitational deformation blocks.
