Bridge one:

Varzaghan-Tabriz road.

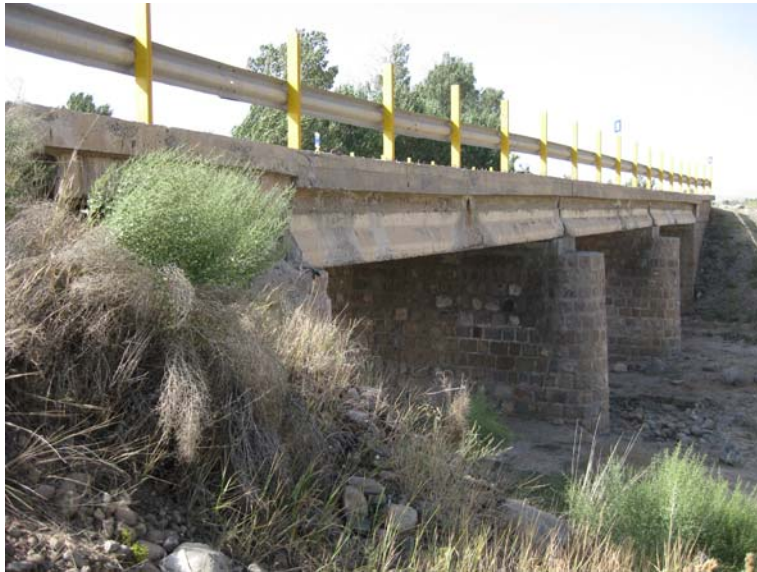
East view

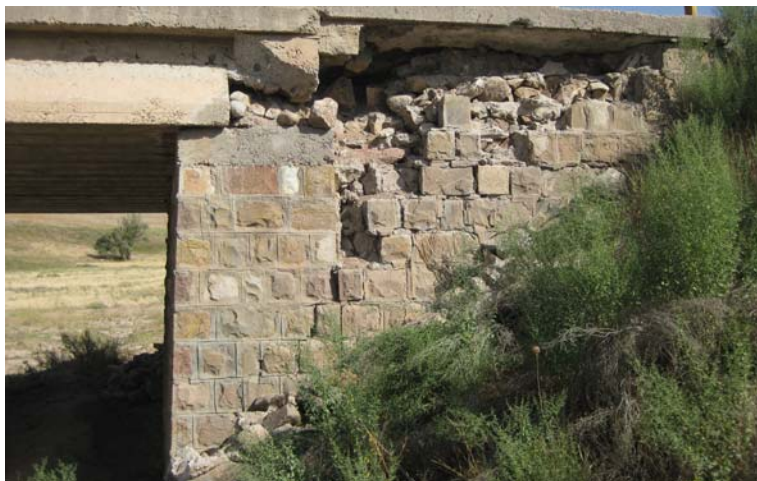
Damage to Abutment- West view

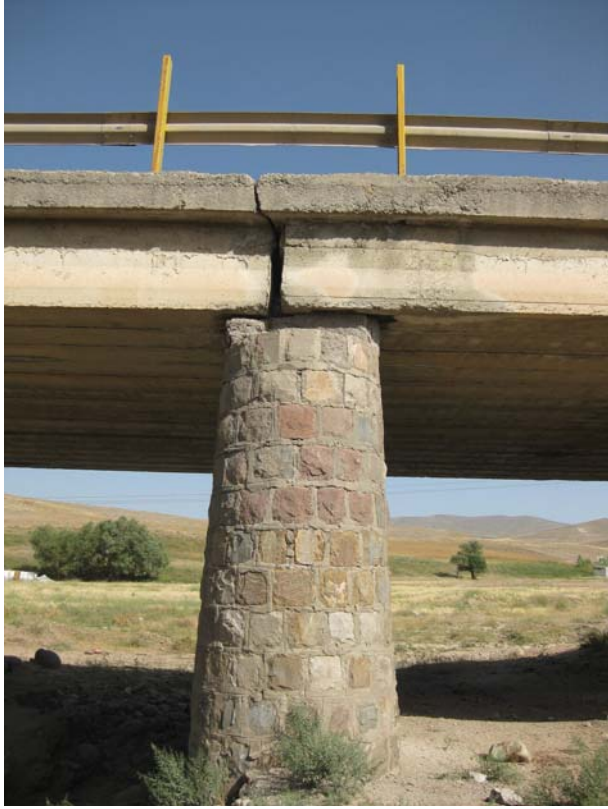
Sliding of the bridge- West View

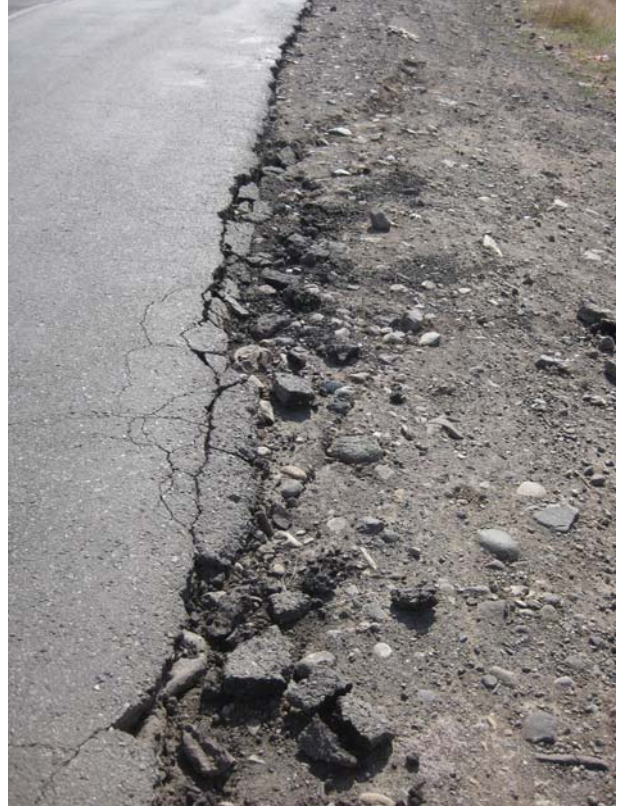
Cracks appeared due to landslides 100m after the bridge
