Damage of Infrastructures due to 2011 Great East Japan Earthquake

Keiichi Tamura

Public Works Research Institute, Japan

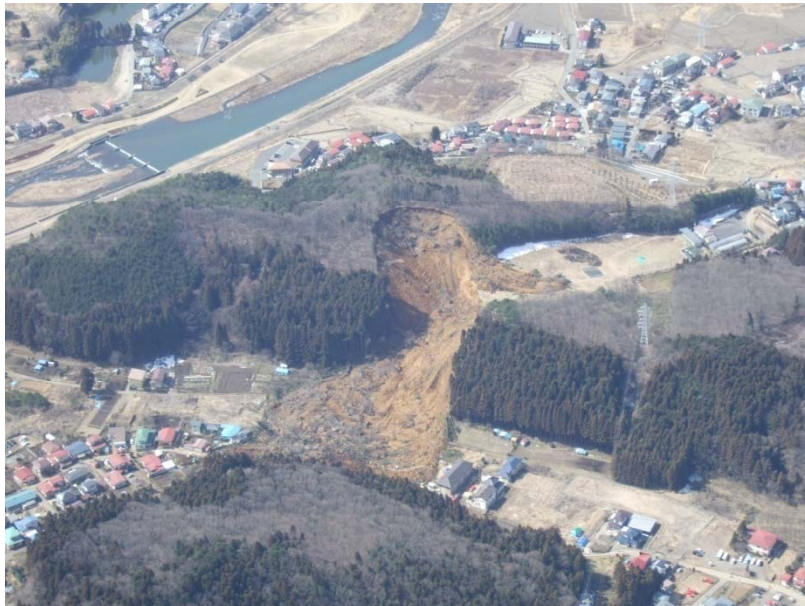
Hanokitaira, Shirakawa City

- Width: 70m, Length: 160m
- 13 deaths, 10 destroyed houses
- Mainly consists of aeolian deposit of volcanic ash soil.

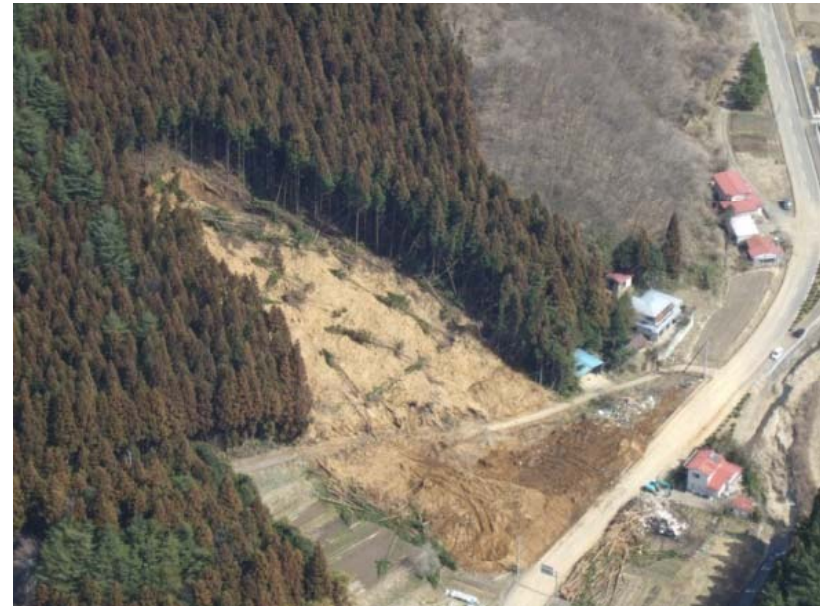
Okanouchi, Shirakawa City

- Width: 50m, Length: 100m
- 1 death, 1 destroyed house
- Mainly consists of aeolian deposit of volcanic ash soil.

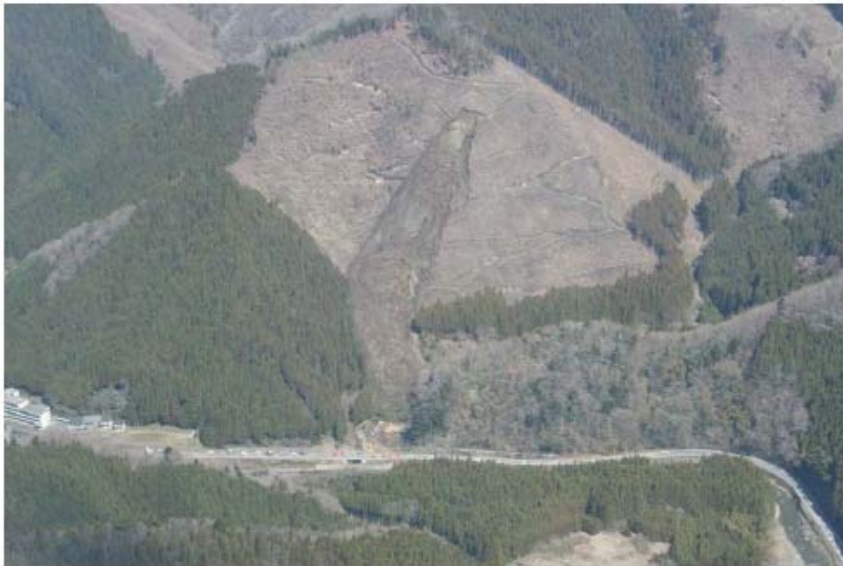
Tabito, Iwaki City

- An aftershock (M7.1) occurred on April 11. Maximum seismic intensity was 6-.
- Induced slope failures and landslides.
- In Tabito, Iwaki City, a landslide destroyed 3 houses, caused 3 deaths, and generated a landslide dam.

- Height: 170m, Width: 50m

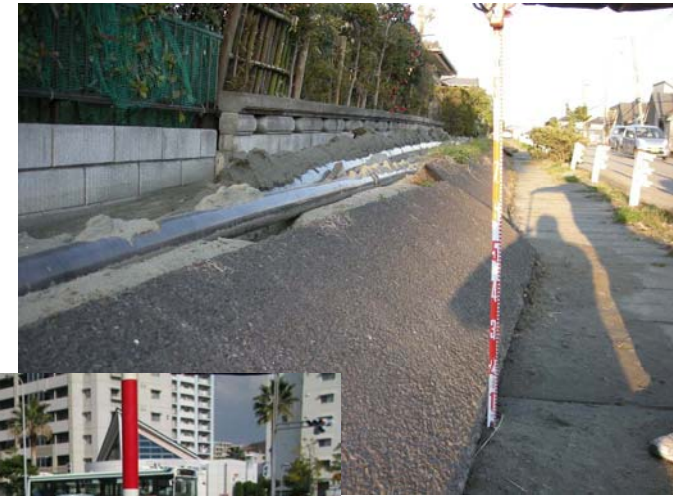
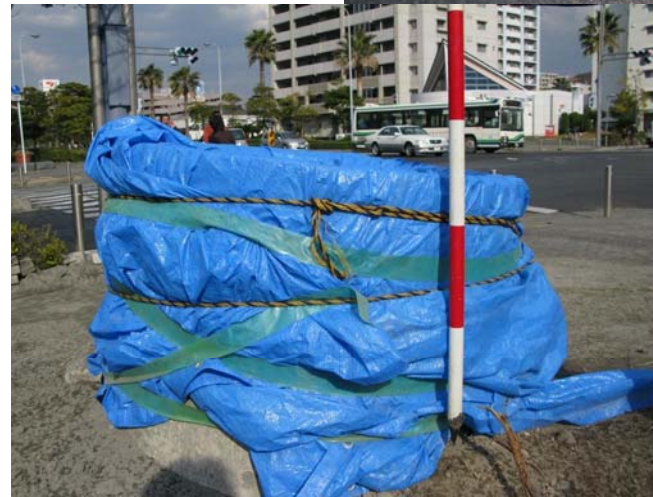
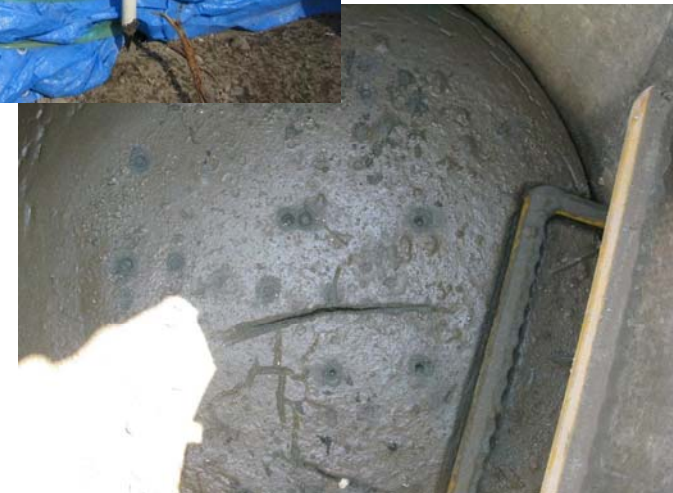
Waste water pipe
damaged area due to
liquefaction

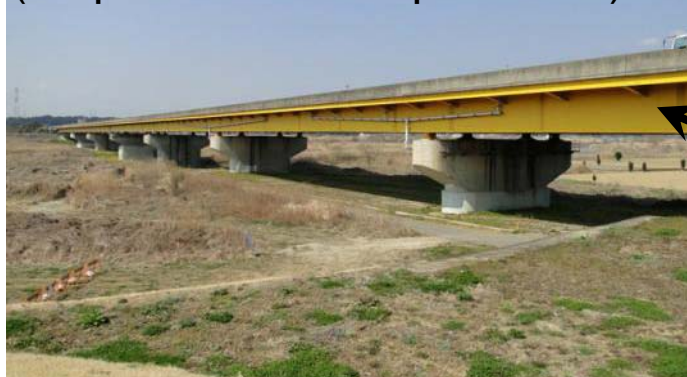
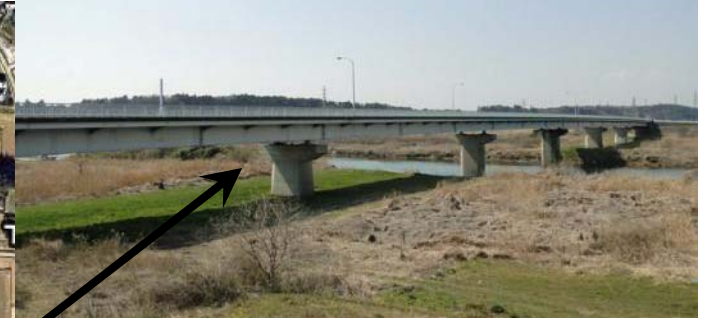
Damage to cut-off section of long. rebars

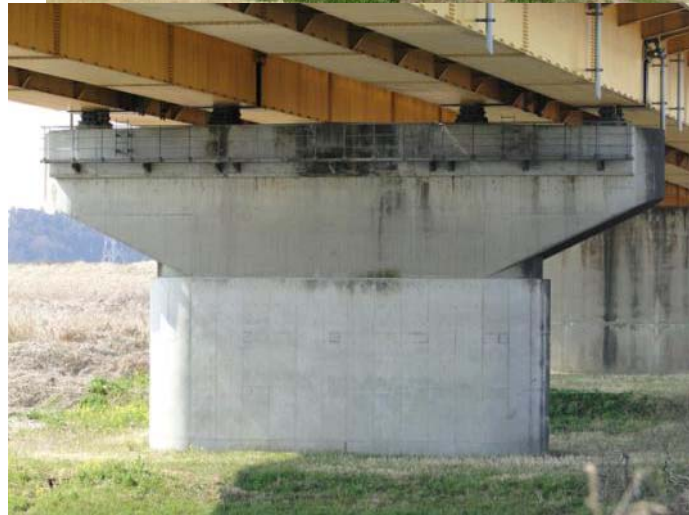
No damage to piers or bearings

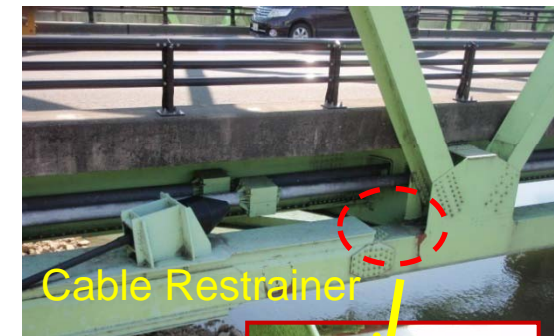
4. Backwall of abutment (0.7%)

- Crack

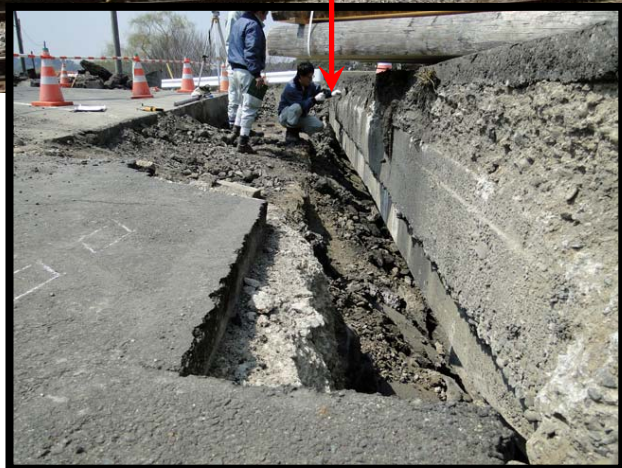
Overpass

Damage to approach of bridge

- Settlement of backfill soil of abutment

40 cm
settlement

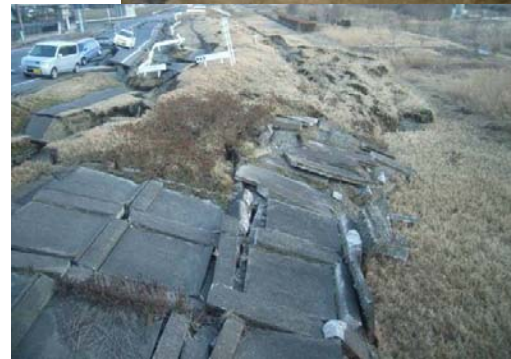
Effects of liquefaction

Liquefaction
at adjacent
levee

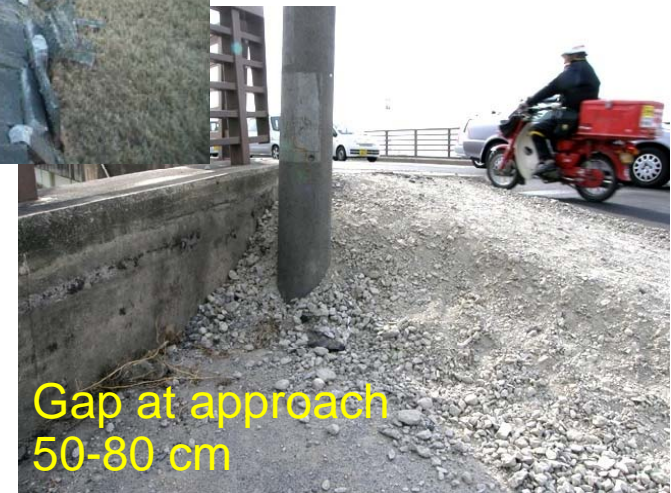
Gap at approach
50-80 cm

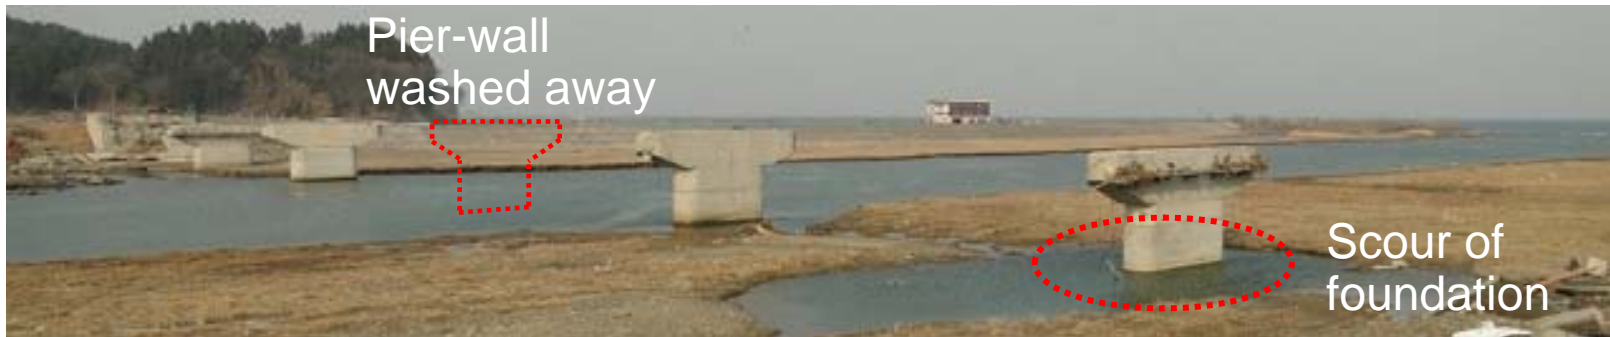
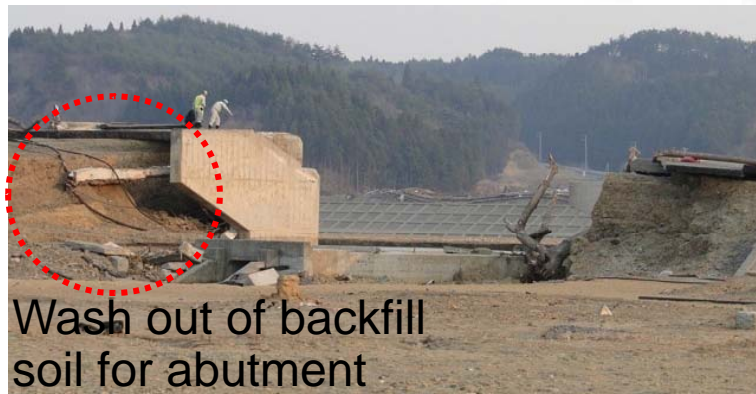
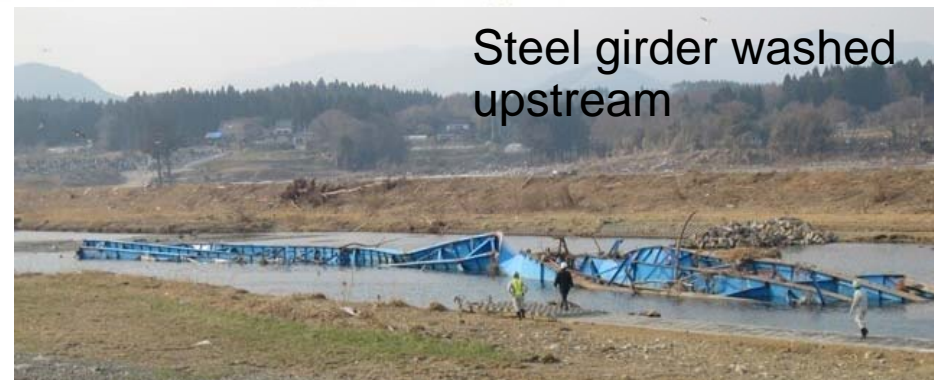
Effects of tsunami

- 6-span steel girder bridge (two 3-span continuous girders).
- All spans of girders, one substructure and backfill soil of abutments were washed away.

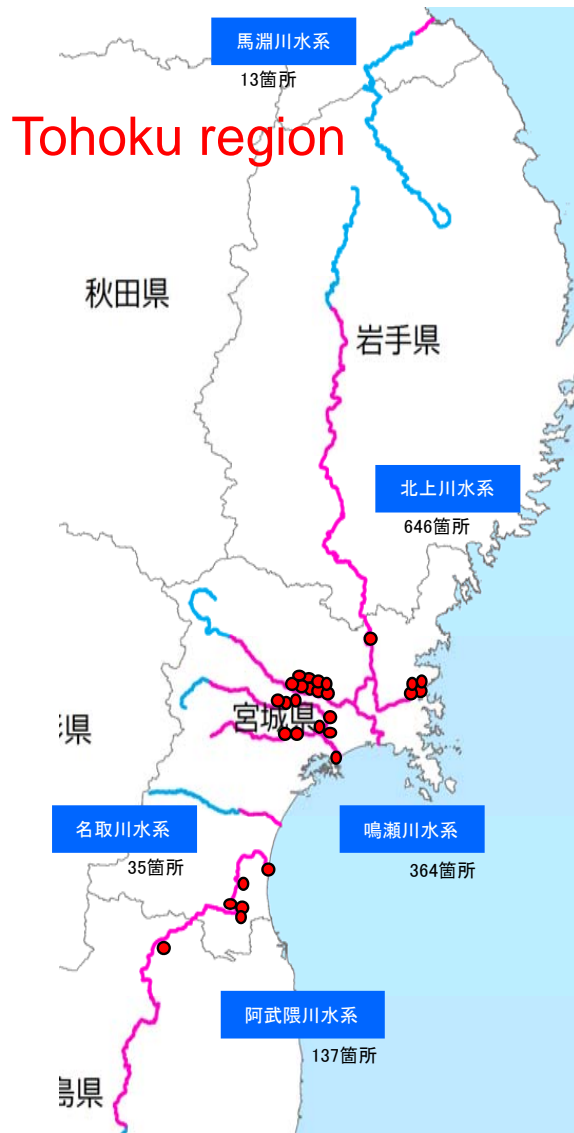
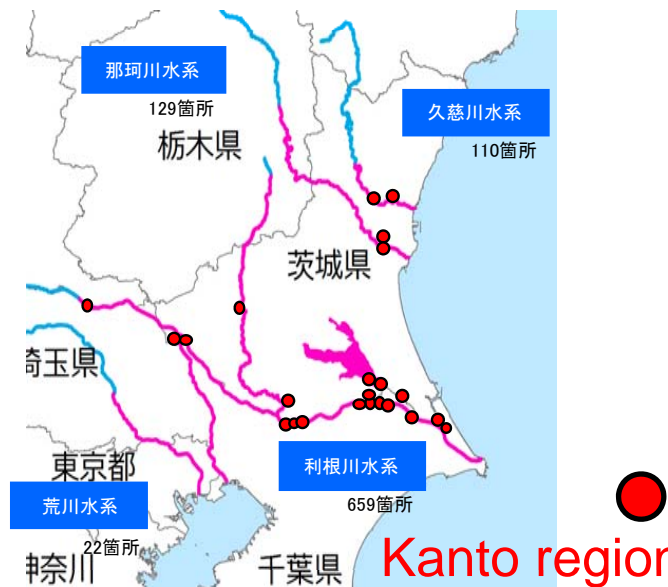
Location of levees damaged

- Levees were widely damaged over Tohoku and Kanto regions.
- Damaged levees along the rivers directly administered by MLIT exceeded 2,000.
- Major damage was due to liquefaction.

● Significant damage

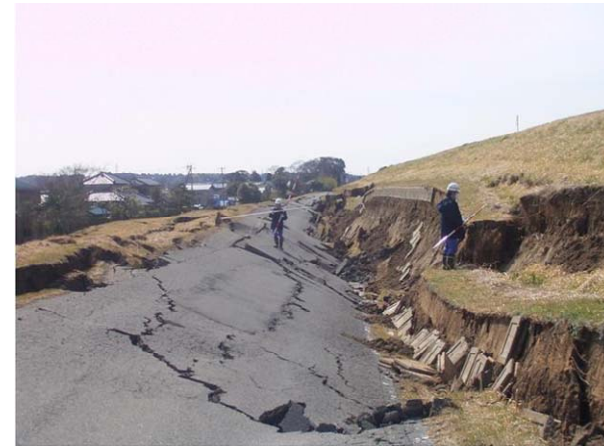
Tone River, Chiba Prefecture

- Typical damage of levees includes crack, settlement, slope failure, etc.

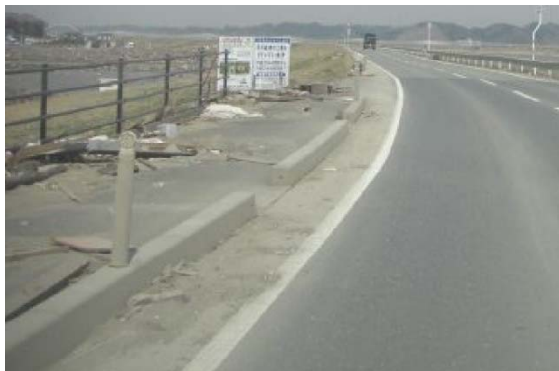
Effectiveness of earthquake countermeasures

- Naruse River (Nakashimo). Improved by sand compaction piles.
- Although the inner side of levee was inundated with tsunami, no settlement or deformation of levee occurred due to ground motion.
