2009年インドネシアスマトラ沖地震 復旧支援協力チーム被害調査報告会

調査日: 2009年10月16日-18日
開催日時: 平成21年10月29日(木) 14:00~17:00
開催場所: 土木会館2階講堂

東京大学生産技術研究所
都市基盤安全工学国際研究センター

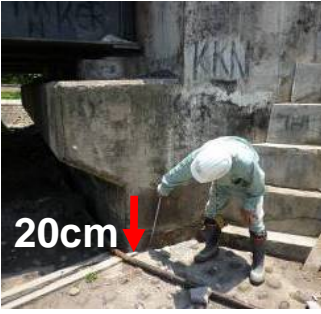
(2)

Bridge 4

20cm settle down at abutment(2)

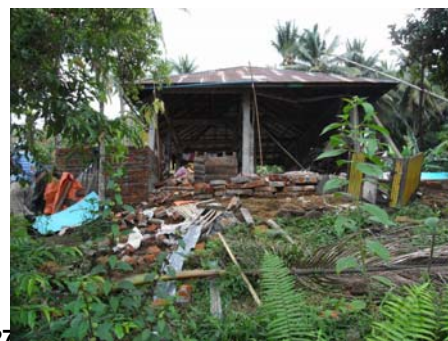
Some houses slide away

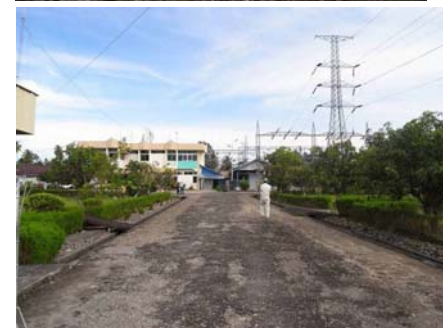
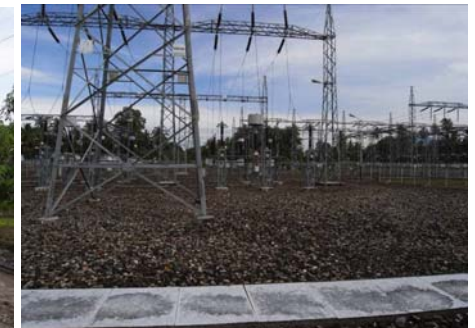
Electric power station

2 ceramic Isolators were broken, 2 days later, recovered.

Towers: No damaged
