# Quick report of preliminary reconnaissance of the 2024 Noto-hanto Earthquake in Japan —No.2—

Masakatsu Miyajima (Professor Emeritus, Kanazawa University)

Takao Hashimoto (Specially Appointed Professor, Kokushikan University)

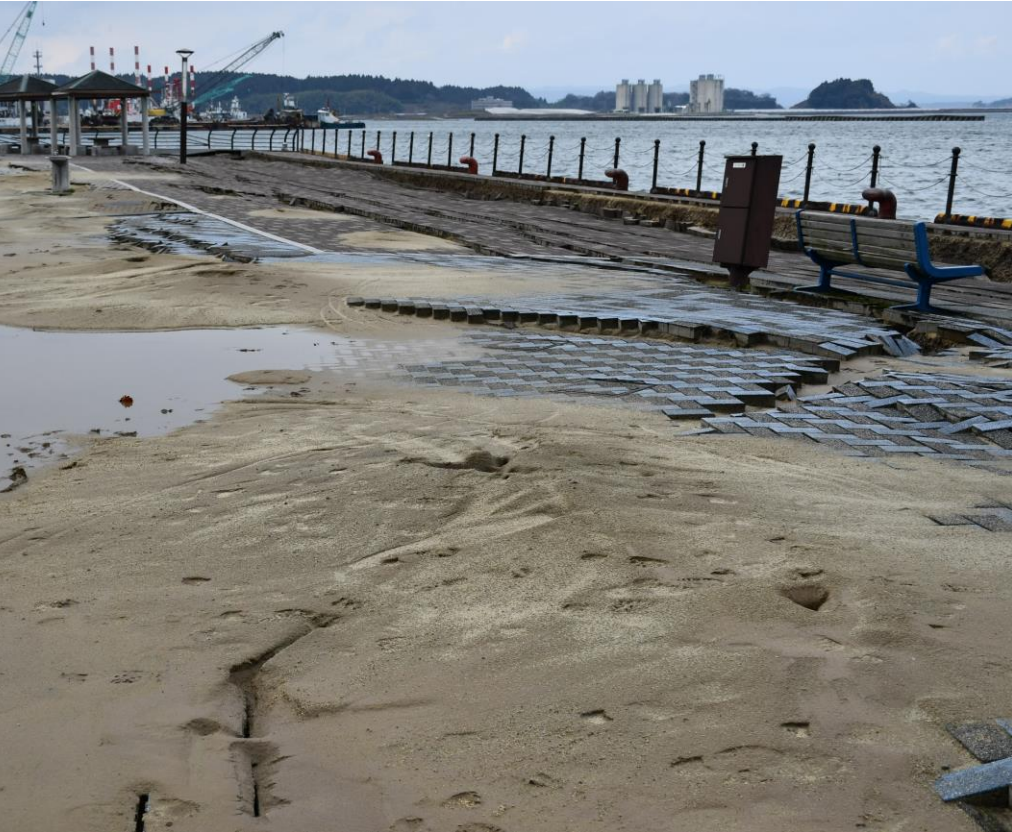
Subsidence and ejected sand due to liquefaction (Map④)

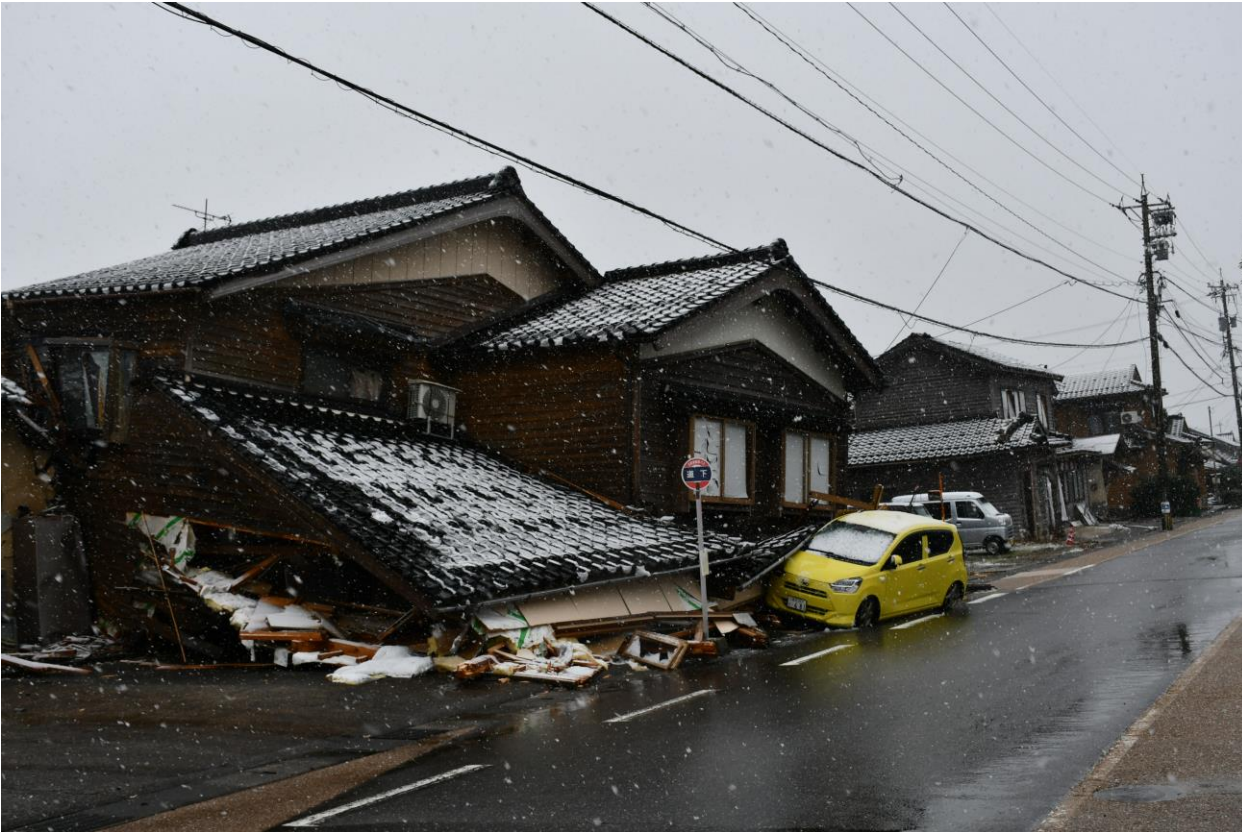
Collapse of wooden houses (Map①)

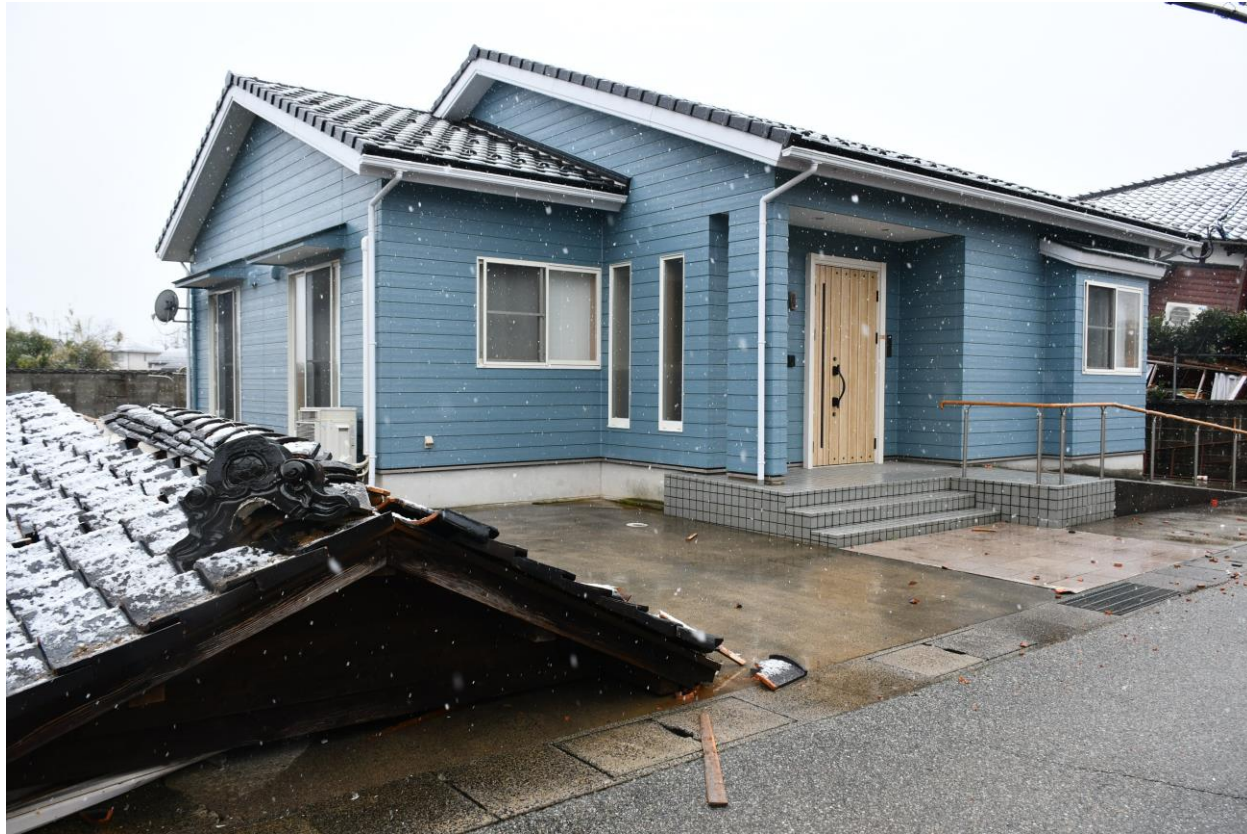
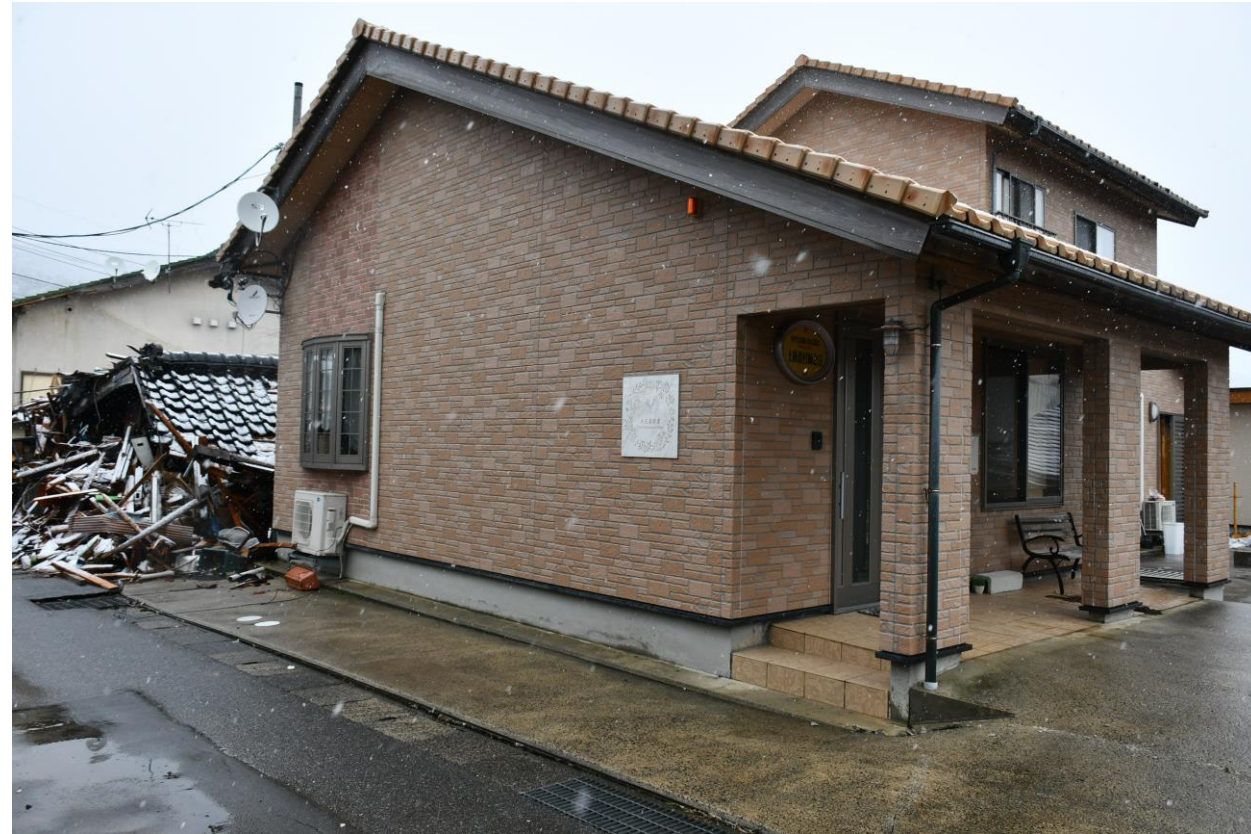
New houses were undamaged even in the affected area (Map①)

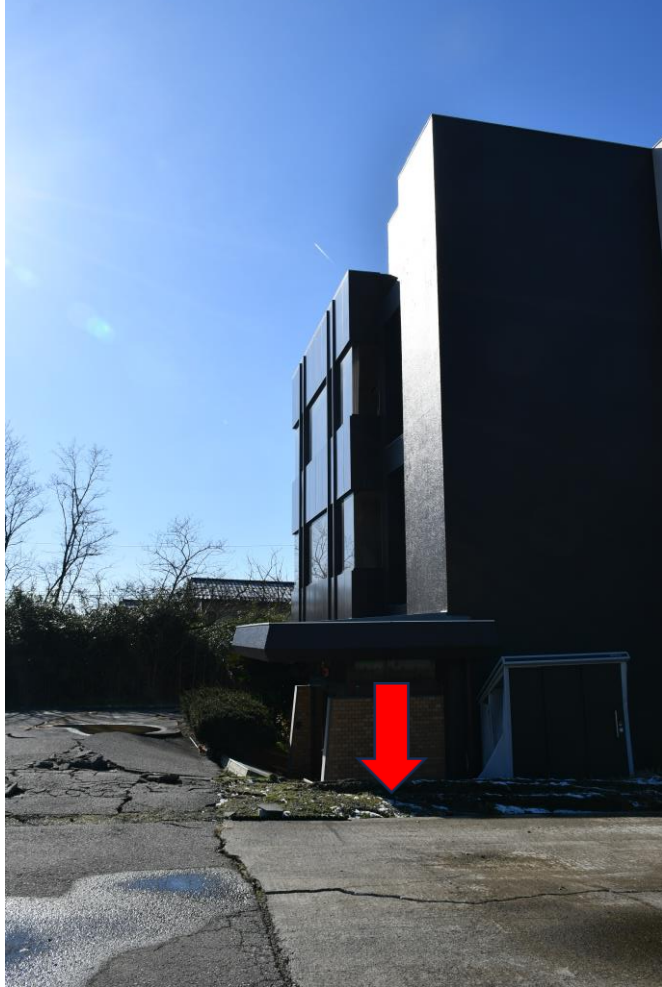
Subsidence of RC building due to liquefaction (Map②)

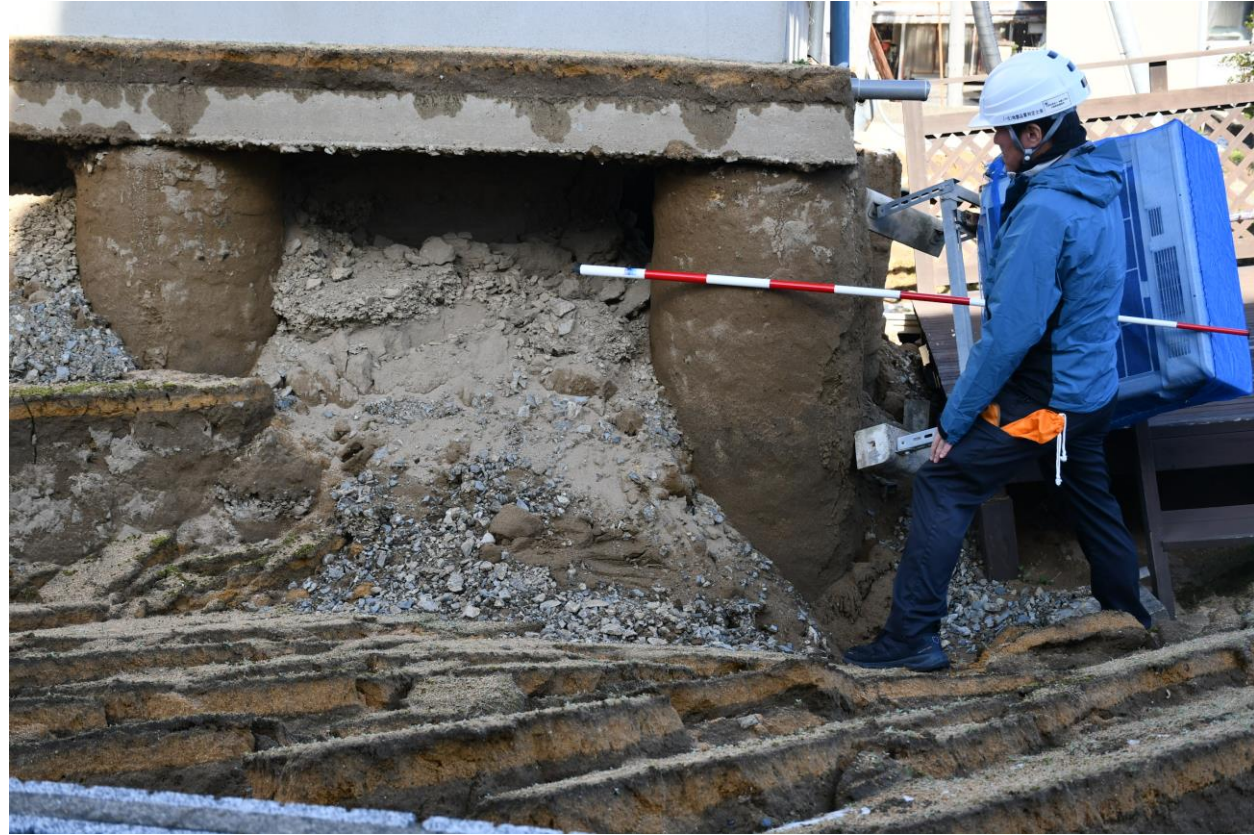
A house with ground improvement was no damage (Map③)
