A Quick Report  
on  
2025 Mandalay-Sagaing (Myanmar) Earthquake

Ömer Aydan

University of the Ryukyus, Okinawa, Japan

3<sup>rd</sup> Draft April 10

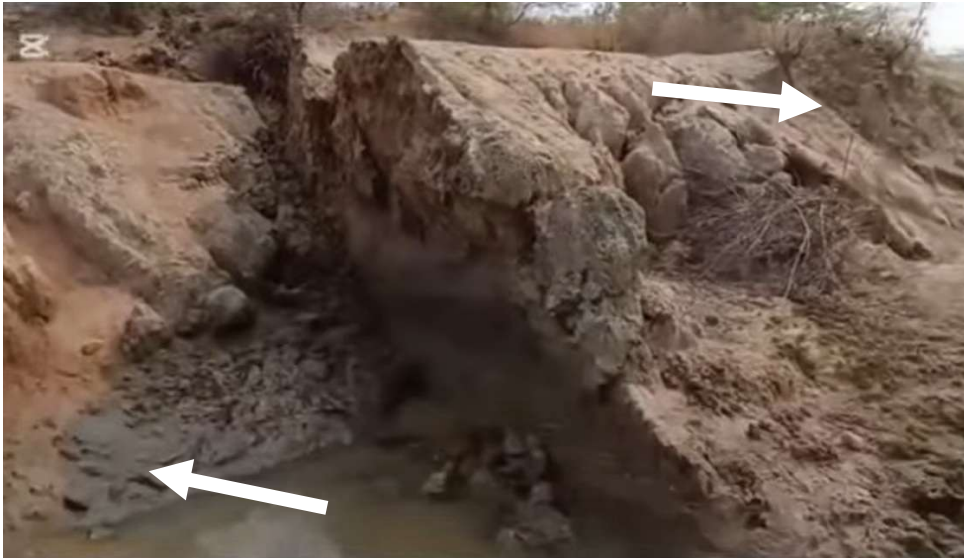
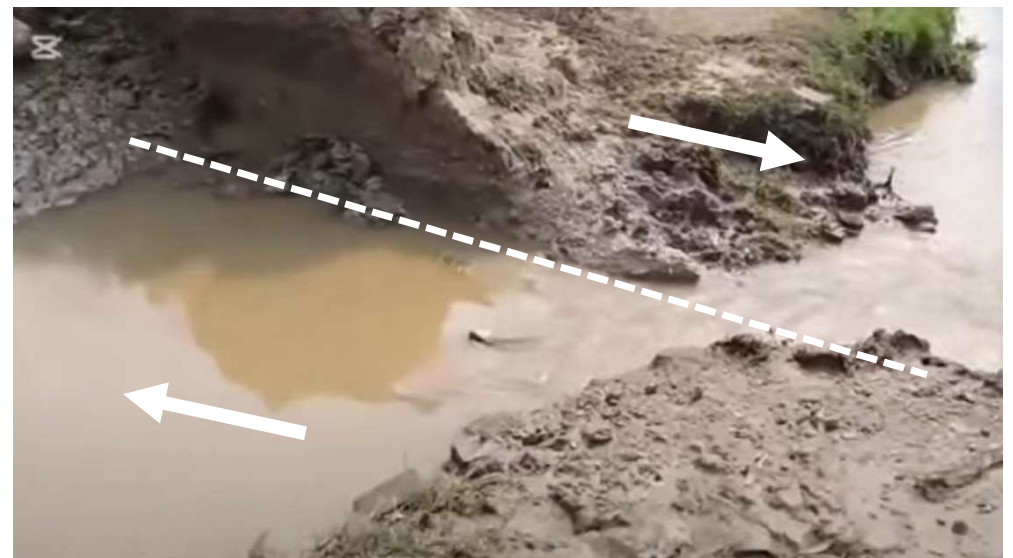
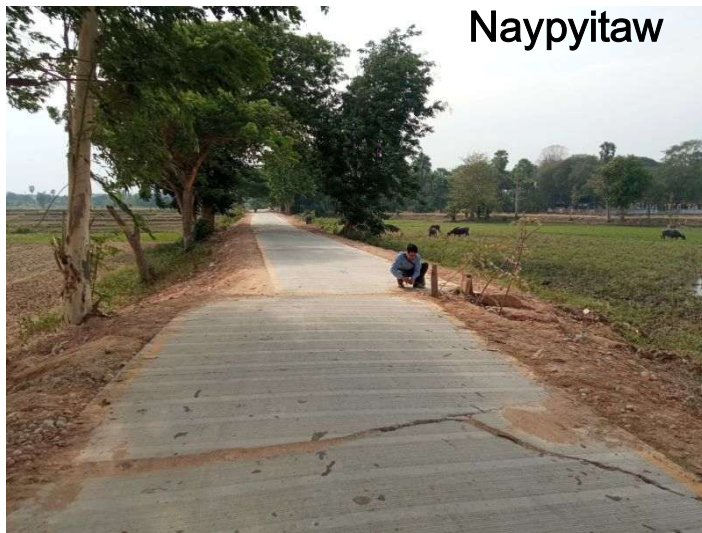
## Surface Ruptures near Sagaing

Damage is due to faulting

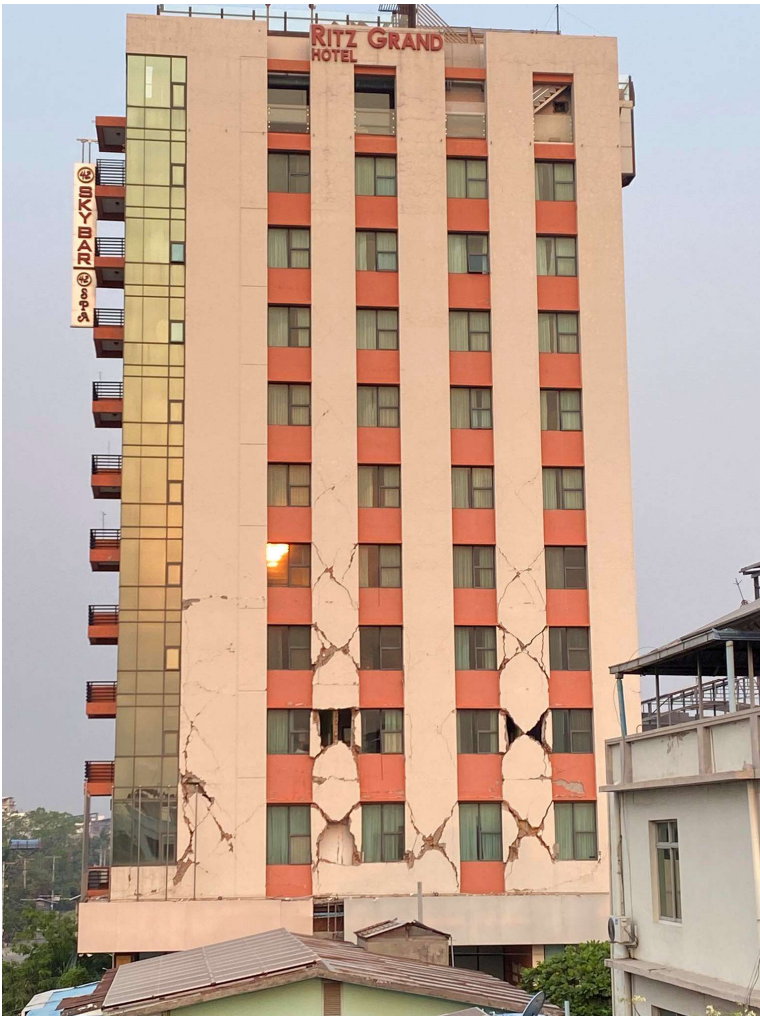
Mandalay

Soft-floor and pancake modes

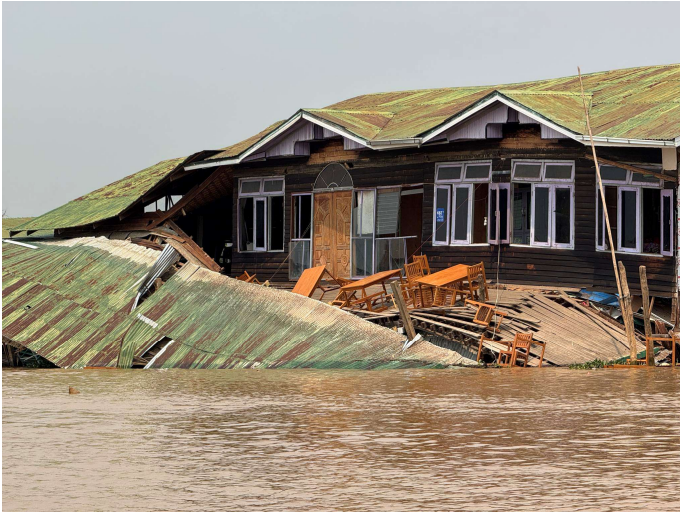
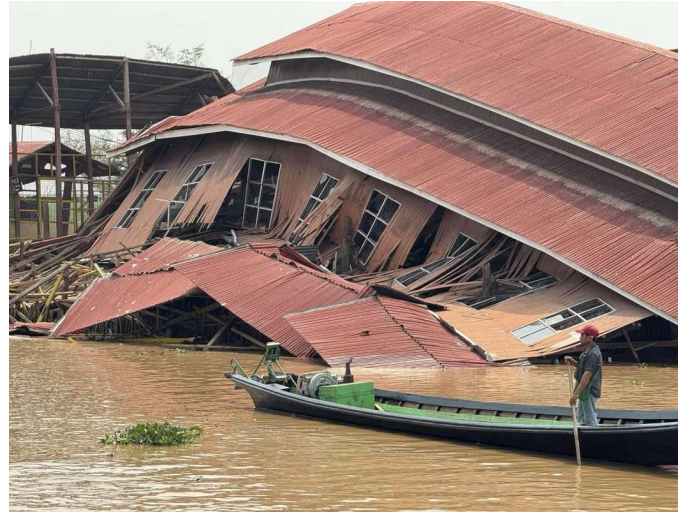
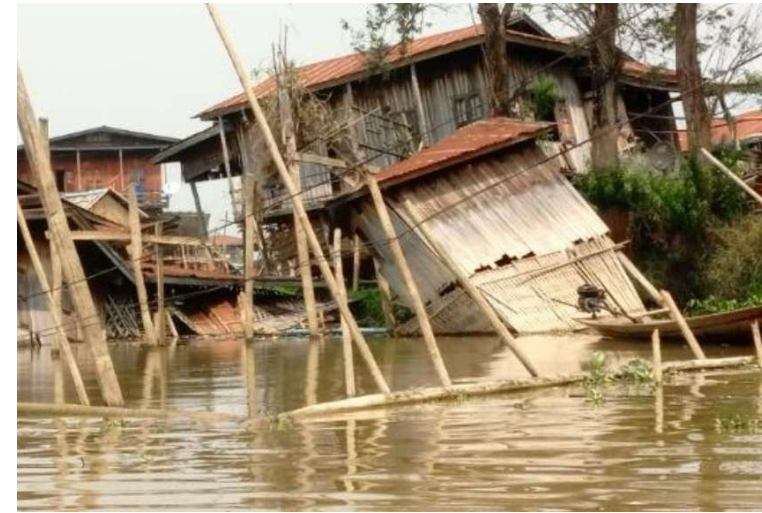
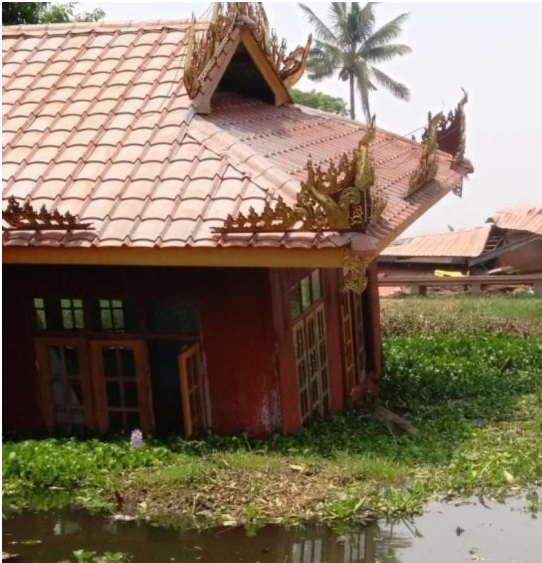
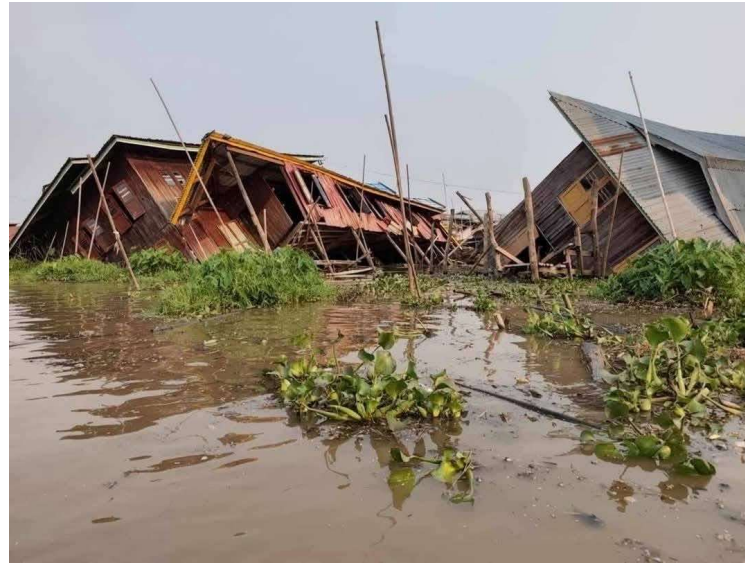
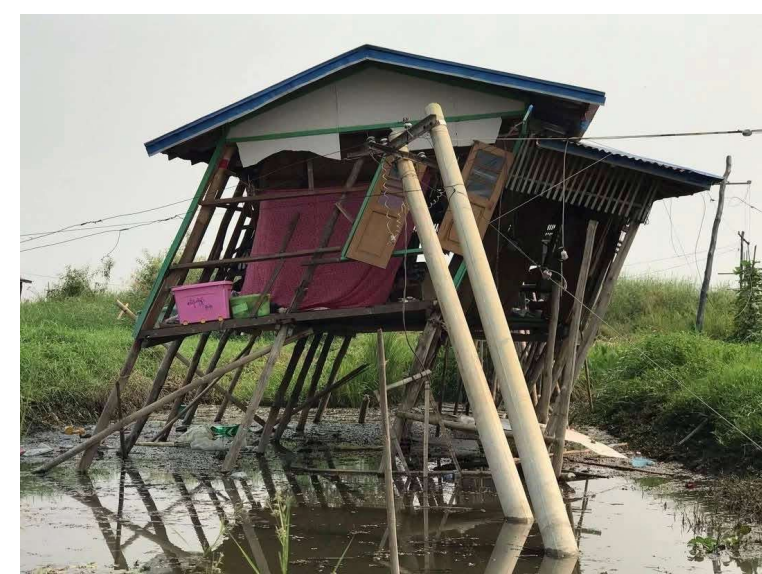
Bearing capacity issues on soft ground along lake shores

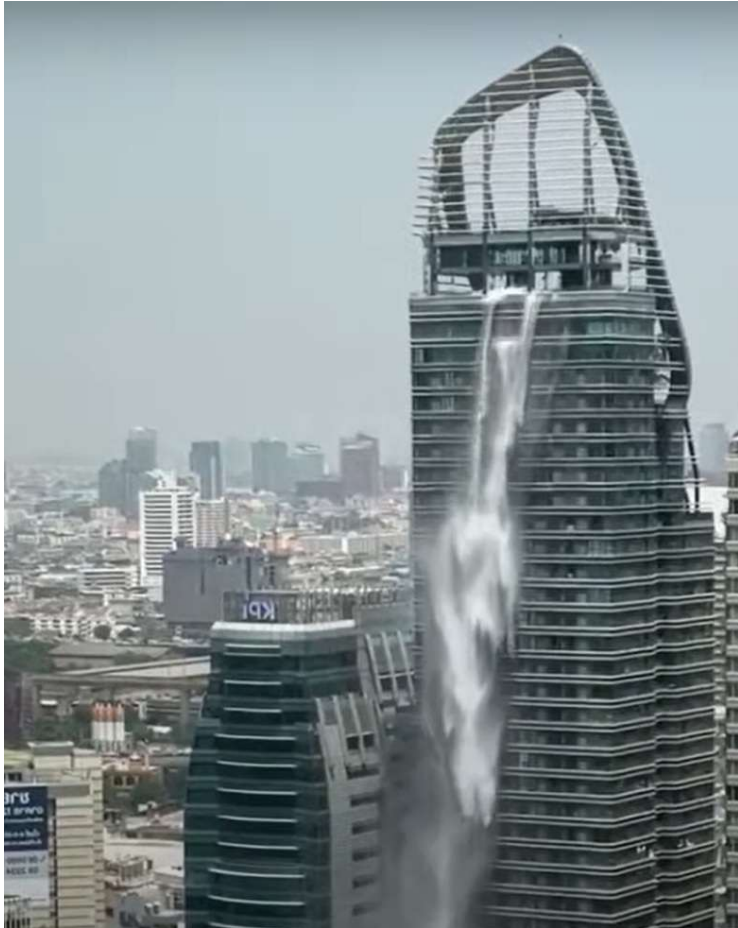
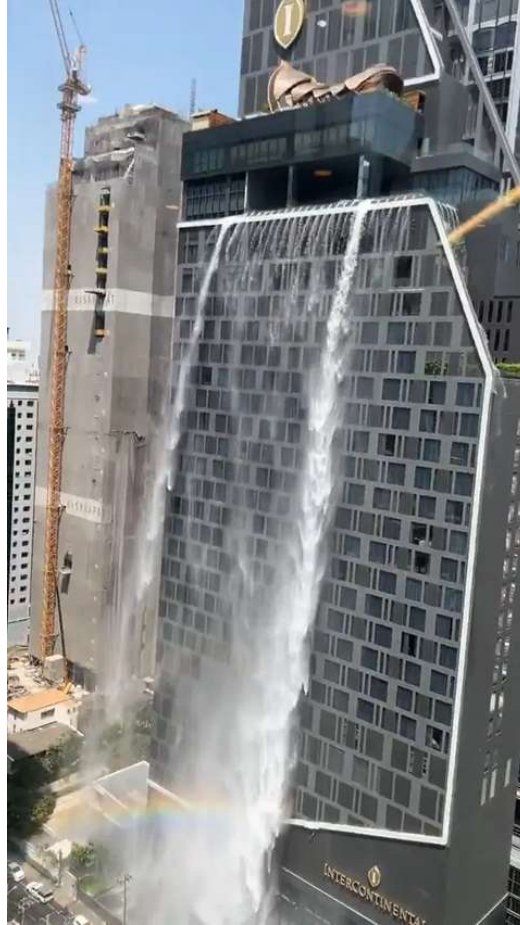
waterfall from the high-rise hotels with pools, Bangkok
